# Perfection Inspection, Inc

**Property Address:  
611 Rockwood St SE  
Salem OR 97306**

**4/18/2024**

**Jim Allhiser**

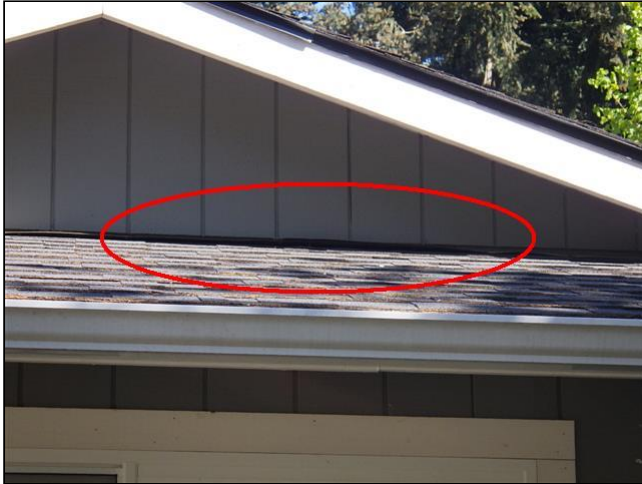
1.1 Item 1(Picture)

- 🔧 The roof-to-wall (apron) flashing was loose and could be vulnerable to water intrusion. Noted on the front of the building. A qualified roofing contractor should inspect further and correct as needed

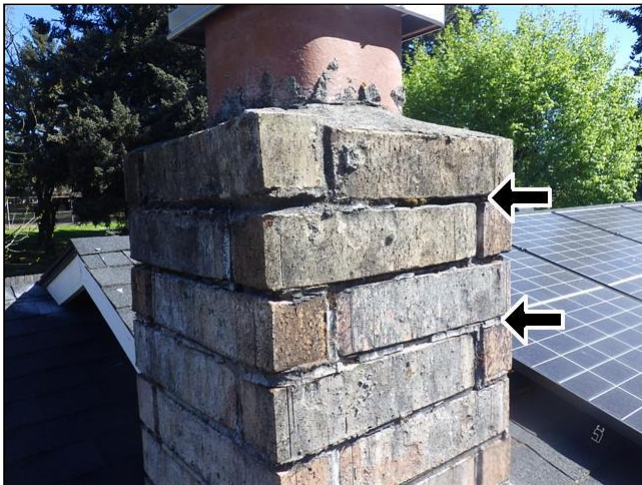
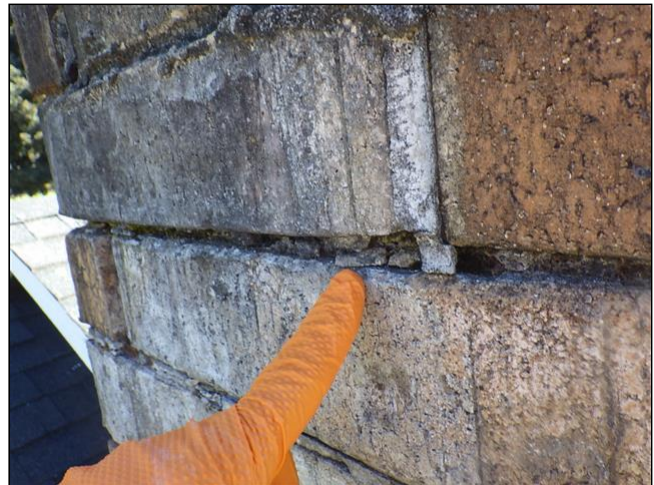
- 🔧 The masonry chimney has loose mortar. Further deterioration may occur if not repaired. A qualified contractor should inspect and repair as needed.

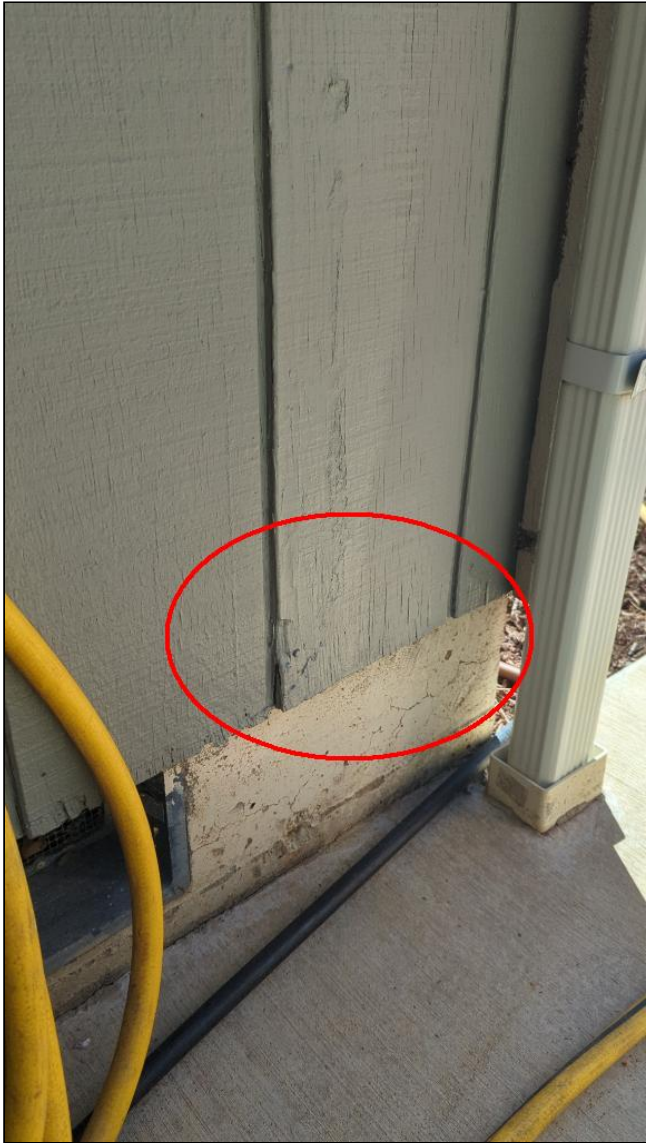
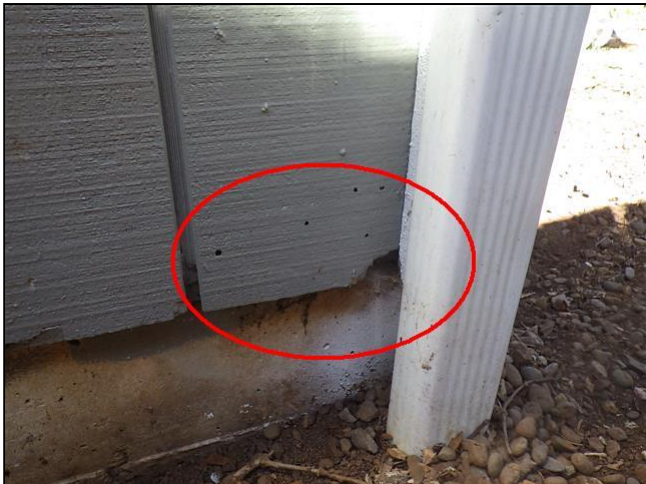
(1) The siding was deteriorated on bottom edge along the front and rear of the building (refer to pictures). Further deterioration can occur if not corrected. A qualified contractor should inspect and repair as needed.

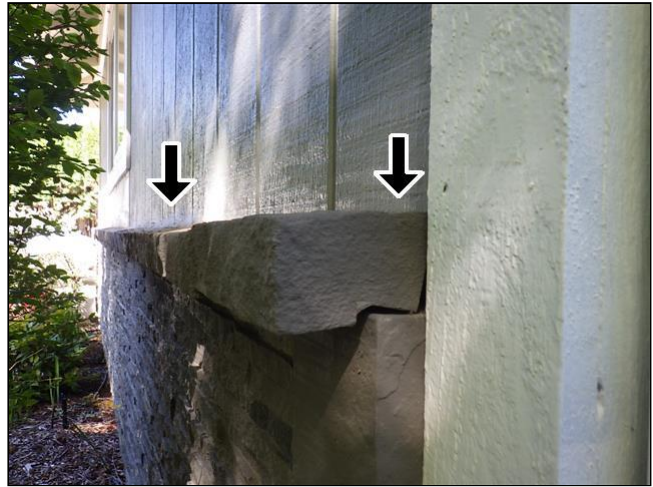
2.0 Item 5(Picture)

(2) The artificial stone veneer transitions at the front of the building was missing the top flashing.

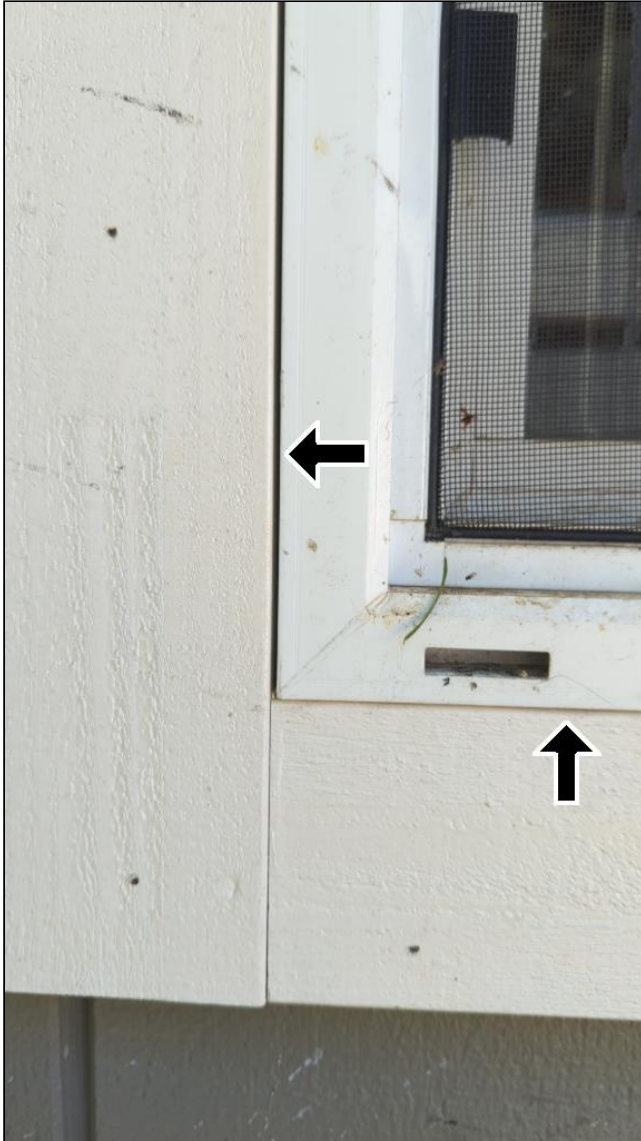
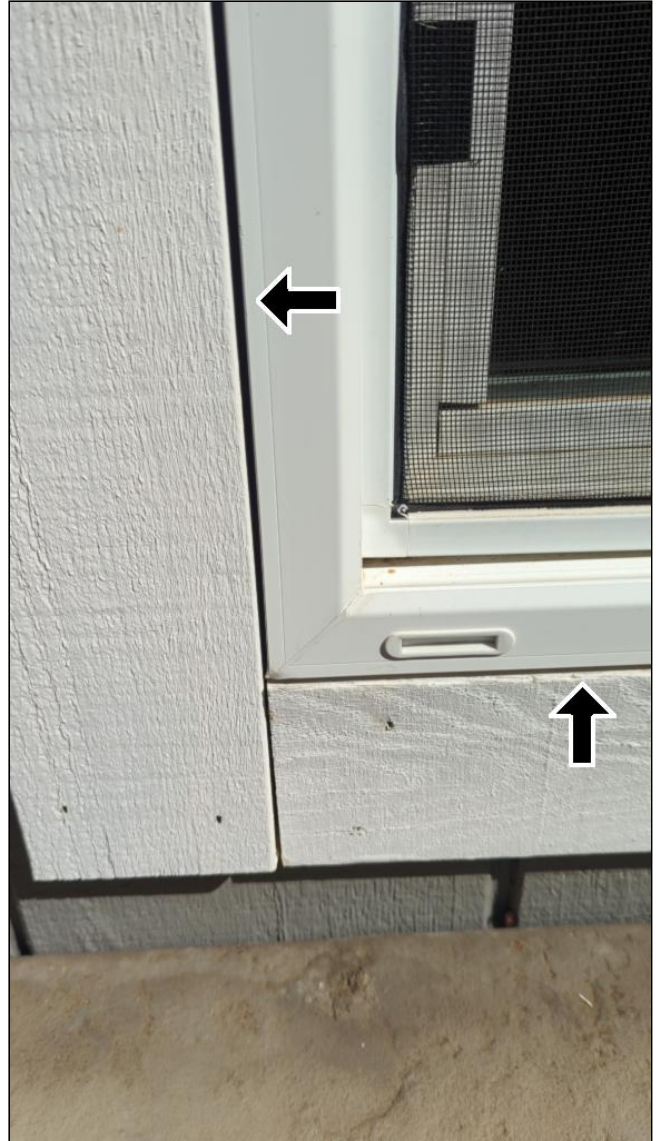
The window frames have open caulking joints at most windows. Deterioration may occur if not corrected. A qualified person should repair or replace as needed.

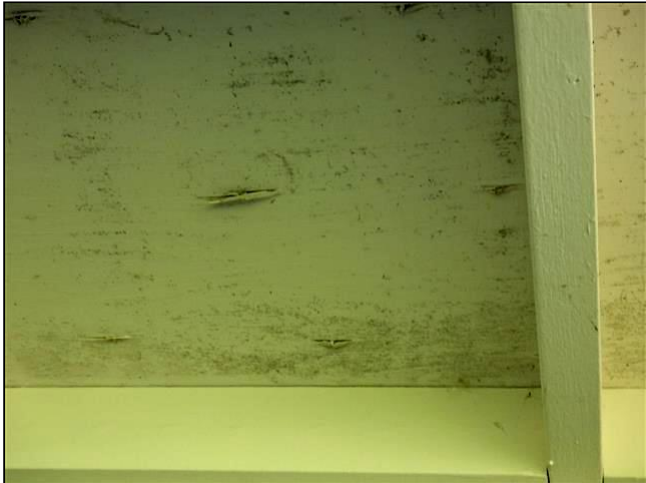
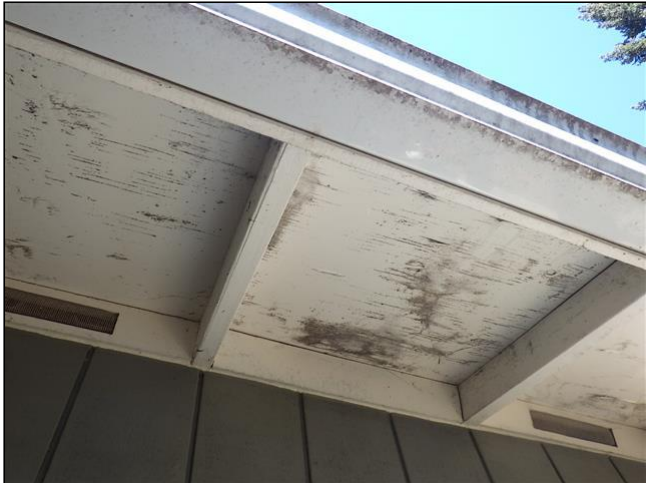
- 🔍 (1) The eave boards at eave on the exterior shows evidence of moisture staining had darkened areas of fungus/algae growth. This is normal and the eaves should be routinely painted/cleaned as necessary. I recommend prep and paint using a qualified contractor.

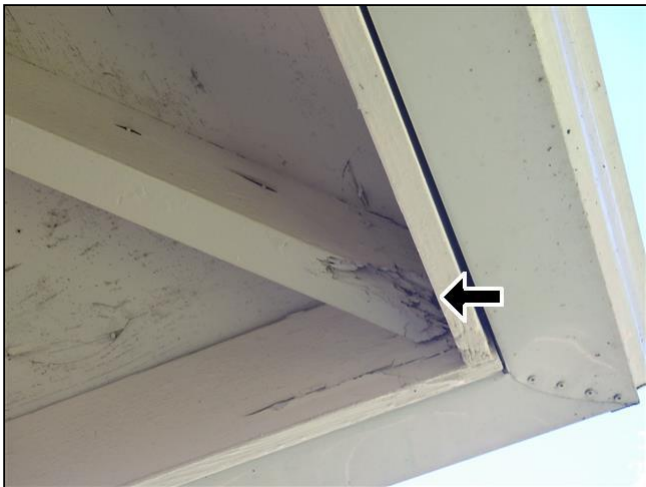
2.5 Item 3(Picture)

- 🔍 (2) The truss tails (behind gutter) at eave on the rear of the building (refer to picture(s)) had evidence of minor deterioration. This damage appears to be related to past gutter leakage that has been repaired. This issue should be monitored and repaired if future leakage/damage is noted.

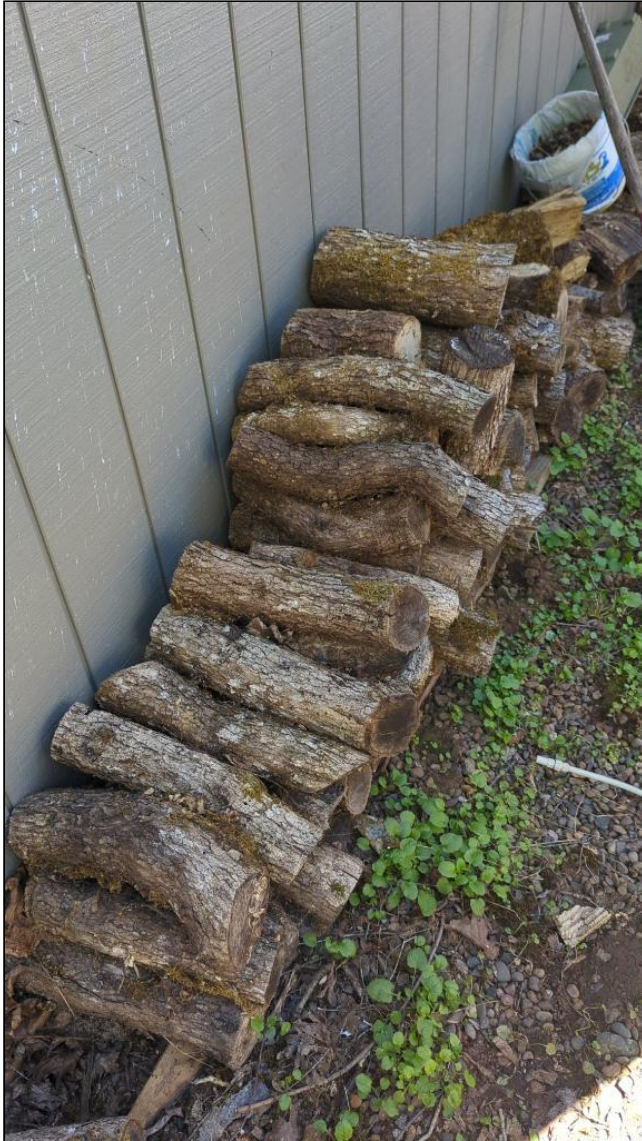
2.6 Item 1(Picture)

- 🔨 The significant wood to soil contact should be removed from the rear of the building. This task should be performed in order to provide a less conducive environment for wood destroying organisms.

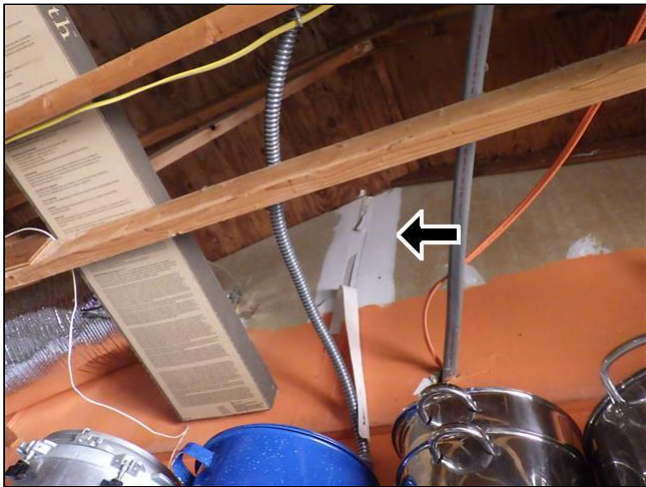
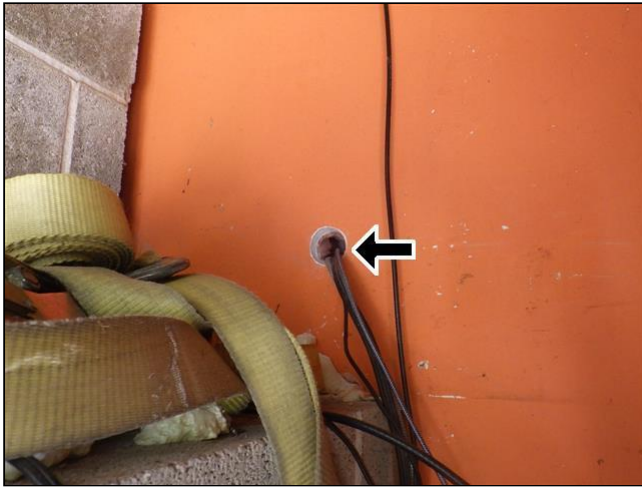
(1) The wall that separates garage from heated space had damaged fire taping and some holes that should be filled. This is considered unsafe until corrected. A qualified person should correct for safety.

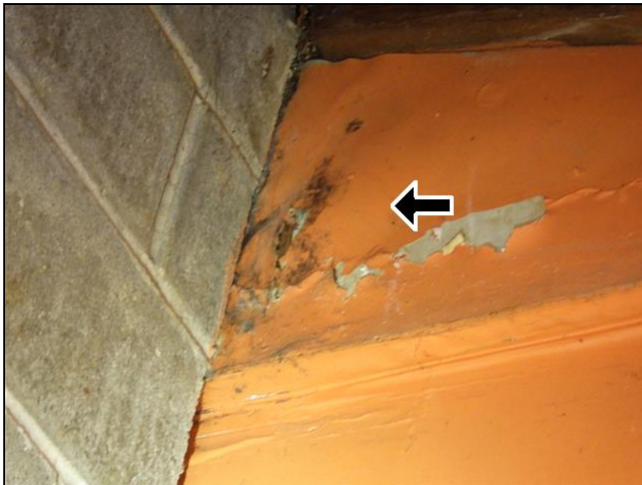
3.1 Item 4(Picture)

- ⚠ (2) Signs of apparent fungi growth is present garage wall (s). We did not inspect, test or determine if this growth is or is not a health hazard. The underlying cause is moisture. I recommend you clean and monitor this area for moisture and repair the moisture conditions if necessary.

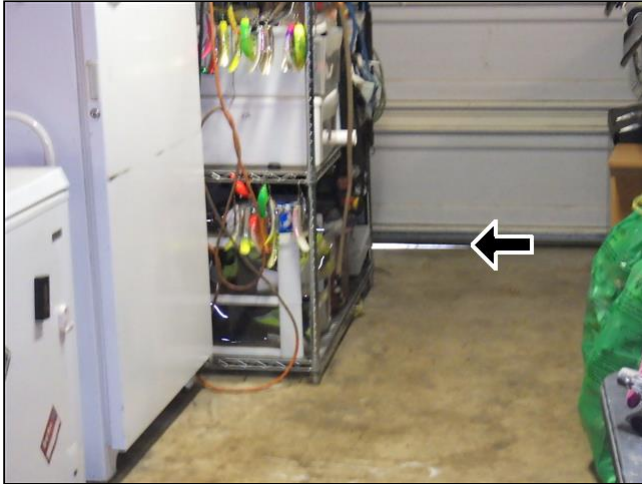
3.3 Item 1(Picture)

- 🔧 The garage door at the front of the building did not close or seal tight at floor. This is for your information. A qualified person should repair or replace as needed.

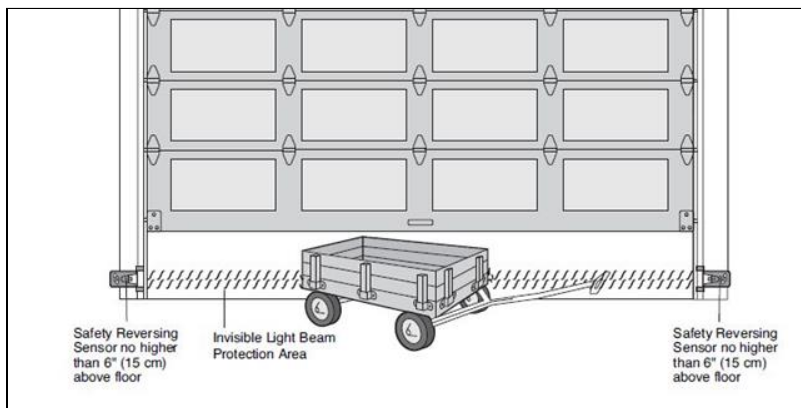
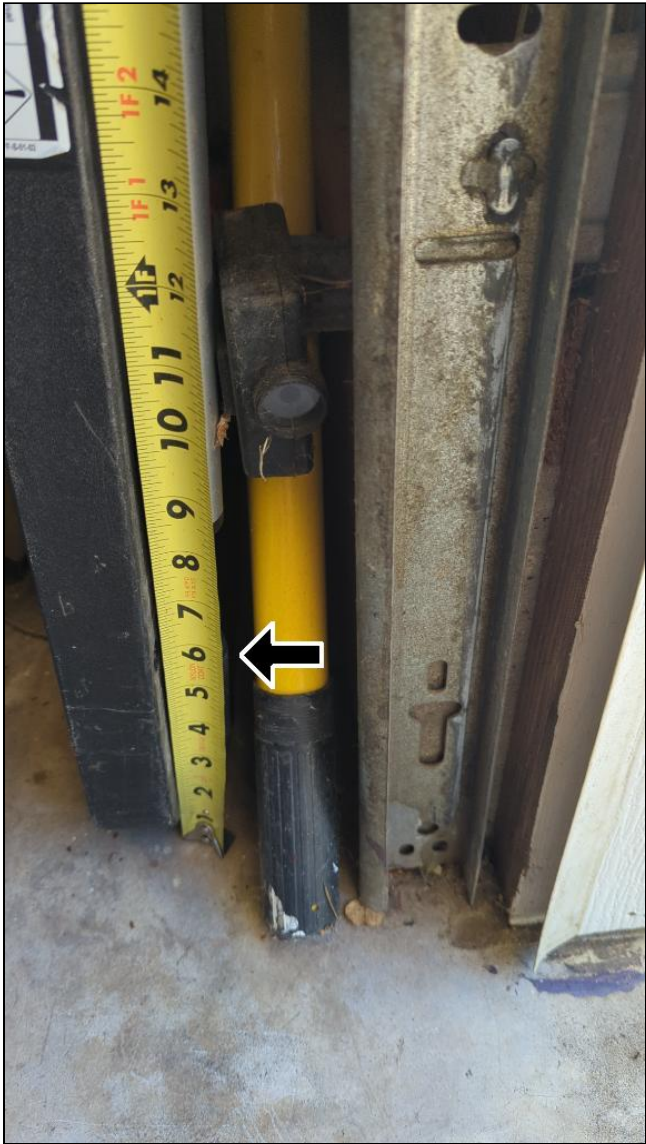
(1) The automatic opener for garage door has electric eyes that have been installed higher than 6 inches off the ground. This is considered unsafe, is contrary to manufactures directions and needs correcting. A qualified contractor should inspect and repair as needed.

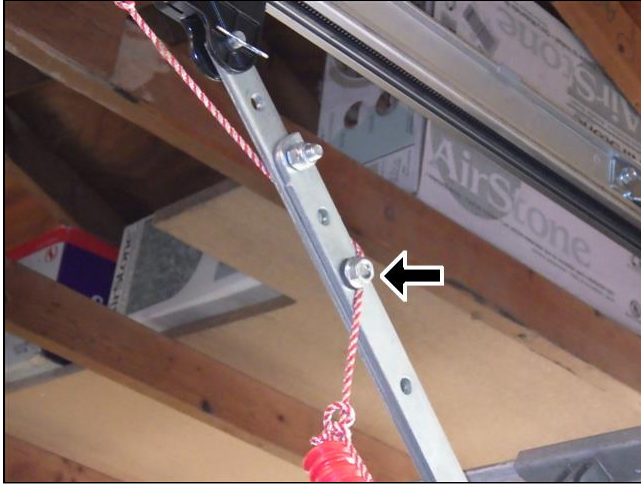
3.5 Item 5(Picture)

- 🔧 (3) The automatic opener for garage door at the front of the building had loose a connection where the opener attaches to the door. This should be repaired/replaced. A qualified contractor should inspect and repair as needed.

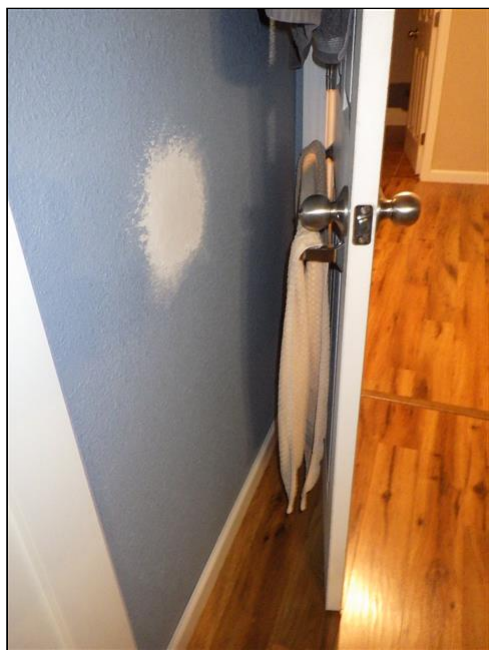
4.1 Item 1(Picture)

The wall had been patched at the master bedroom where the door handle had damaged the drywall. This repair should be finished, painted and the door stop should be repaired to prevent this damage in the future.

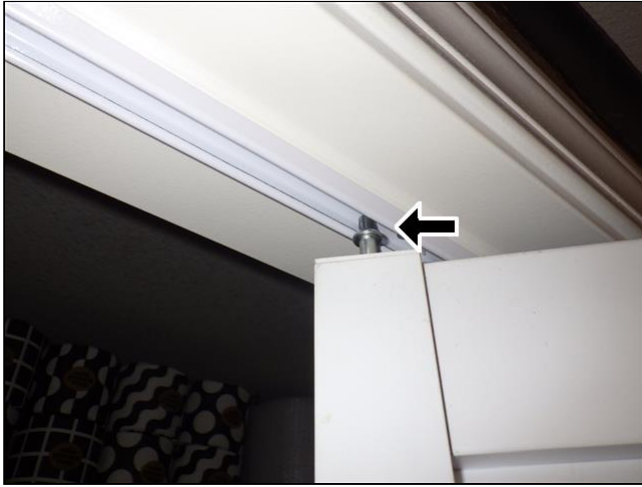
4.5 Item 1(Picture)

(1) The bifold door had a missing track roller at the washer/dryer room. This is for your information. A qualified person should repair or replace as needed.

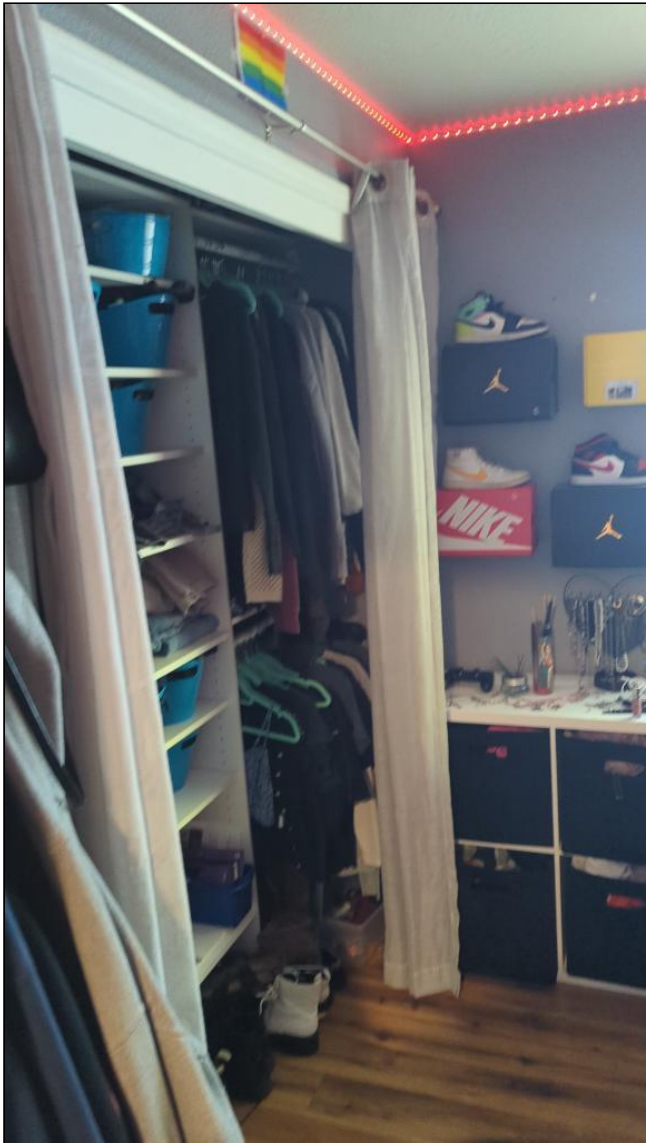
4.5 Item 2(Picture)

🔍 (2) The closet doors were missing at the bedrooms. This is for your information. A qualified contractor should inspect and repair as needed.

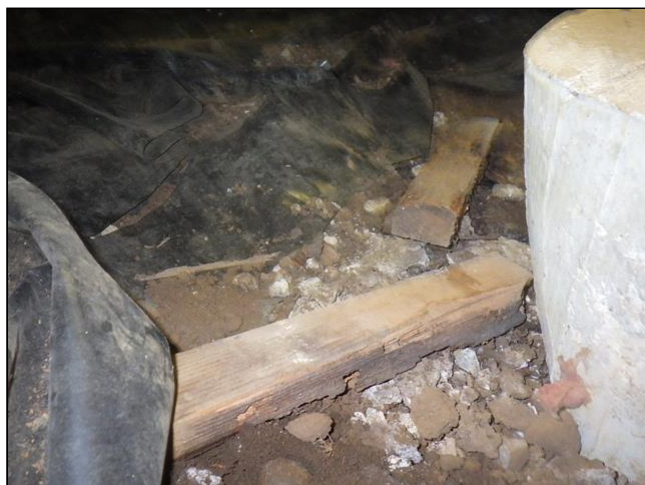
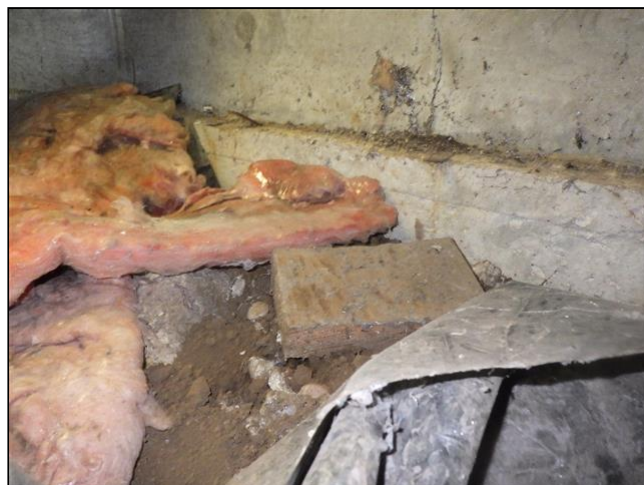
- 🔧 The wood/cellulose construction debris should be removed from the crawlspace. The excess wood that is under the building can be an excellent home base for wood destroying organisms, allowing them to multiply. When the wood runs out or the wood destroying organisms start looking for more they may look to your building. In general all pieces large enough to be caught in a garden rake should be removed.

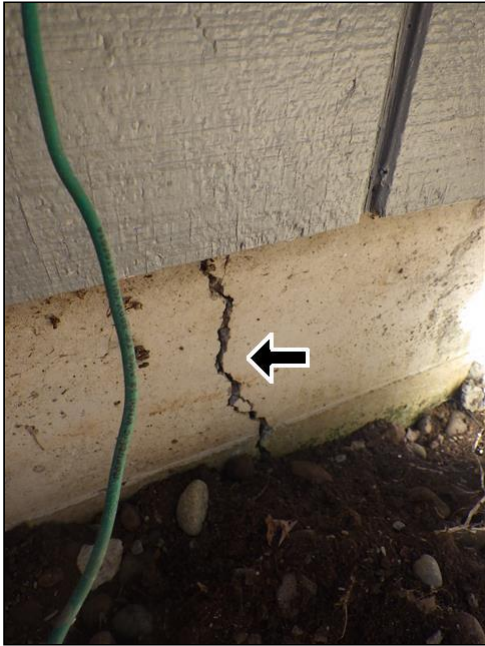
5.2 Item 1(Picture)

- 🔍 (1) The cracks in wall at front of the garage had a small amount of displacement. The crack did indicate settlement however it appears that the crack has been in place for a long time due to the abraded edges. These cracks should be closely monitored for movement or change in shape. If changes are noted, a structural engineer should be consulted for repairs.

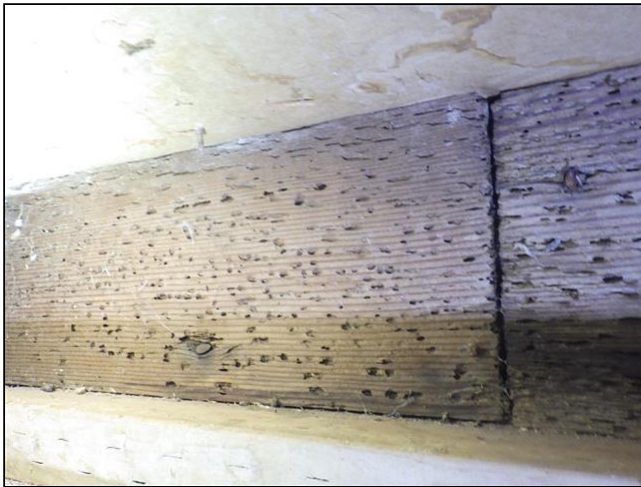
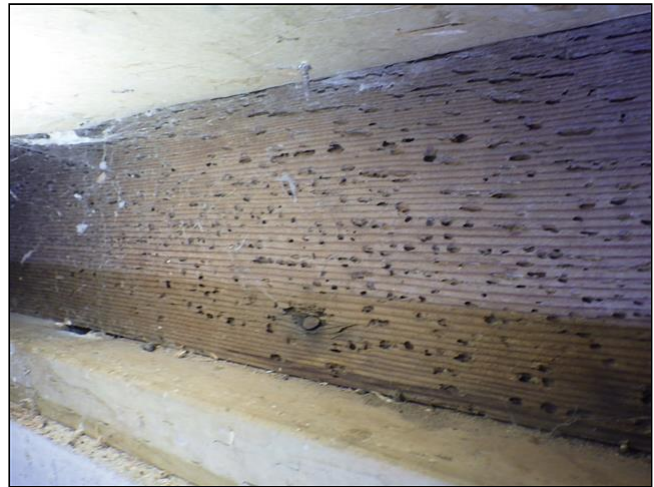
- 🔍 (2) The rear rim joist was a douglas fir 2x that had a virus when it was a tree on the stump. This wood grain can appear to be related to pests that damage house structure however it is not. No repairs or issues are noted in these sections of structure and this is for your information.

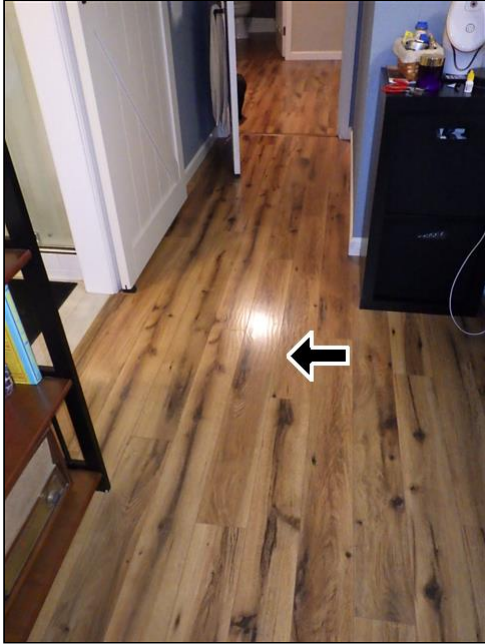
5.4 Item 1(Picture)

- 🔍 The flooring had areas of slope. This is not unusual in buildings of this age and is related to the various materials used to support the floor and various areas of repairs over the years. I recommend repair or replace as needed.

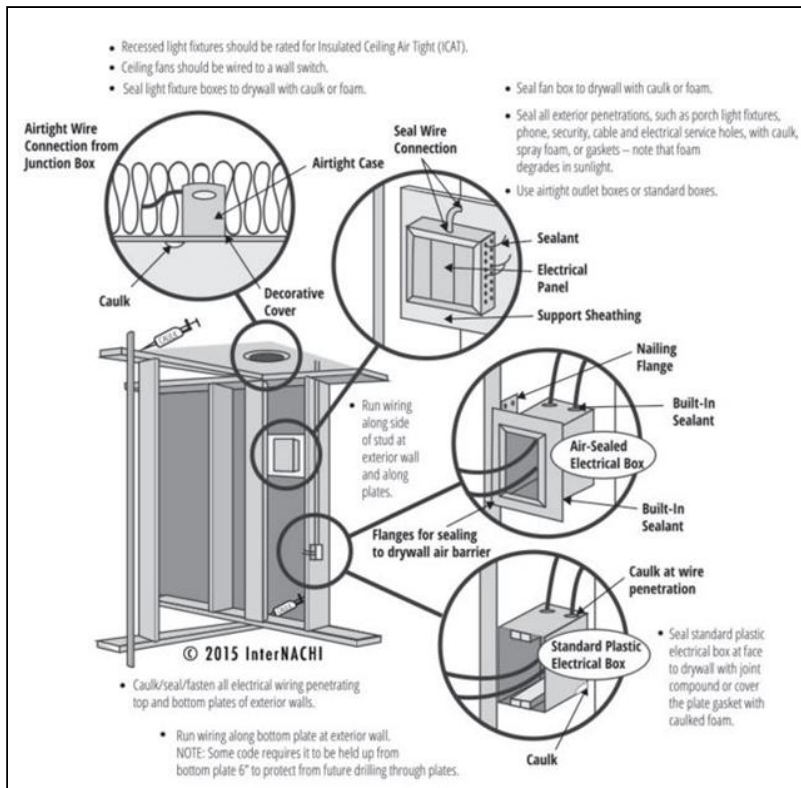
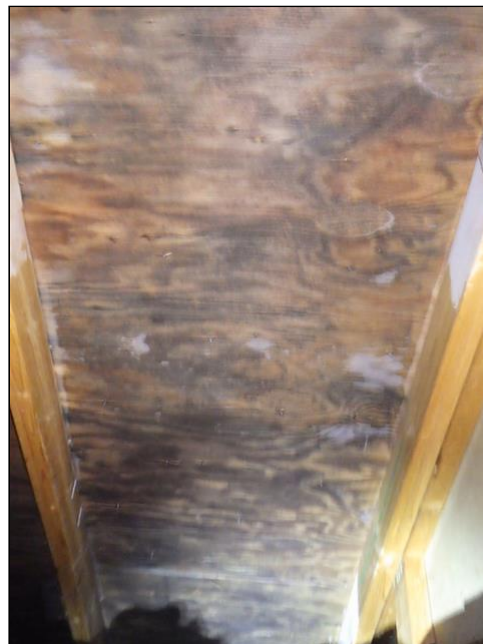
(1) The roof sheathing has signs of condensation and apparent fungal growth in areas. Signs of fungi growth indicate that there is too much moisture vapor in the attic. Proper steps to reduce the home's moisture should be taken along with the sealing of the bypasses noted in the attic, to prevent warm, moist house air from readily entering the attic. A insulation/sealing contractor should perform repairs to the bypasses. A qualified, licensed mold remediation should also be performed.

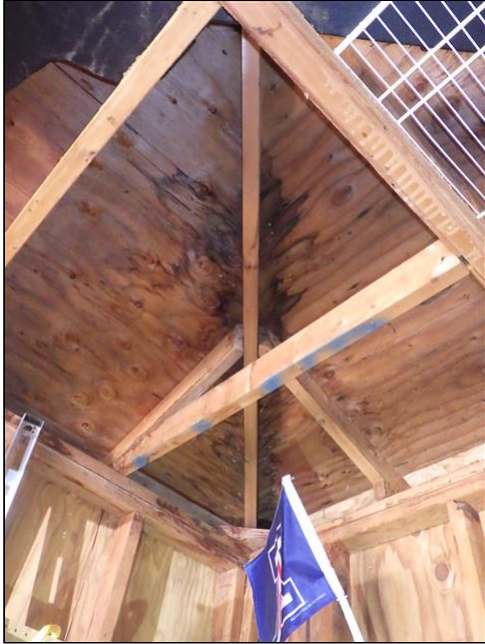
5.6 Item 4(Picture)

- 🔍 (2) Water stains are on the roofing structure around the chimney and on the rear ridge of the garage. The stains appear to be related to the previous roofing and no current leakage was observed at the time of the inspection. It is recommend to monitor after a heavy rain and repair if needed.

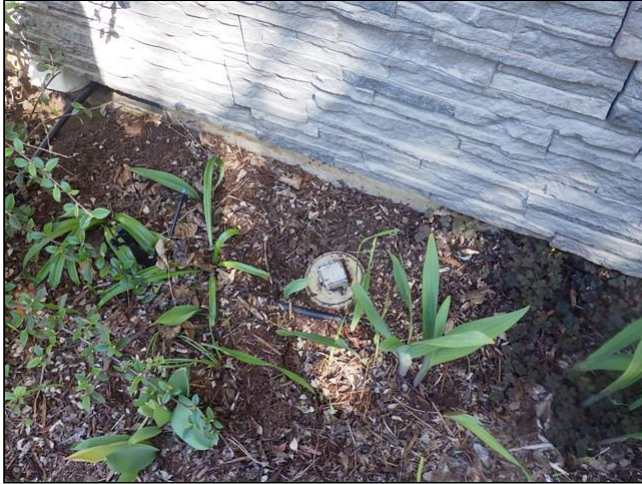
6.0 Item 1(Picture)

- 🔧 (1) You should strongly consider having the sewer line scoped. Issues with the main underground waste line can be common and the repairs can be costly. The main under ground soil pipe could not be viewed and was not inspected.

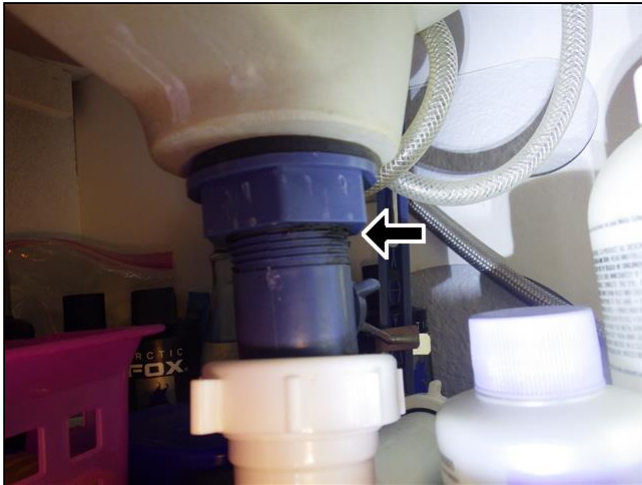
6.0 Item 2(Picture)

- 🔍 (2) The plumbing waste line shows evidence of past leakage at the master bath sink (left sink). This area should be monitored and repaired if necessary.

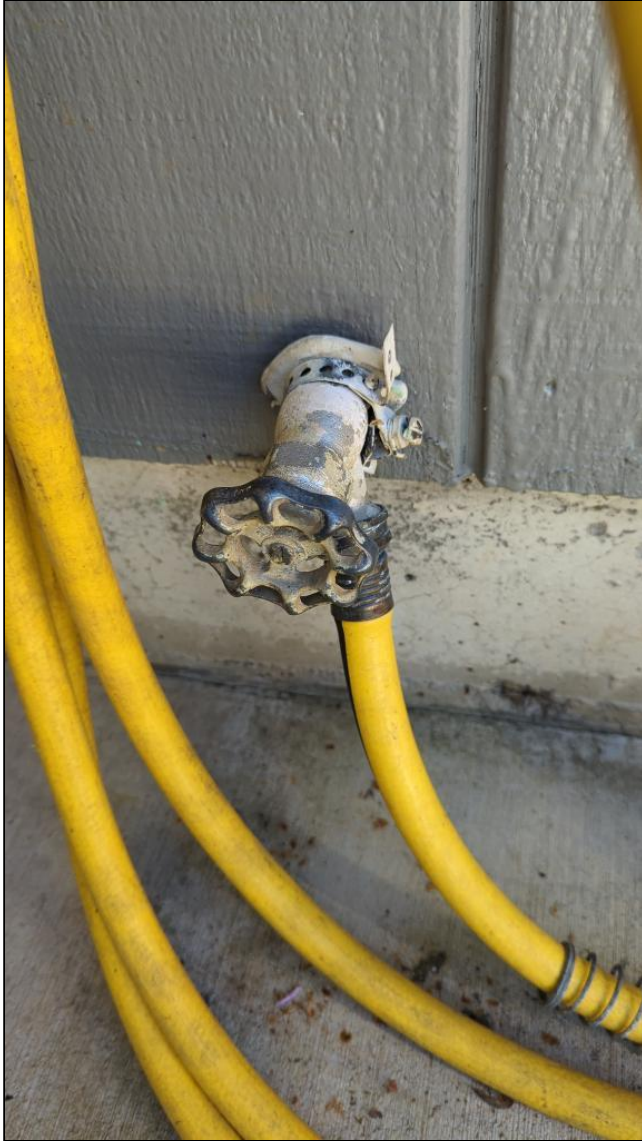
6.1 Item 1(Picture)

- 🔧 (1) The outside water faucets do not have vacuum-breakers (anti-siphon valves) installed at the front and rear. The valves prevent harmful liquids from entering your water system and should be installed to improve the safety of the building. A qualified licensed plumber should repair or correct as needed.

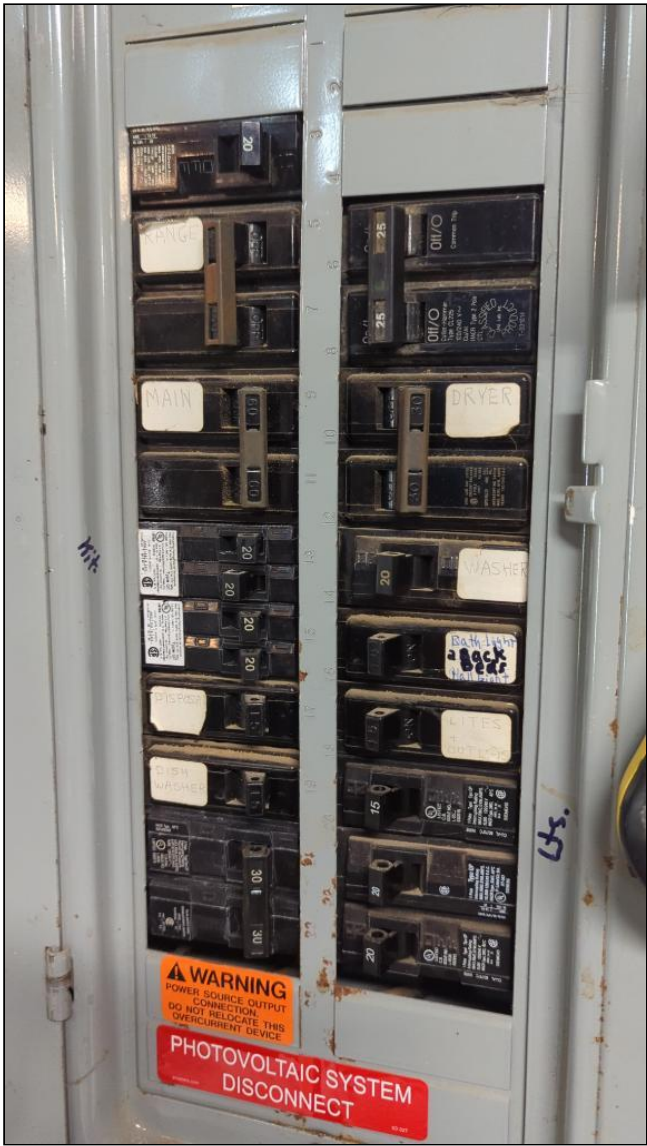
7.1 Item 1(Picture)

🔧 (1) Some labels are present, but are illegible or confusing. I recommend correcting for safety reasons.

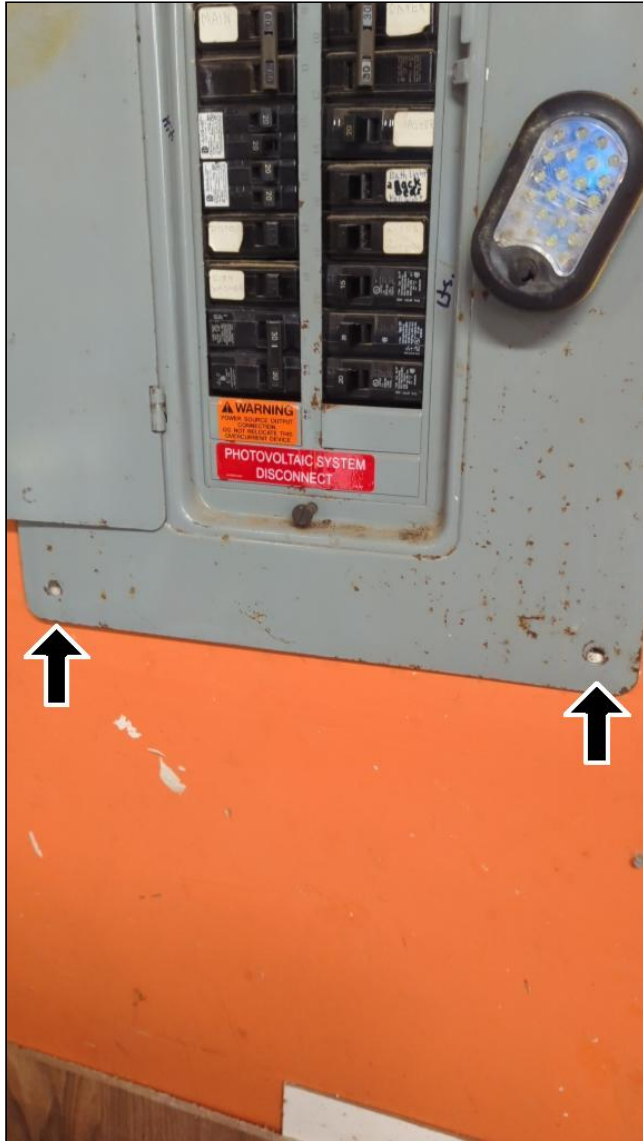
7.1 Item 2(Picture)

- 🔧 (2) Screw(s) missing from the panel cover. All of the screws should be installed for the cover to function properly in an emergency over-current situation. The screw(s) should be replaced with a proper screw designed for this panel.

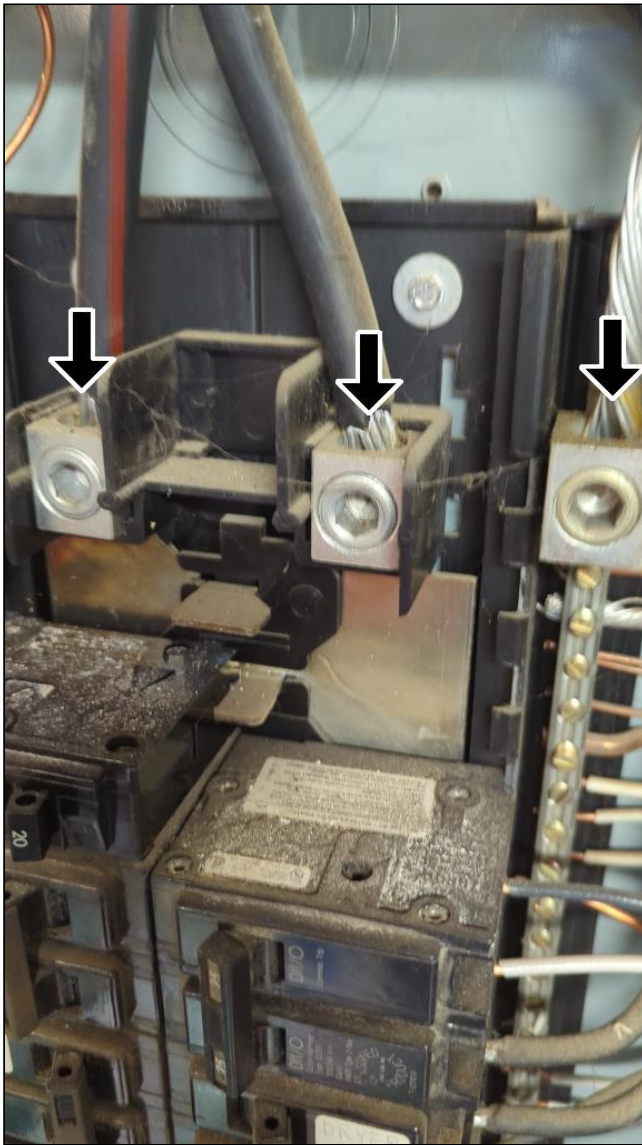
7.1 Item 3(Picture)

- ⚡ (3) The main aluminum conductors did not appear to have anti-oxidant paste. This paste is especially important on aluminum to prevent early oxidation, and corrosion. Some wire manufactures do not specify the use of the anti-oxidant however the brand of the wire can not be determined. A qualified, licensed electrician should examine the lugs, tighten if necessary and apply the anti-oxidant paste.

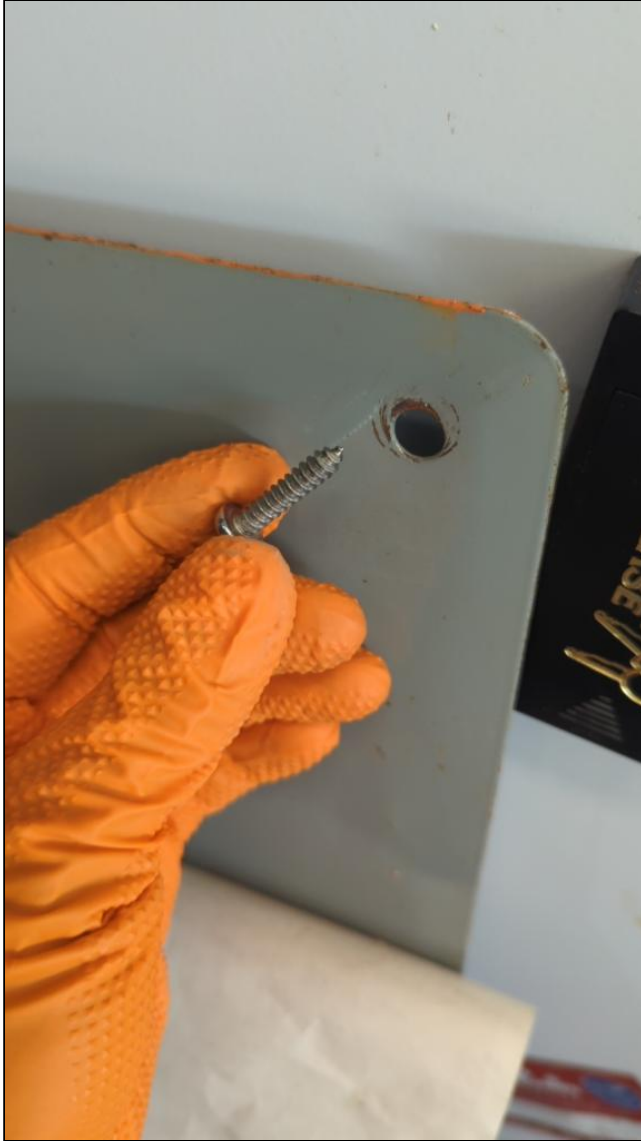
7.1 Item 4(Picture)

- 🔧 (4) Improper screw(s) are in use on the main panel cover. Screws that have a sharp point can penetrate wires that are in the panel and cause a dangerous condition. The screw(s) should be replaced with a proper screw designed for this panel.

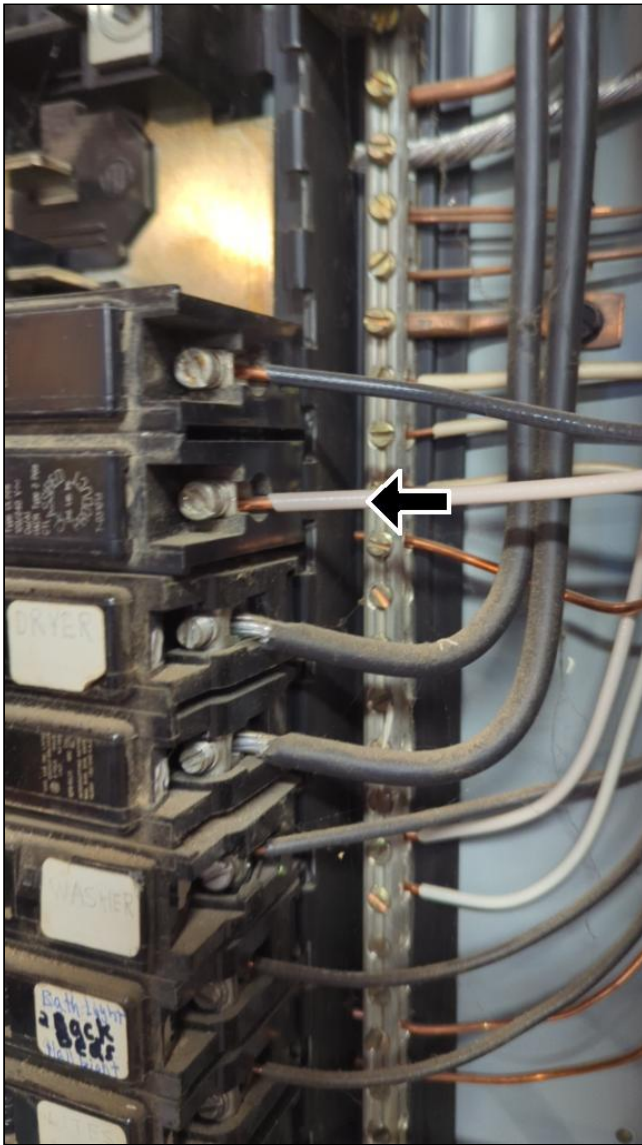
7.2 Item 1(Picture)

- 🔧 White branch circuits that are being used as hot wires are not labeled with "phase tape" should be corrected. This is strictly a labeling issue and does not effect the ability of the wire to carry electrons. Phase wire in a circuit may be black, red, orange (high leg delta) insulated wire, sometimes other colors, but never green, gray, or white (whether these are solid colors or stripes). I recommend a licensed electrician inspect further and correct as needed.

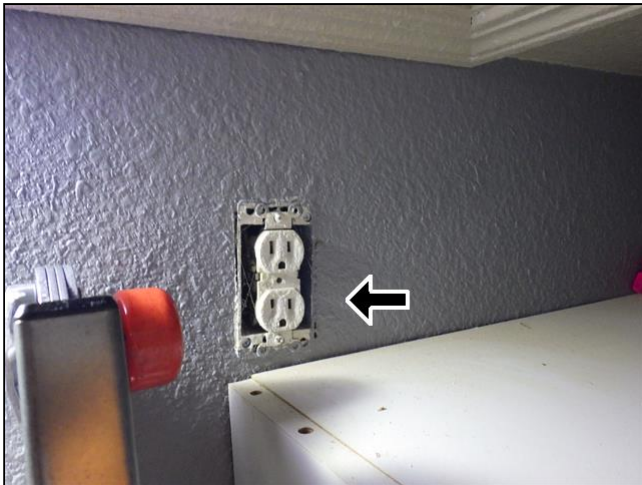
7.3 Item 2(Picture)

- 🔧 (2) The "three-prong" outlet was missing cover-plate in the middle bedroom closet. This is for your information. I recommend repair as needed.

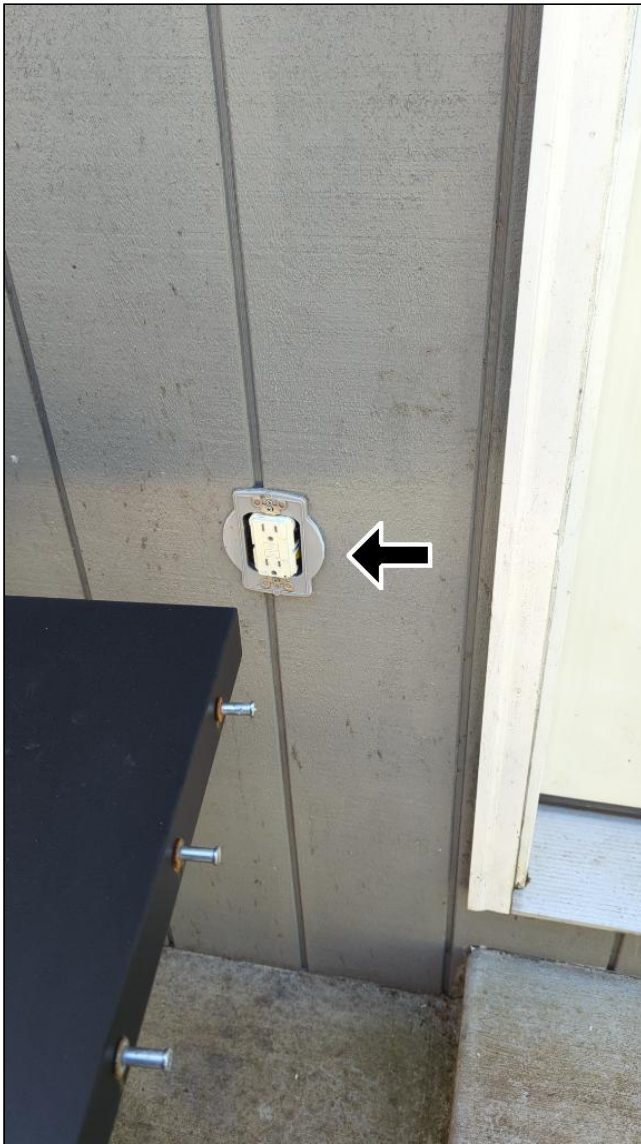
7.4 Item 1(Picture)

🔧 The outside outlet cover at the rear of the building was damaged and needs to be repaired or replaced.

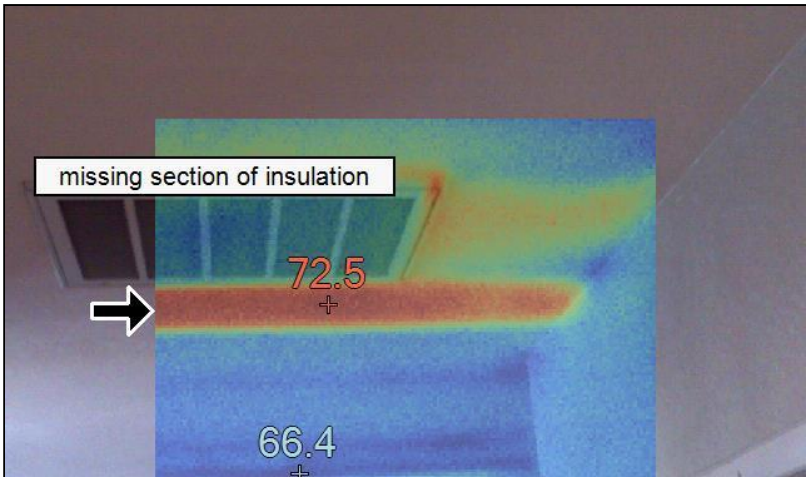
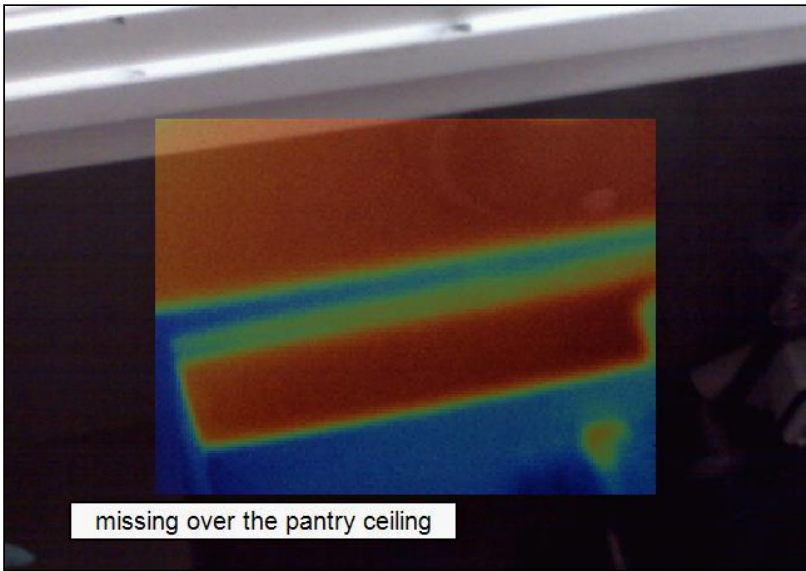
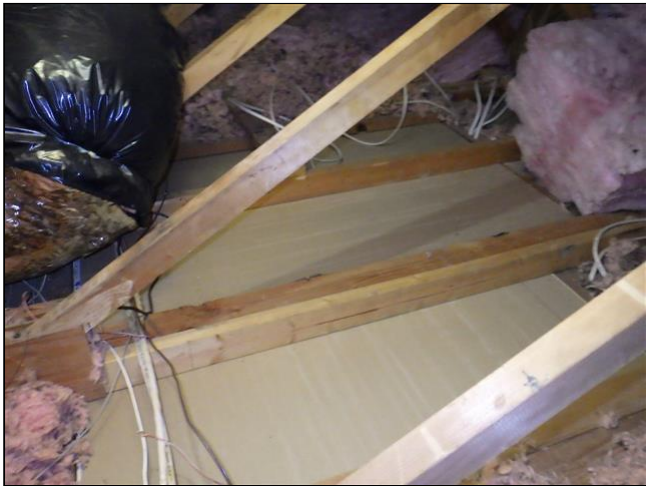
(1) Insulation was missing or compressed in sections of the attic. Heat loss can occur more on this building than one that is properly insulated. A qualified contractor should inspect and repair as needed.

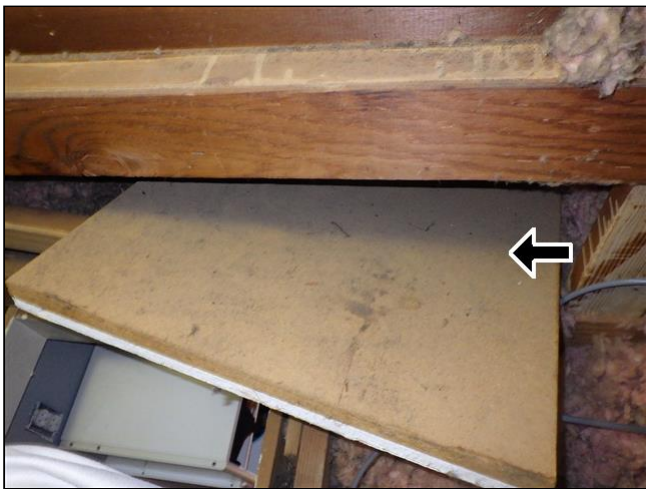
9.0 Item 4(Picture)

🔧 (2) Insulation was missing from the attic hatch. Heat loss can occur more on this home than one that is properly insulated. A qualified person should repair or replace as needed.
