# Perfection Inspection, Inc

**Property Address:  
611 Rockwood St SE  
Salem OR 97306**

**4/18/2024**

**Jim Allhiser**

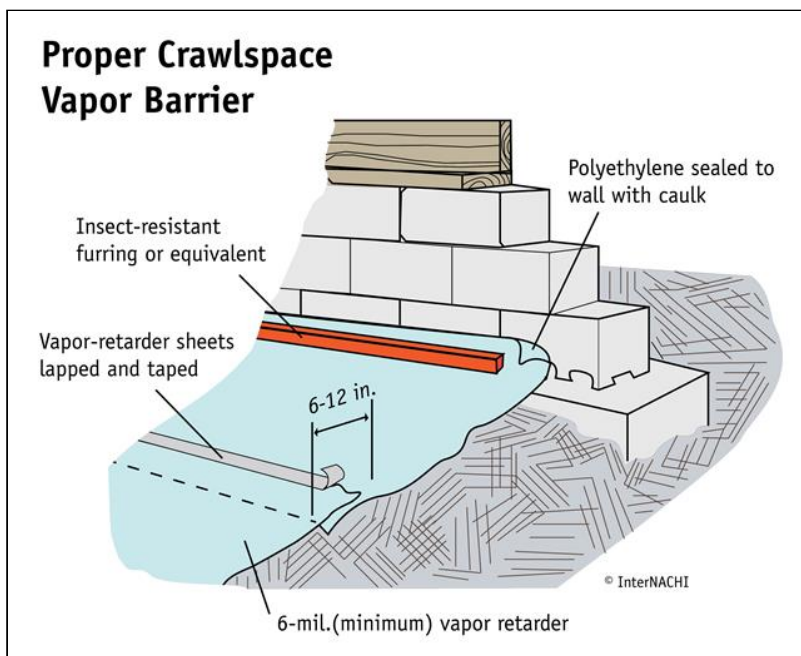
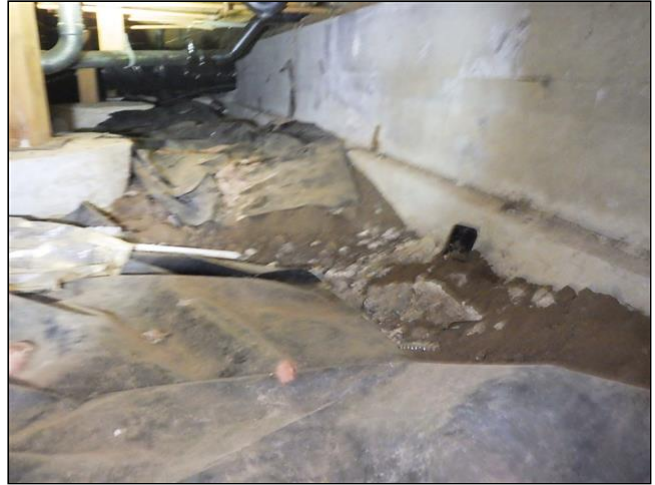
- 🔧 The vapor retarder (plastic) on the crawlspace ground was missing in areas. A vapor barrier provides added protection to the floor system from moisture or dampness that can enter from ground. A qualified, licensed professional should install a new layer of 6 mill. black plastic vapor retarder where needed.

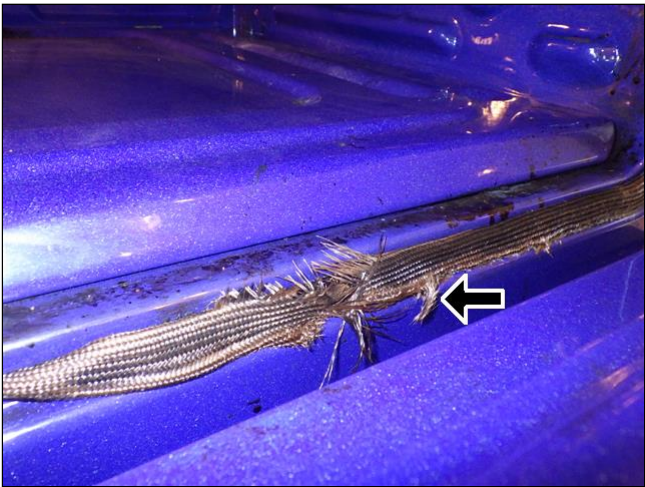
10.2 Item 1(Picture)

The oven door gasket was worn. I recommend repair as needed.
