# Perfection<sup>✓</sup> Inspection, Inc

**Property Address:  
2840 Bolton Terrace S  
Salem OR 97302**

**11/20/2023**

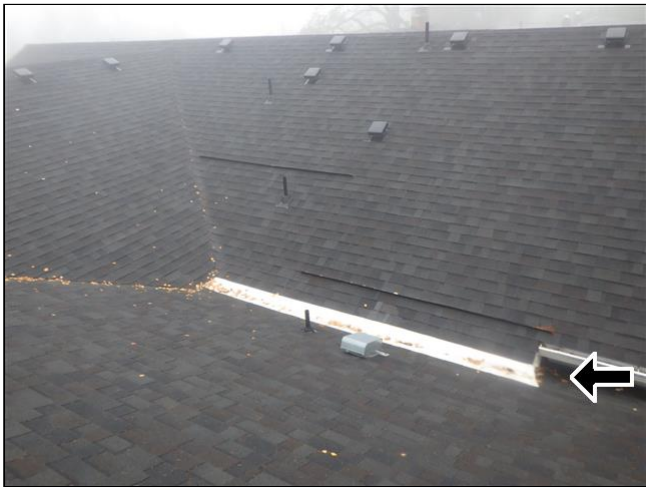
1.0 Item 1(Picture)

The roof covering has a vulnerable area at the rear of building (refer to picture(s)). This is for your information. I recommend monitoring this issue to determine if repairs are necessary.

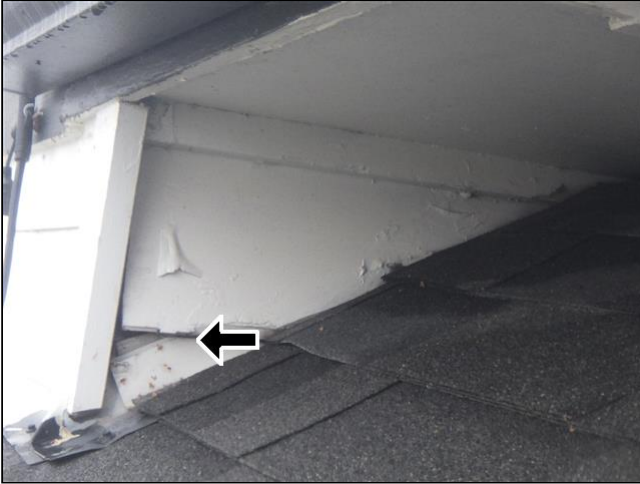
1.1 Item 1(Picture)

- 🔧 The roof-to-wall flashing was not installed properly and could be vulnerable to water intrusion. Noted on the front of building (refer to picture(s)). A qualified roofing contractor should inspect further and correct as needed

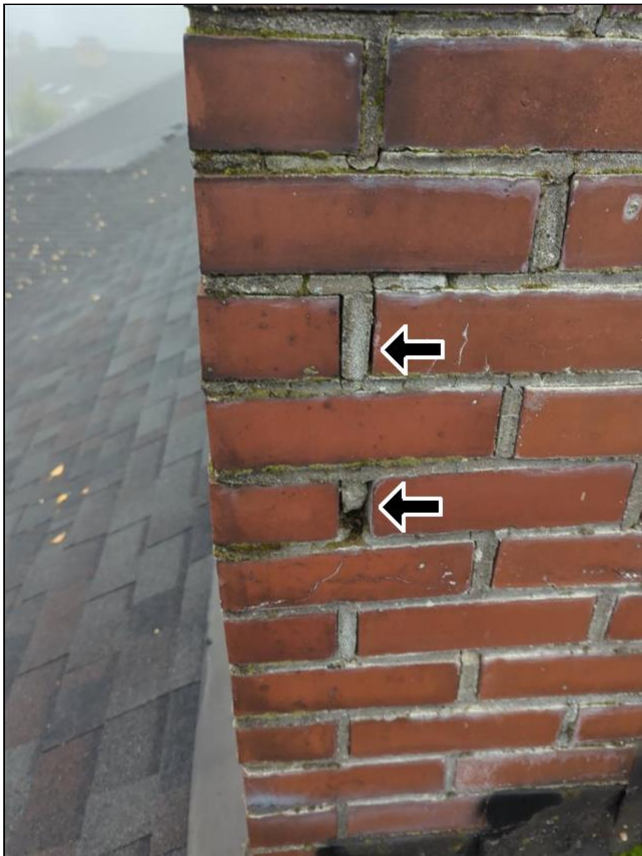
1.2 Item 1(Picture)

- 🔧 (1) The main center masonry chimney had loose mortar. Further deterioration may occur if not repaired. A qualified contractor should inspect and repair as needed.

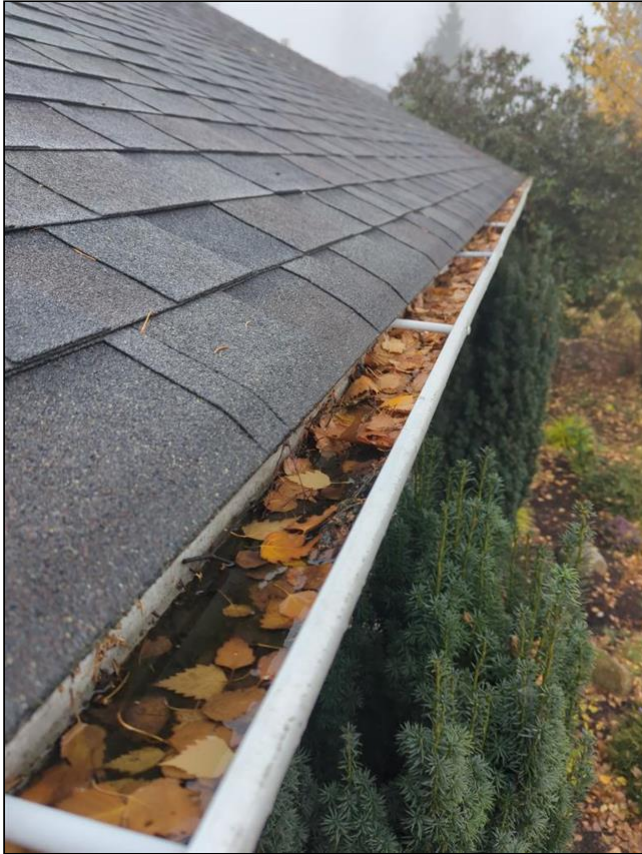
1.3 Item 3(Picture)

(2) The gutters had debris in areas and need to be cleaned. This is a maintenance issue and is important to prevent storm water issues around the building.

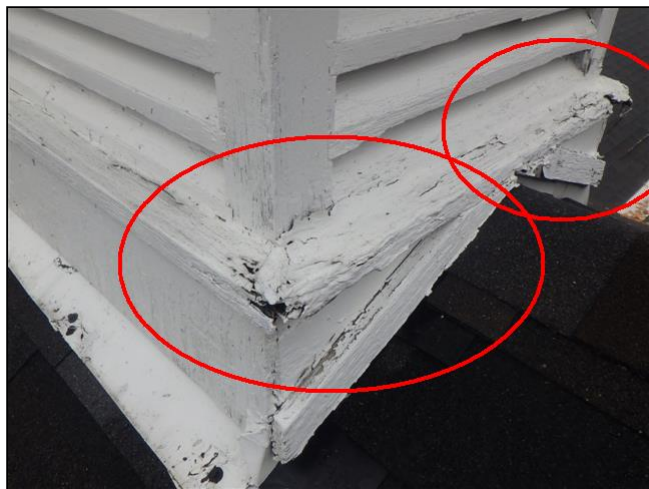
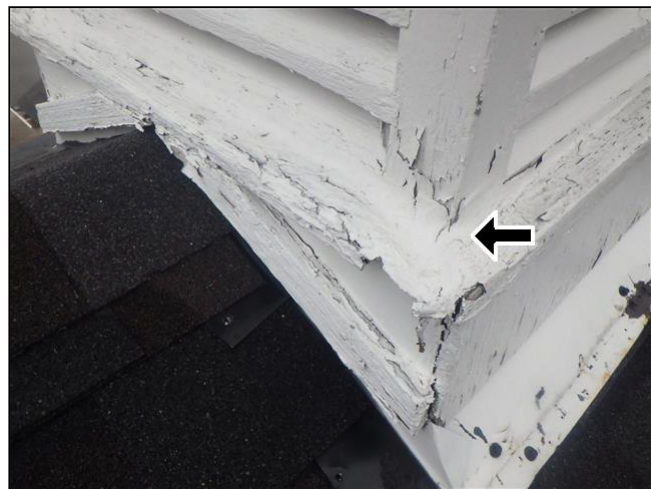
2.0 Item 1(Picture)

(1) The wood trim at the cupola (refer to picture(s)) was deteriorated. Further deterioration can occur if not corrected. A qualified contractor should inspect and repair as needed.

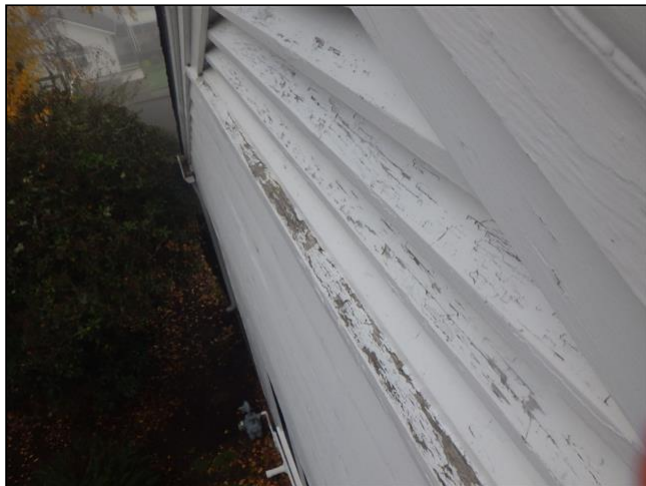
2.0 Item 3(Picture)

🔧 (2) Paint was worn on siding. The building should be properly prepped and painted to preserve the building envelope.

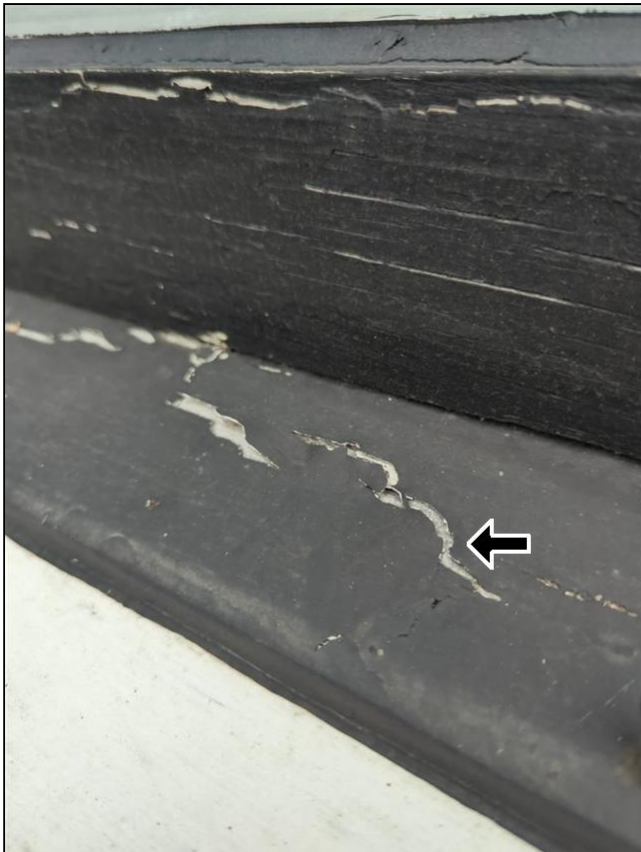
2.2 Item 1(Picture)

- 🔧 (1) The wood trim is peeling paint at most windows. Further deterioration may occur if not repaired. I recommend a qualified contractor inspect and repair as needed.

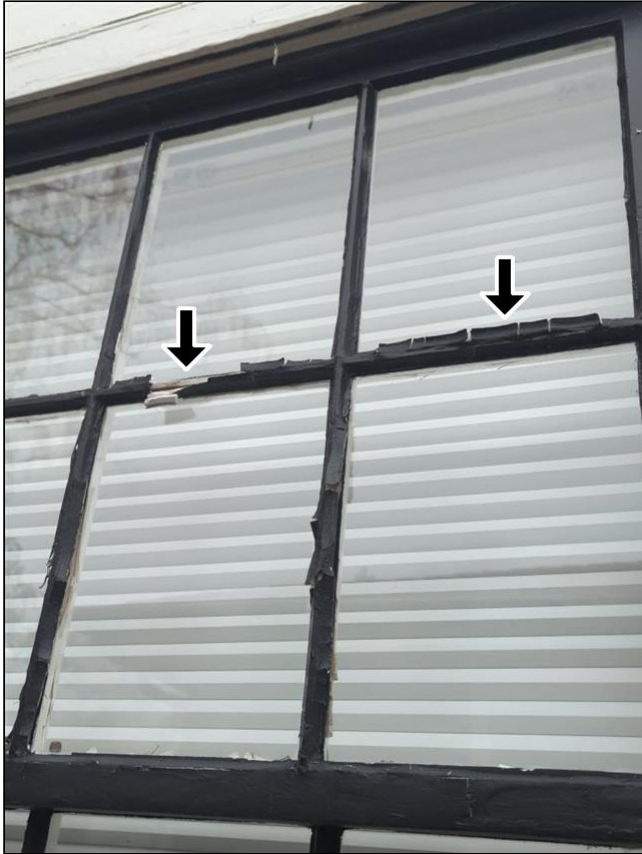
2.2 Item 2(Picture)

- 🔧 (2) The glazing putty that holds the glass in the sash is failing at some windows. A qualified person should repair and re-putty as necessary. This is a normal maintenance item.

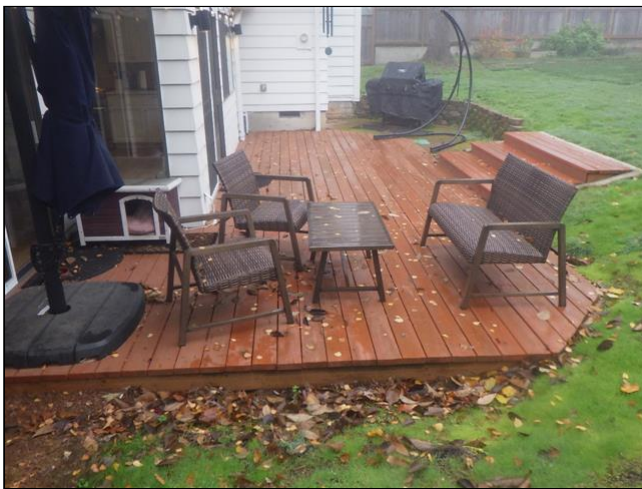
2.3 Item 1(Picture)

- 🔍 The decks have been built close to the ground. This limits the inspection and may limit air movement and ventilation. Attention should be paid to keep the exposed boards painted/stained and provide ventilation at the next deck repair.

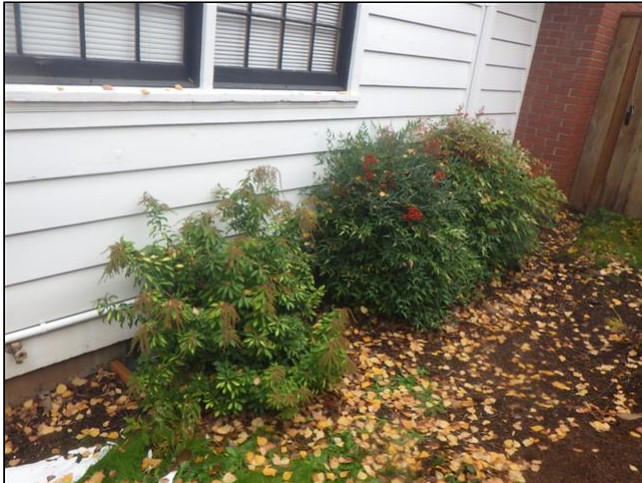
2.4 Item 1(Picture)

(1) The plants should be trimmed or removed from contact with the building. Vegetation in contact with the home can mechanically open the paint, decrease ventilation and may lead to pest/insect issues. 18" of space should be actively maintained.

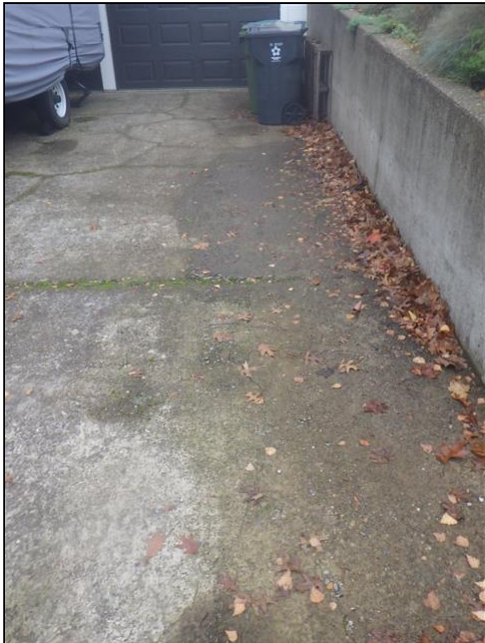
2.4 Item 2(Picture)

(2) The concrete drive at the front of the building was deteriorated in areas. This is normal for this age driveway. I recommend repair as desired.

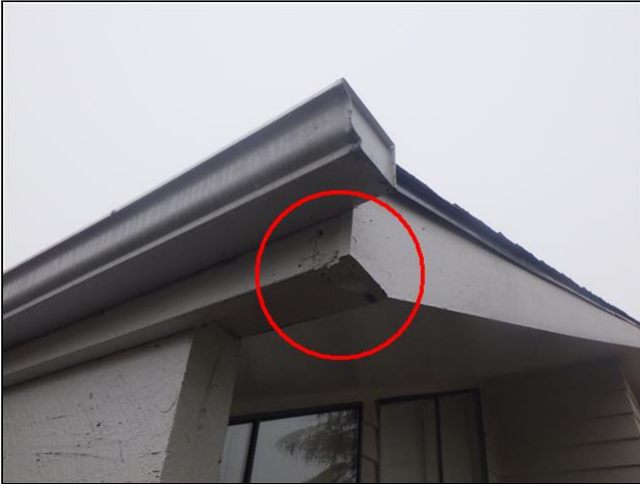
2.5 Item 1(Picture)

The rake rafter on the rear roof slope show signs of deterioration (refer to picture). These should be repaired to prevent further damage to related components.

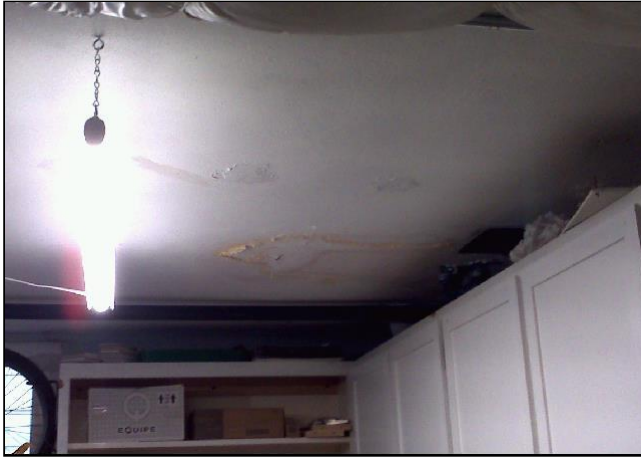
3.0 Item 1(Picture)

- (1) The plaster on the ceiling reveals water stains indicating leaks did or still exists at the garage. The thermal camera and moisture meter were used and they did not indicate a current leak at the time of the inspection. A qualified contractor should inspect and repair as needed.

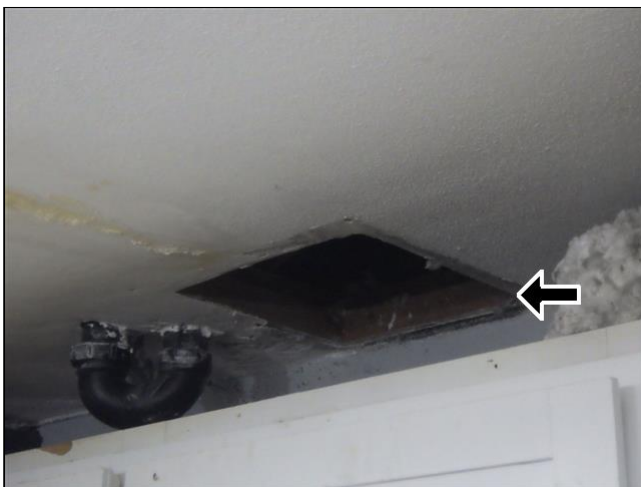
3.0 Item 4(Picture)

- (2) The fire resistance sheathing that separates garage from heated space was compromised. This is considered unsafe until corrected. A qualified person should correct for safety.

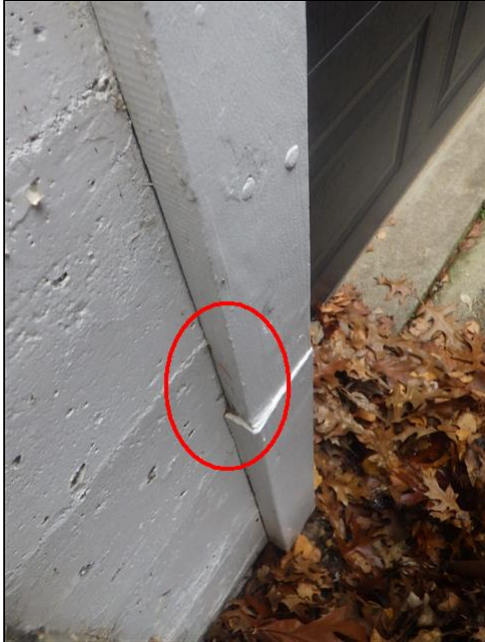
3.3 Item 1(Picture)

The garage door at the front of the building shows deterioration on bottom of side jambs. This should be repaired. A qualified contractor should inspect and repair as needed.

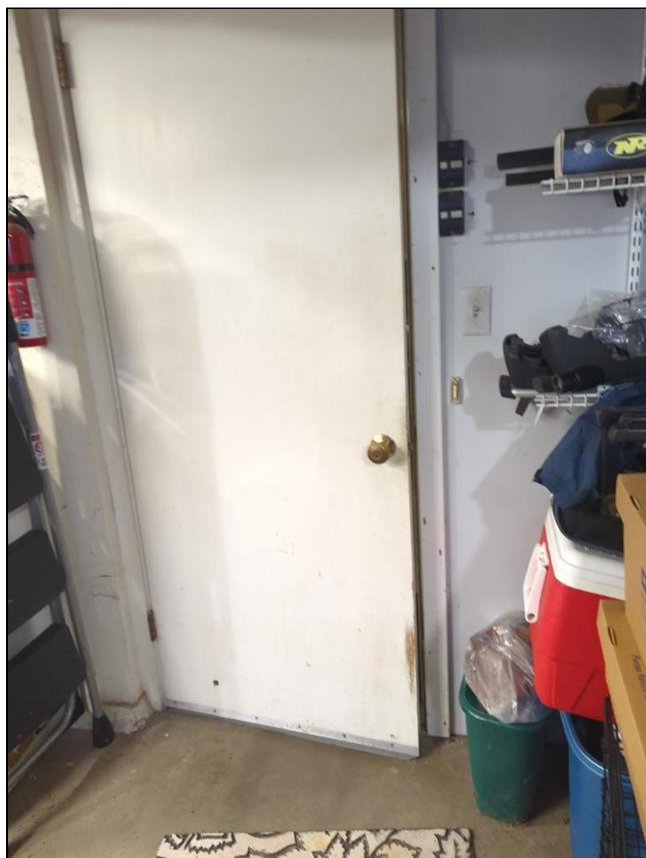
3.4 Item 1(Picture)

- 🔧 (1) The occupant door from inside garage to inside the home was not at least an 1 3/8" solid door. This means that the door may not be a good seal to prevent exhaust or other fumes from entering the home and it may not provide at least 20 minutes of fire resistance. A licensed professional contractor should install a proper solid core, fire resistant door.

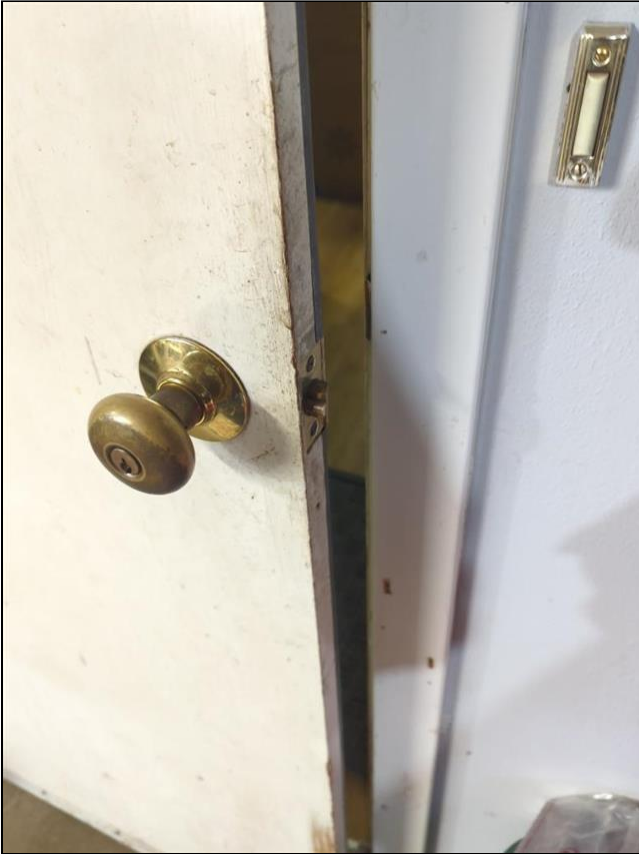
3.4 Item 2(Picture)

- 🔧 (2) The door between the home and the garage does not latch properly. A qualified, licensed contractor should adjust as necessary.

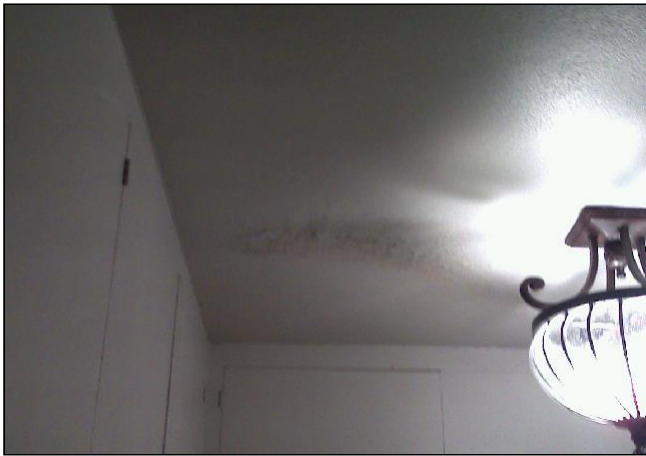
4.0 Item 1(Picture) Master Bedroom

(1) The plaster on the ceiling reveals water stains indicating leaks did or still exist in various areas. The thermal camera and moisture meter were used and they did not indicate current leaks at the time of the inspection. A qualified contractor should inspect and repair as needed.

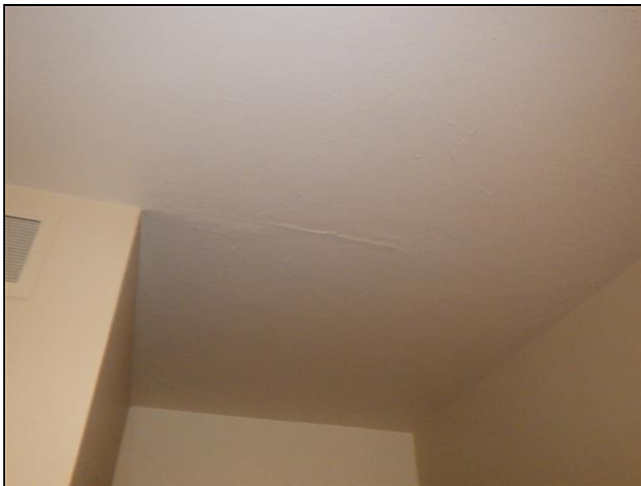
4.0 Item 5(Picture)

(2) The ceiling reveals cracks throughout the home. This damage is considered mostly cosmetic. A qualified person should repair or replace as needed.

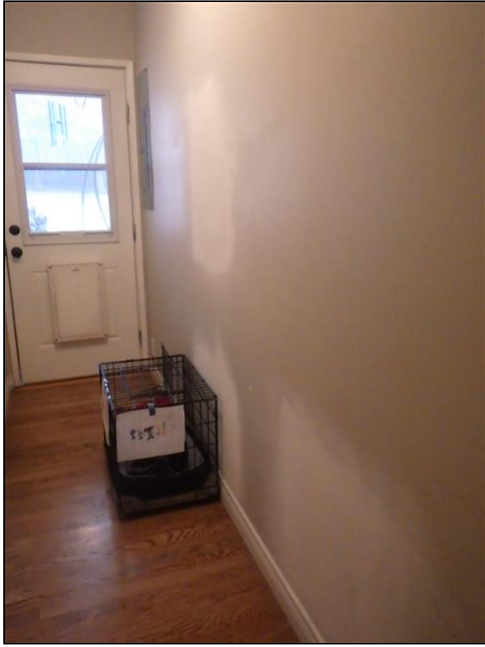
4.1 Item 1(Picture)

The plaster on the wall shows some repair signs at the rear hallway. This appears to be a cosmetic issue and is for your information.

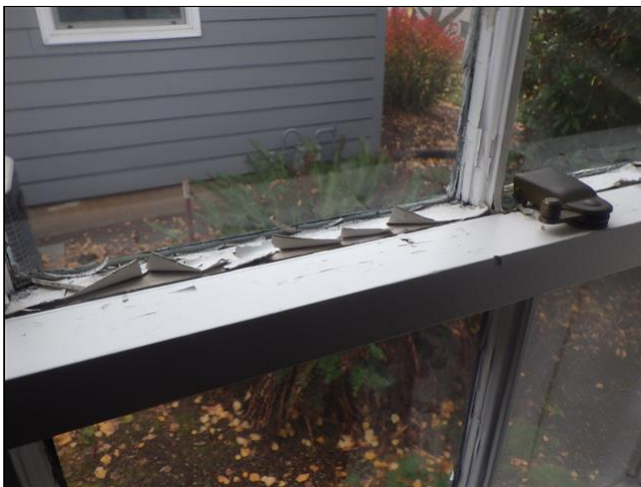
4.6 Item 3(Picture)

- 🔧 (2) Most of the wood windows were stuck or painted shut. This is a maintenance issue and is for your information. A qualified contractor should inspect and repair as needed.

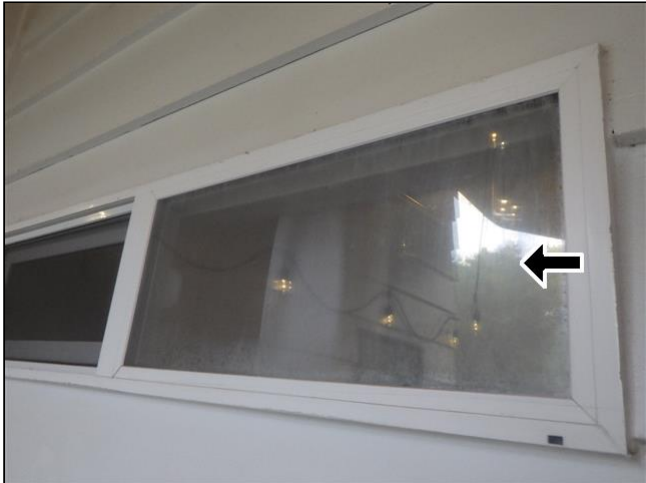
4.6 Item 4(Picture)

- (3) One window was cloudy (moisture trapped between the panes) in the master bath. In order to correct the cloudy appearance of glass, a replacement of glass pane or the unit will be necessary. A qualified contractor should inspect and repair as needed.

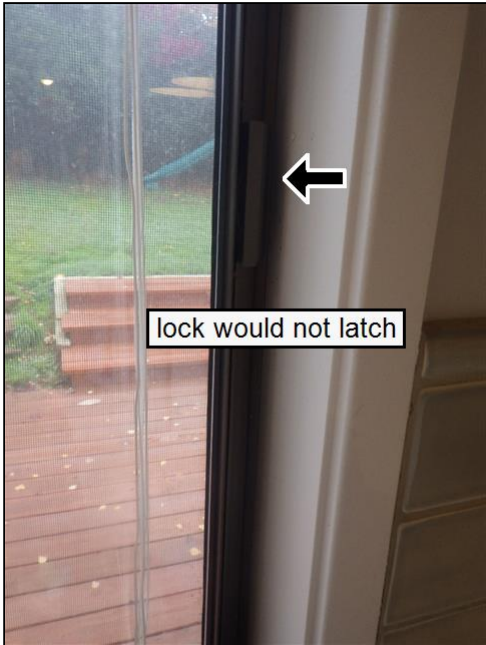
4.6 Item 5(Picture)

- (4) Windows damaged at handle or lock hardware at the kitchen and guest room/office. This should be repaired. A qualified contractor should inspect and repair as needed.

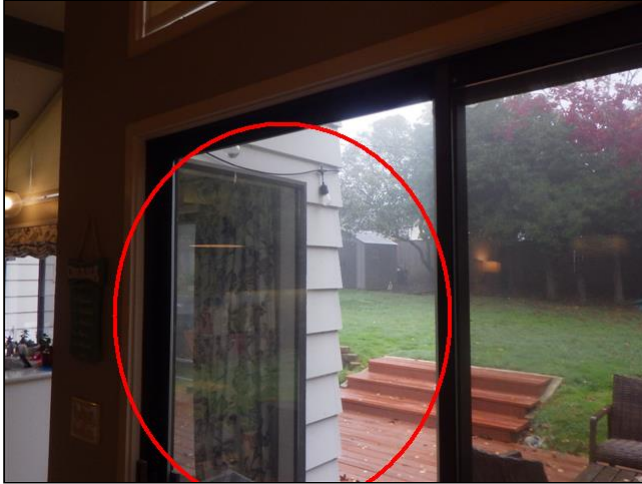
4.6 Item 7(Picture)

- 🔧 (5) Several windows were cloudy (moisture trapped between the panes) in the kitchen, living room and guest room/office. In order to correct the cloudy appearance of glass, a replacement of glass pane or the unit will be necessary. A qualified contractor should inspect and repair as needed.

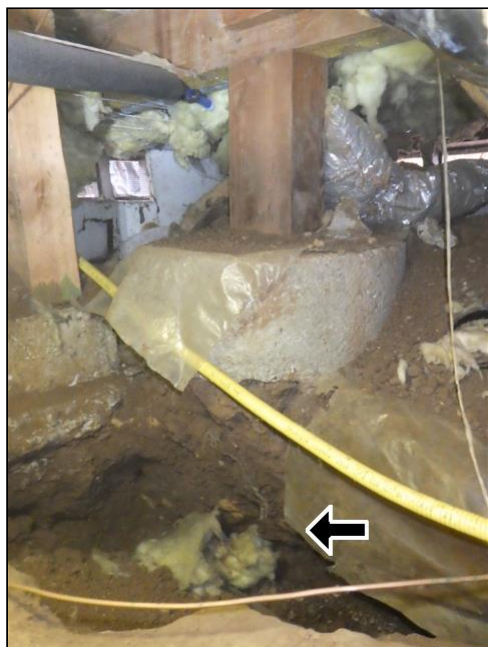
5.3 Item 1(Picture)

- 🔧 The support post at the rear of the building was under-cut in the crawlspace from apparent plumbing repairs. Repairs are needed. A qualified engineer should inspect and repair or replace as needed.

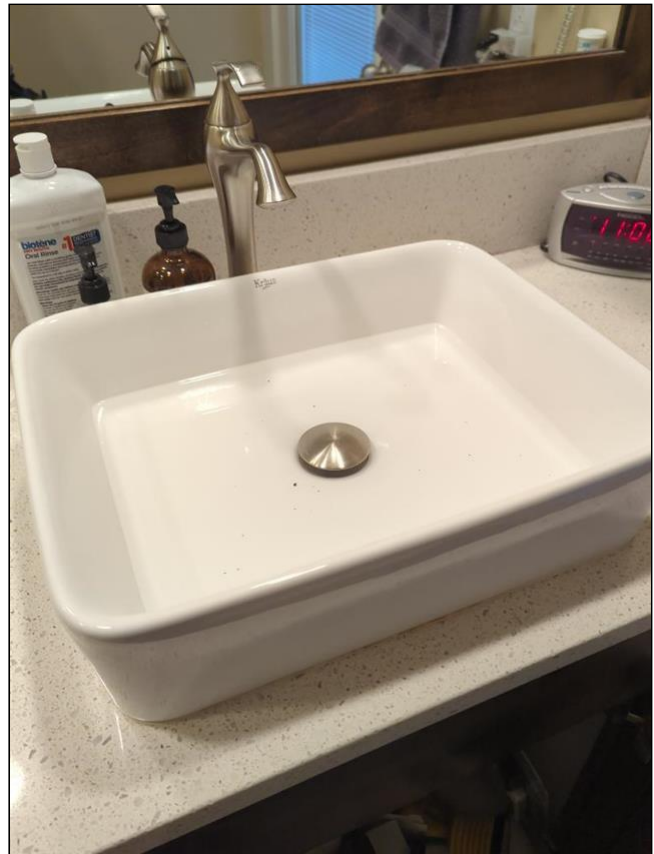
6.0 Item 2(Picture)

- 🔧 (1) You should strongly consider having the sewer line scoped. Issues with the main underground waste line can be common and the repairs can be costly. The main under ground soil pipe could not be viewed and was not inspected.
- 🔧 (2) The plumbing waste line drained slowly at the master bath (right sink). The cause of a slow drain can range from a simple debris clog at the stop valve or at the trap under the drain. Sometimes the drain can be partially clogged down line. I am unable to determine the cause of the slow drain. A qualified licensed plumber should repair or correct as needed.

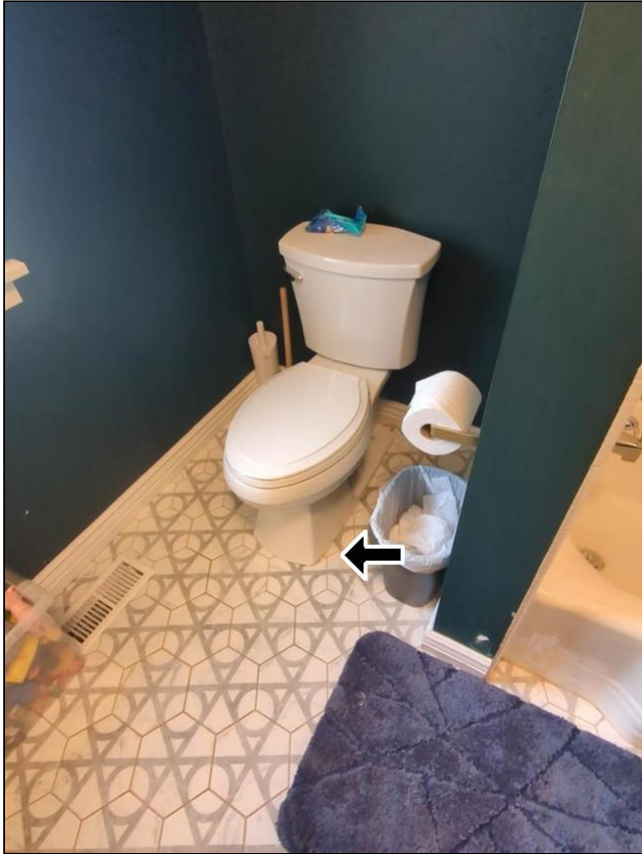
6.0 Item 3(Picture)

- 🔧 (3) The toilet was loose at floor at the hall bath. Repairs should involve re-setting the toilet on a new wax seal. I recommend a qualified licensed plumber repair or correct as needed.

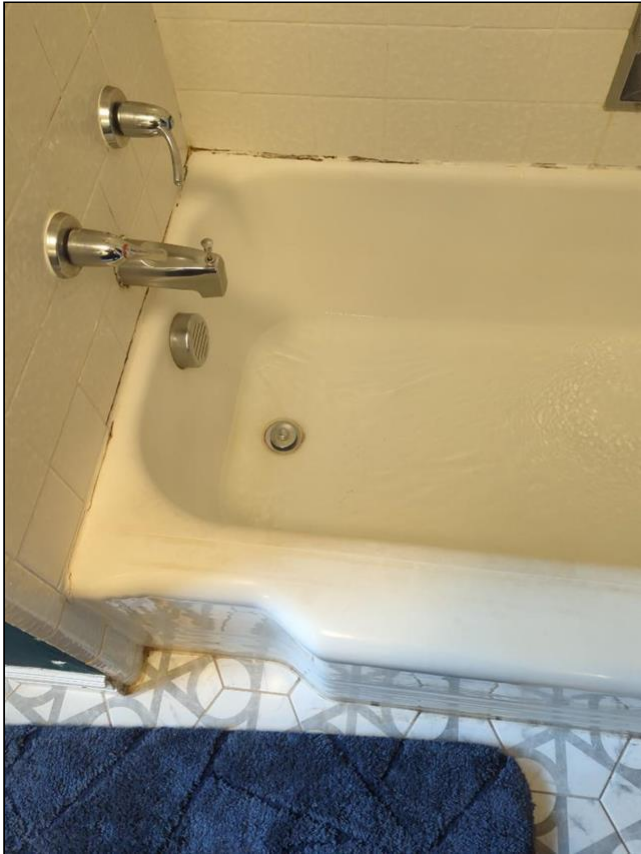
6.0 Item 4(Picture)

- 🔧 (4) The plumbing waste line drained slowly at the hall bath tub. The cause of a slow drain can range from a simple debris clog at the stop valve or at the trap under the drain. Sometimes the drain can be partially clogged down line. I am unable to determine the cause of the slow drain. A qualified licensed plumber should repair or correct as needed.

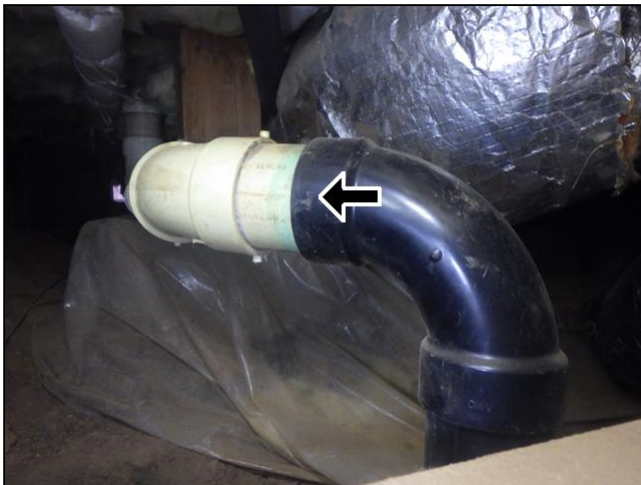
6.0 Item 5(Picture)

- 🔍 (5) The plumbing waste line had been repaired improperly in the rear crawlspace. PVC should not be glued directly to ABS. I recommend a licensed plumber inspect further and repair as necessary.

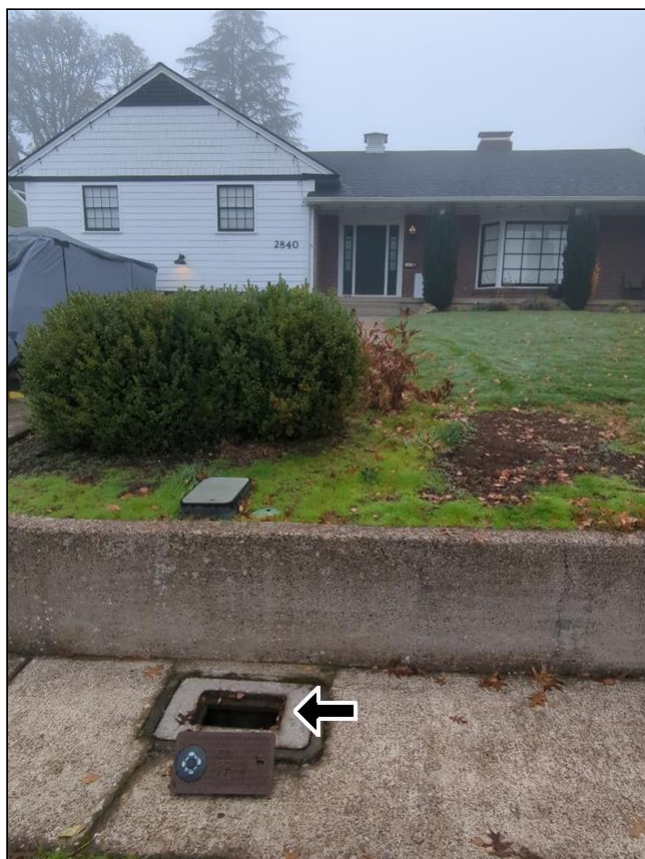
6.3 Item 1(Picture)

The main shut offs were located outside in the ground and on the garage wall.

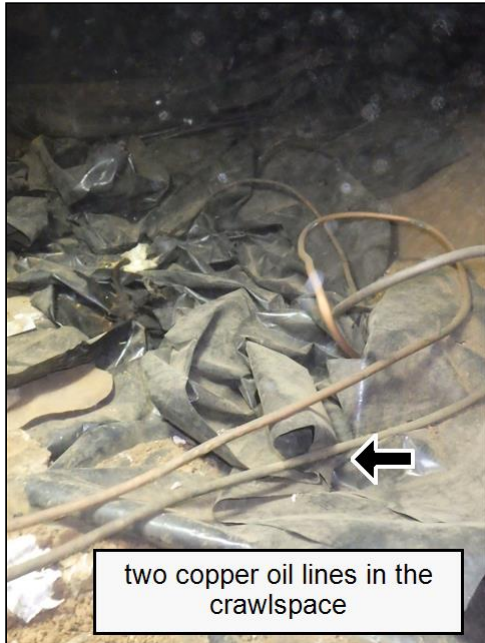
6.4 Item 1(Picture)

Gas was currently being used as the energy source for heat system but it was evident that there was an oil tank that was once used. I did not look for or find the oil tank nor did I determine whether oil tank remains on property. Which means that I did not inspect the abandoned oil tank (if any) for leaks or soil contamination.

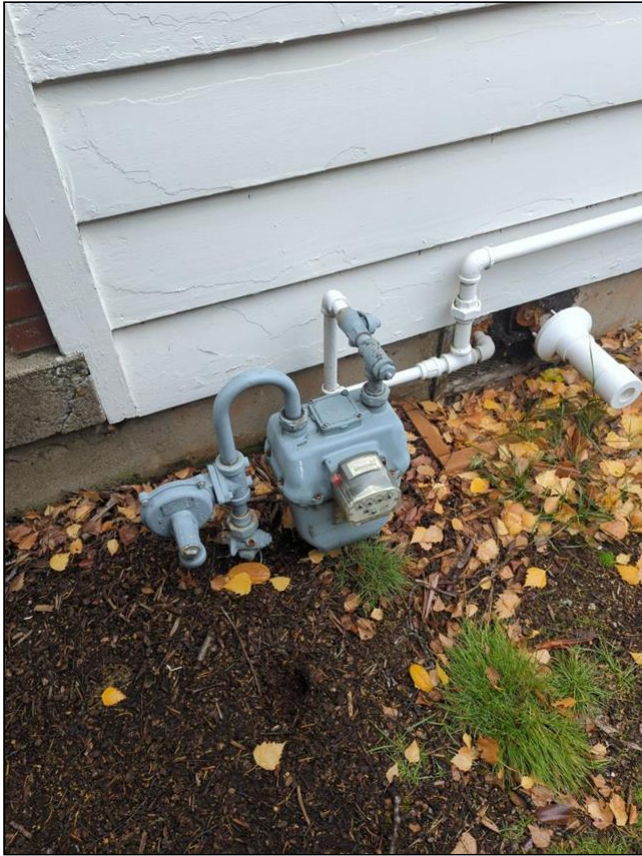
6.5 Item 1(Picture)

The main fuel shut off was at gas meter outside

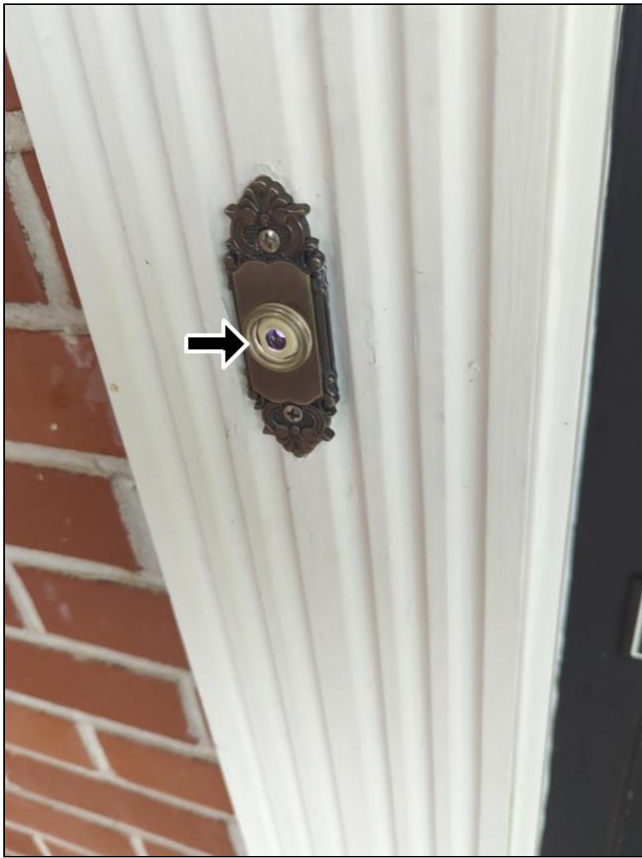
7.3 Item 1(Picture)

- 🔧 (1) Doorbell button was damaged. This should be repaired as desired.

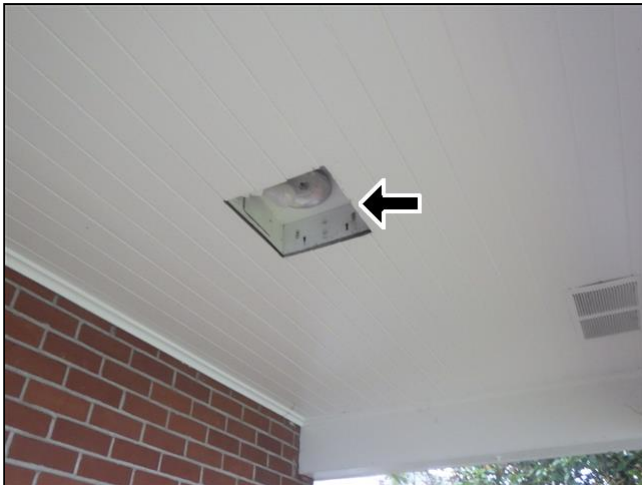
7.3 Item 2(Picture)

- 🔧 (2) The light fixture did not work and was missing cover at the front of home. Electrical issues are considered a hazard until repaired. A qualified licensed electrician should perform repairs that involve wiring.

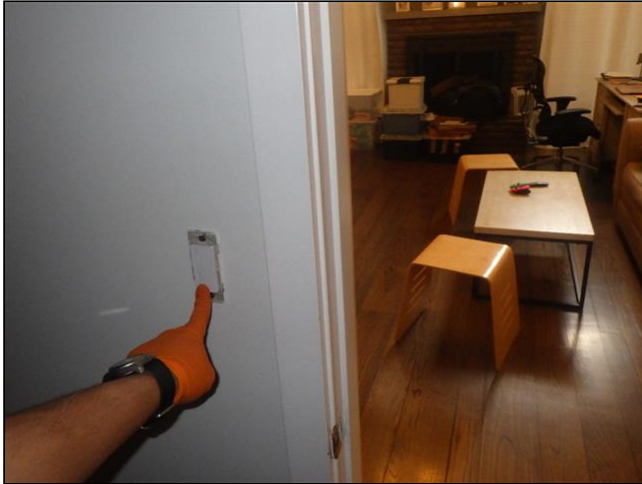
7.3 Item 3(Picture)

- 🔧 (3) The wall switch purpose was unknown (could not identify) at the Guest bath. This is for your information.  
🔍

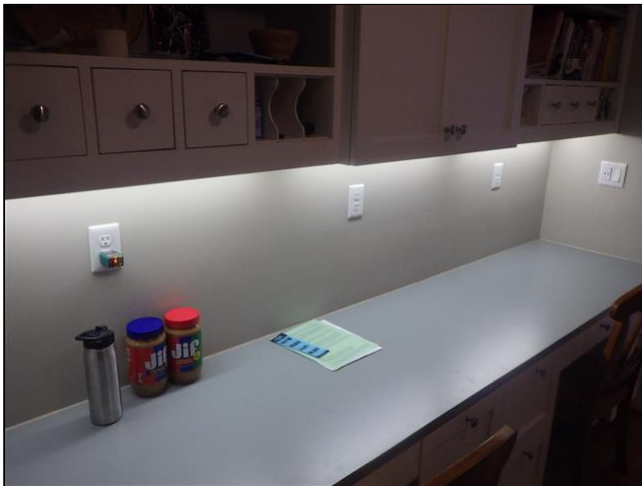
7.3 Item 4(Picture)

- 🔧 (4) The "three-prong" outlets were not grounded throughout the building. Electrical issues are considered a hazard until repaired. A qualified licensed electrician should correct as needed.

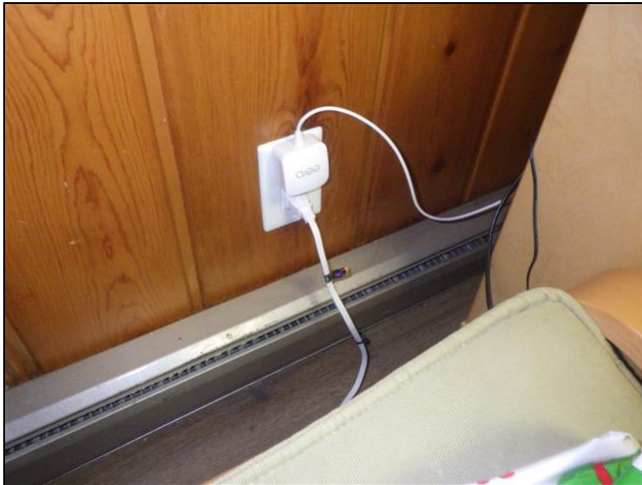
7.3 Item 7(Picture)

- 🔧 (6) The "three-prong" outlet installed above the baseboard heater in the lower level. This is a safety issue that needs to be corrected. A qualified licensed electrician should perform repairs that involve wiring.

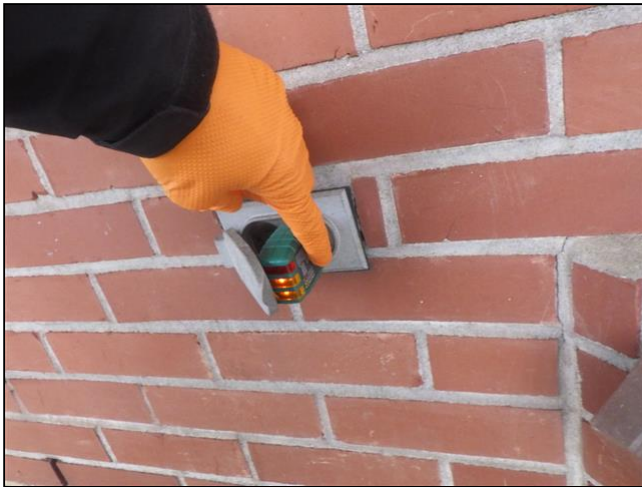
7.5 Item 1(Picture)

- 🔧 (1) The addition of GFCI's to the building in the exterior, garage and kitchen would be a wise modern safety update.

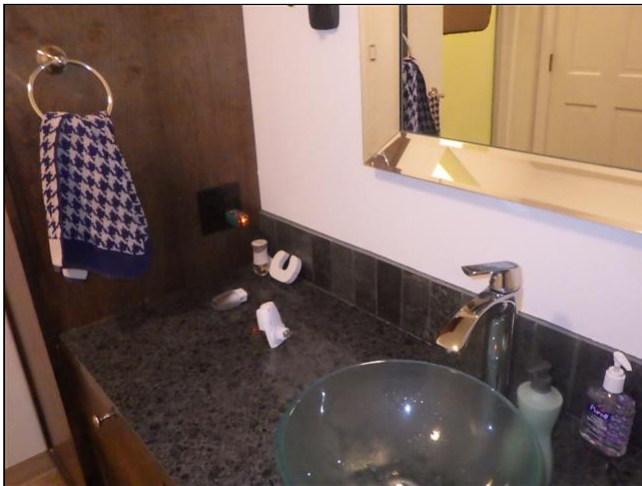
7.5 Item 2(Picture)

- 🔧 (2) The GFCI outlets at the bathrooms were non-grounded outlets. These outlets are protected by a GFCI which is more safe than a non-grounded outlet that is not protected by a GFCI, however, it should be labeled a non-grounded GFCI and it is not as safe as a grounded GFCI (for your information).

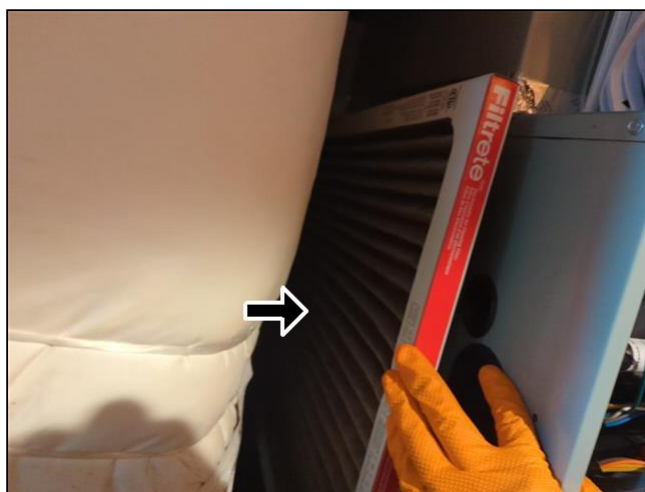
8.3 Item 1(Picture)

(1) The filter was clogged and dirty. The filter needs to be replaced. I recommend repair or replace as needed using a qualified person. Generally filters should be cleaned/replaced every one to two months.

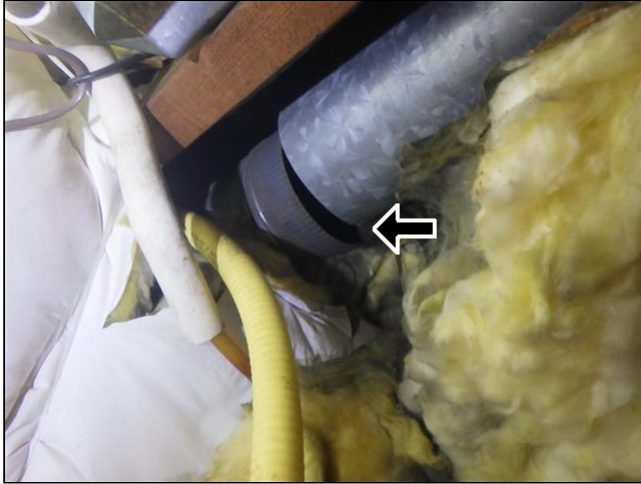
8.3 Item 2(Picture)

- 🔧 (2) The supply duct pipe was disconnected in the crawlspace above the furnace. Energy loss is occurring in crawlspace and immediate correction is needed. A qualified HVAC person should inspect further and repair or replace as needed.

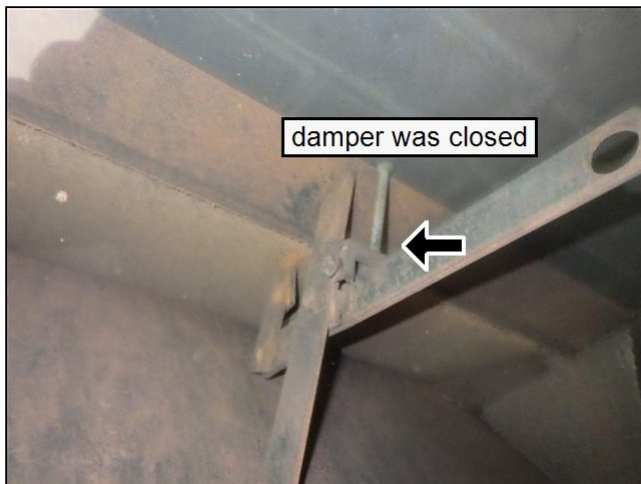
8.7 Item 1(Picture)

- 🔧 The damper for fireplace at the family room clamp or lock that forces lid to stay open (required for Vented Gas/LP logs) was not functioning properly. Repairs should be made so unit works properly. A qualified contractor should inspect and repair as needed.

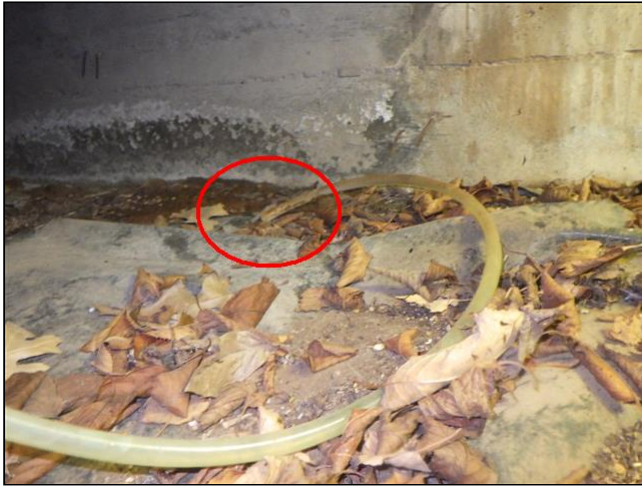
8.8 Item 1(Picture)

(3) The condensate line did not properly extend and dump out of the crawlspace. This condition can lead to moisture issues under the home. A licensed HVAC contractor should service or repair unit.

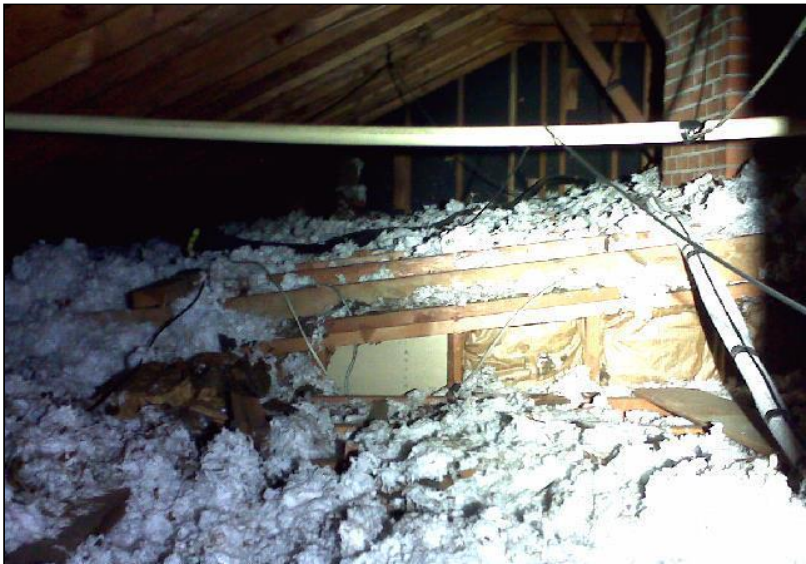
9.0 Item 1(Picture)

Fiberglass (Batts) insulation was fallen in areas of the vault in attic. Heat loss can occur more on this home than one that is properly insulated. A qualified contractor should inspect and repair as needed.

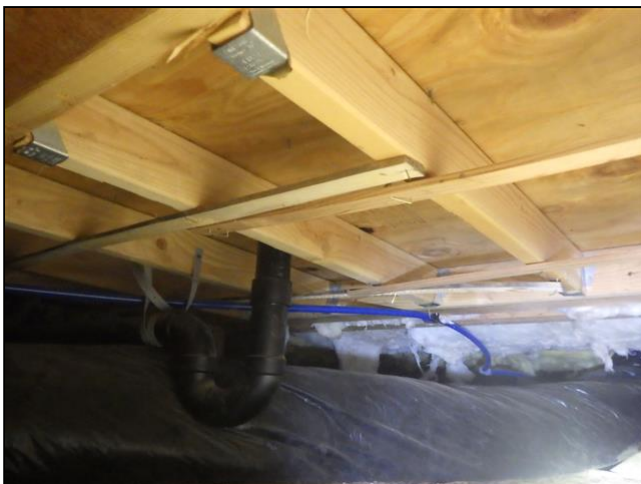
9.1 Item 1(Picture)

- (1) The insulation was missing under the master bathroom. Heat loss can occur more in this building than from one that is properly insulated. A qualified person should repair or replace as needed.

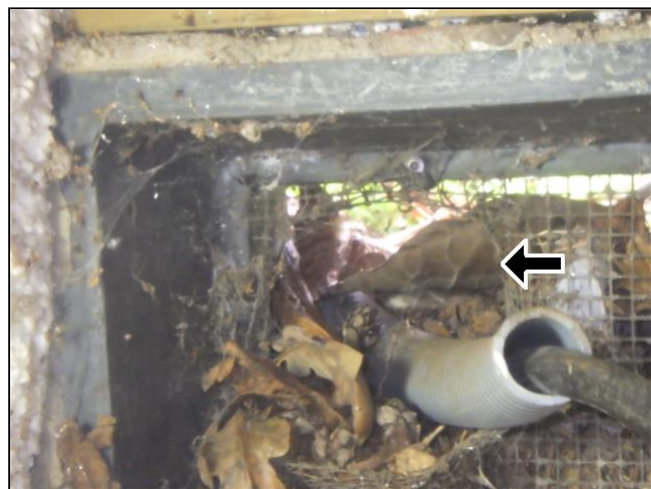
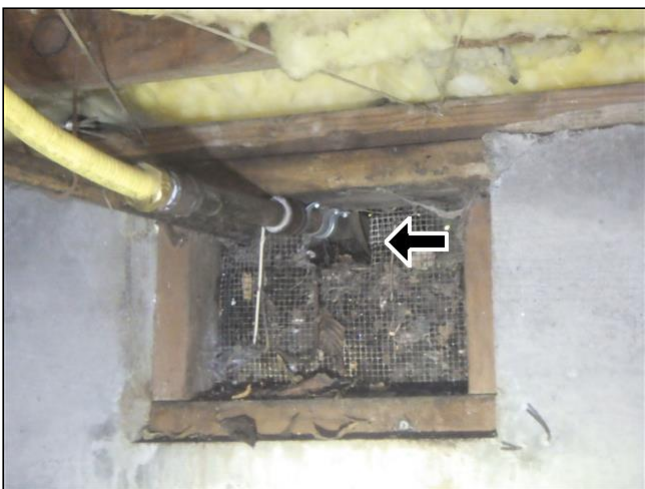
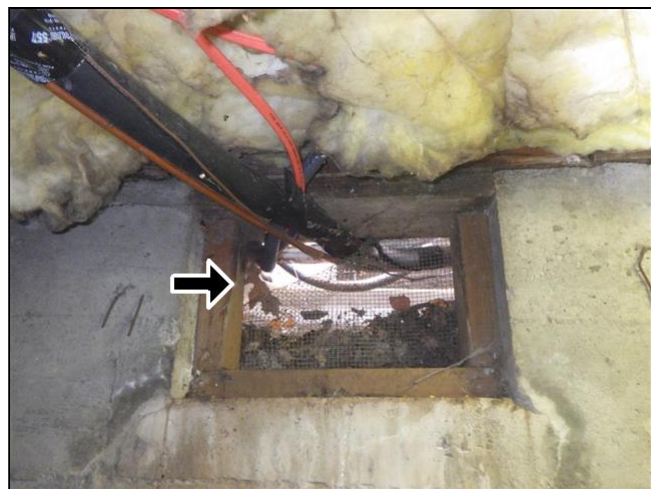
🔧 **Comments:** Inspected, Repair or Replace  
🔧 (1) The foundation has holes large enough for pests at the left side (facing front from the inside) and

rear of the building. Exclusion of pests is the best way to prevent issues. A qualified contractor should inspect and repair as needed.

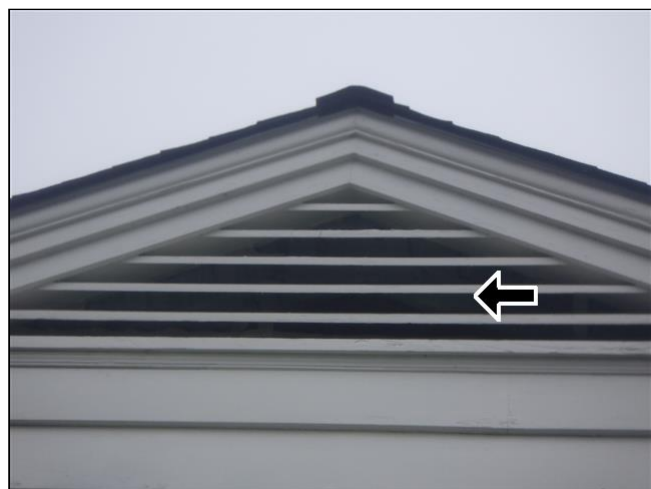
9.3 Item 4(Picture)

(2) The gable vent was missing screen at the left side (facing front from the inside). Pests should be excluded from the attic with proper screening. A qualified contractor should inspect and repair as needed.

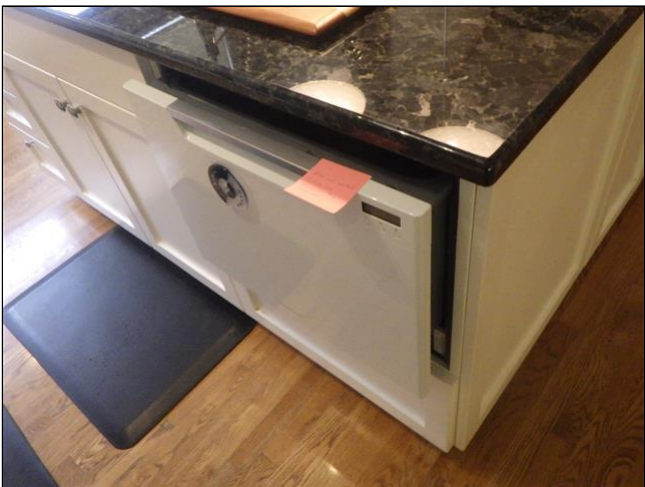
10.1 Item 1(Picture)

The dishwasher drawer did not operate when tested. I recommend repair as necessary.

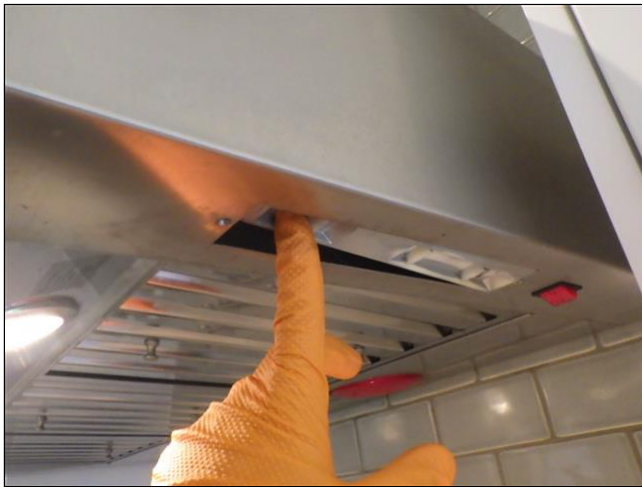
10.3 Item 1(Picture)

The range hood fan controls were loose. I recommend repair or replace as needed.
