# Perfection<sup>✓</sup> Inspection, Inc

**Property Address:  
755 Harmony St  
Lebanon OR 97355**

**9/6/2024**

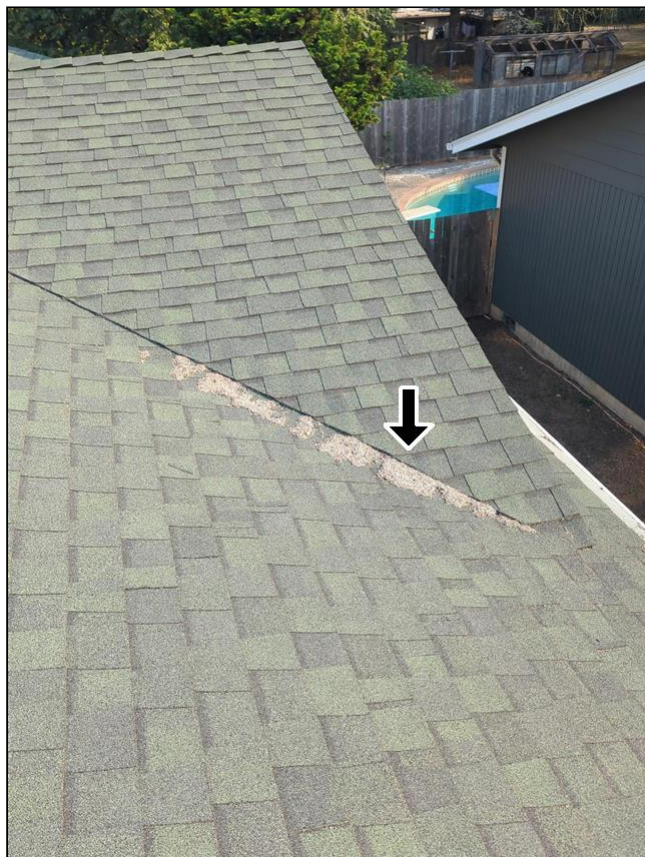
1.0 Item 1(Picture)

- 🏠 The debris that was on the roof should be removed. The debris can cause damage if left in place and shorten the roof's life. No comment can be offered on the condition of the roofing under the debris. A qualified, person should carefully remove debris as necessary.

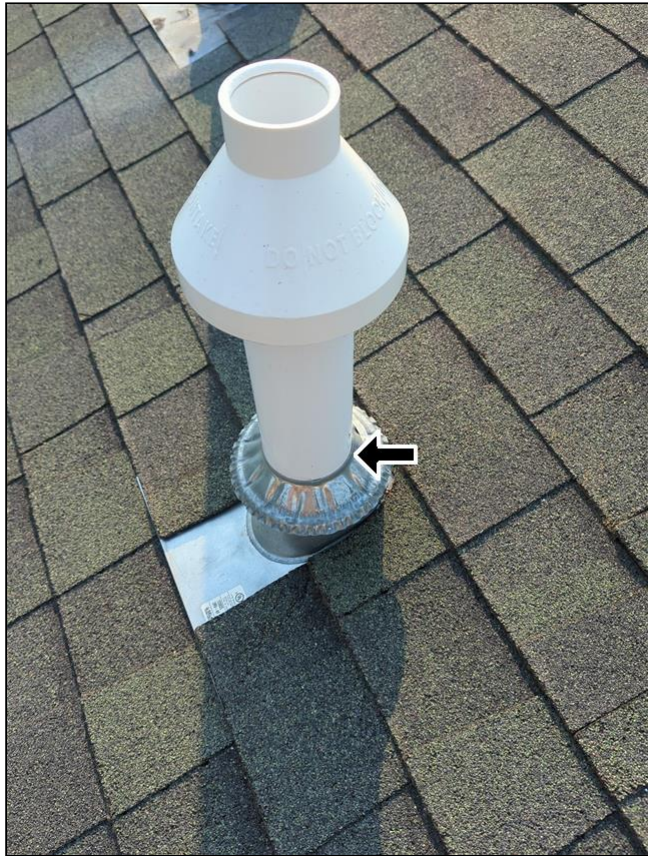
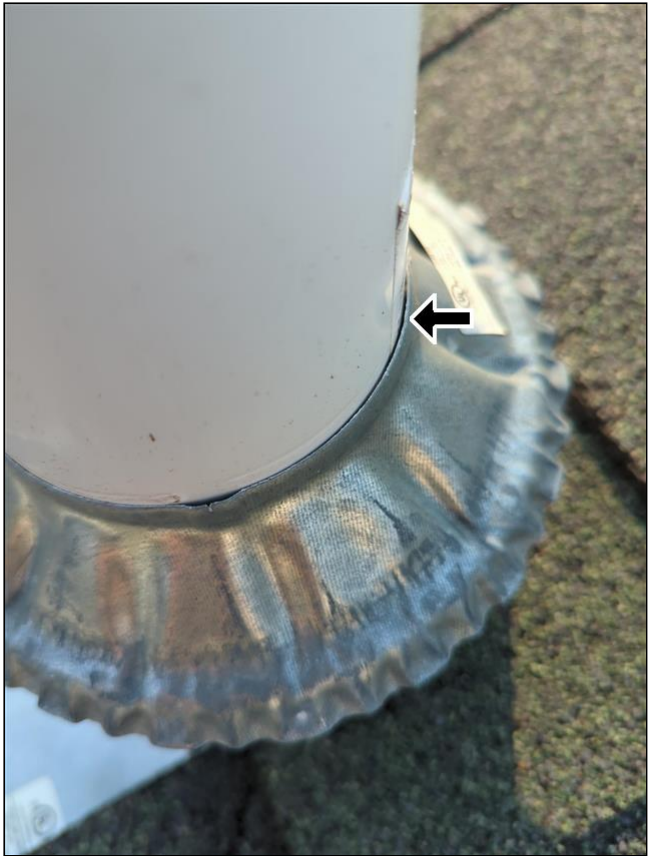
1.1 Item 1(Picture)

The gas flue for the furnace has a flashing joint that should be caulked. This should be repaired by a licensed professional contractor to prevent leakage.

licensed professional contractor to prevent leakage.

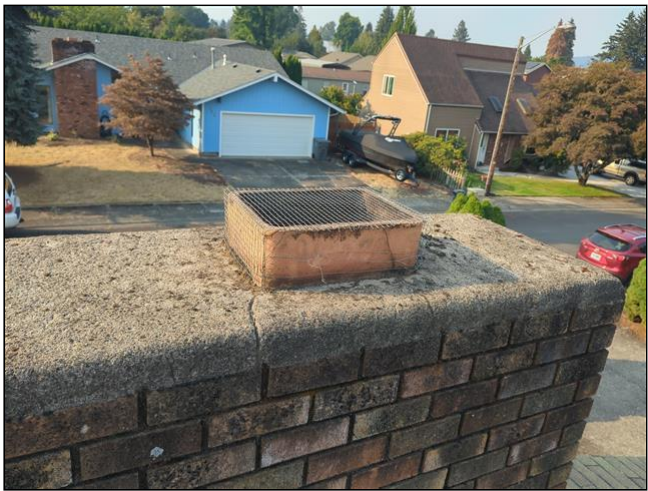
1.2 Item 1(Picture)

(1) The installation of a rain cap/screen is suggested on the masonry chimney. A properly installed rain cap will help shed excess moisture and prevent pests from accessing the chimney. A qualified, licensed professional contractor should install a rain cap.

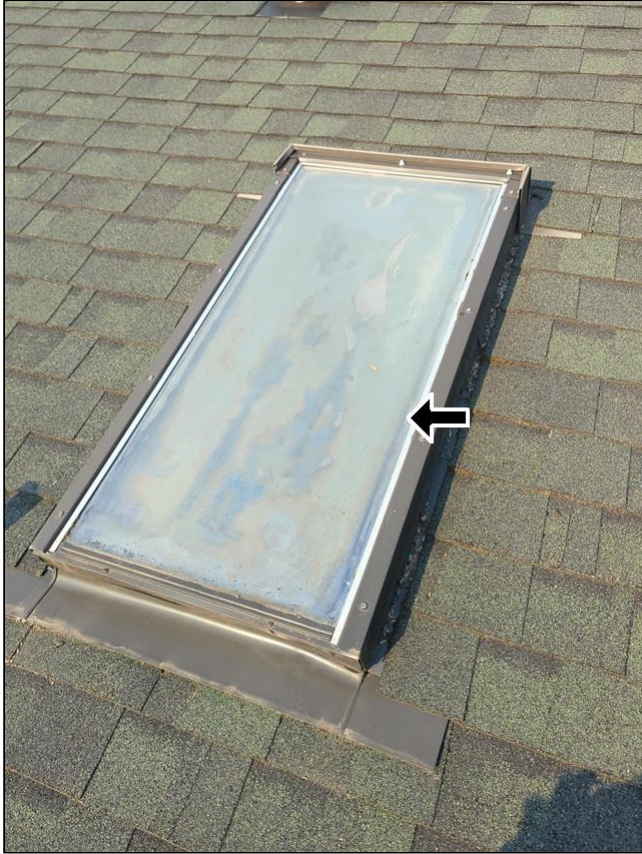
1.2 Item 3(Picture)

- 🔧 (2) One skylight was cloudy, (lost seal) at the hall bath. In order to correct the cloudy appearance of glass, a replacement of glass pane or the unit will be necessary. A qualified contractor should repair or replace as needed.

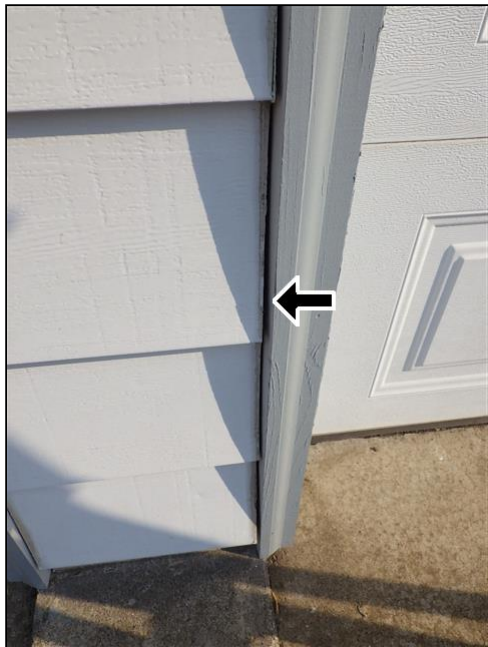
2.0 Item 1(Picture)

The caulking joints were open on the exterior trim. The building should be properly prepped, caulked and painted to preserve the building envelope.

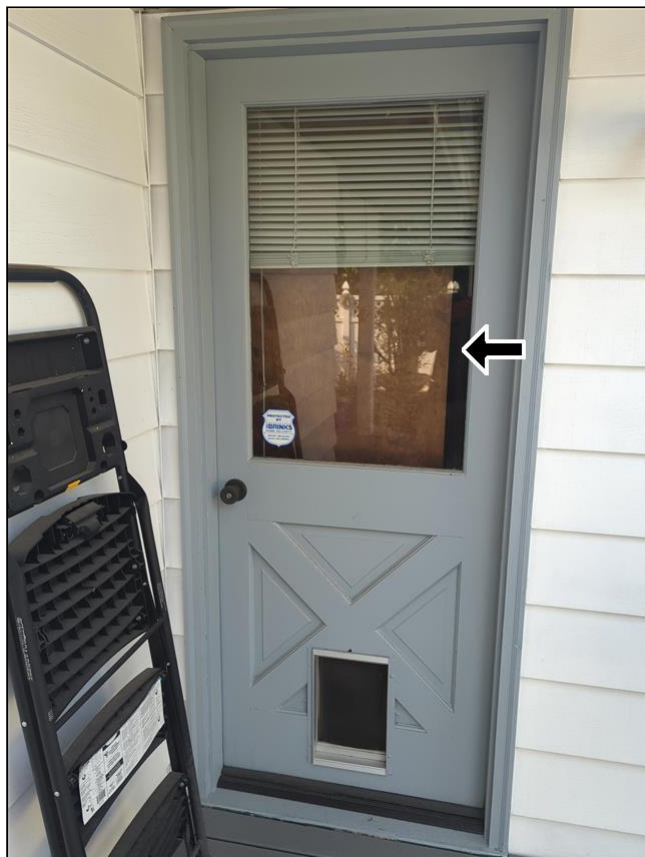
2.1 Item 1(Picture)

- 🔧 The entry door at the rear of the building of home has single pane non tempered glass. Non tempered glass can be dangerous if broken or damaged. Although this was normal when the home was built, replacing the glass will improve the safety of the home.

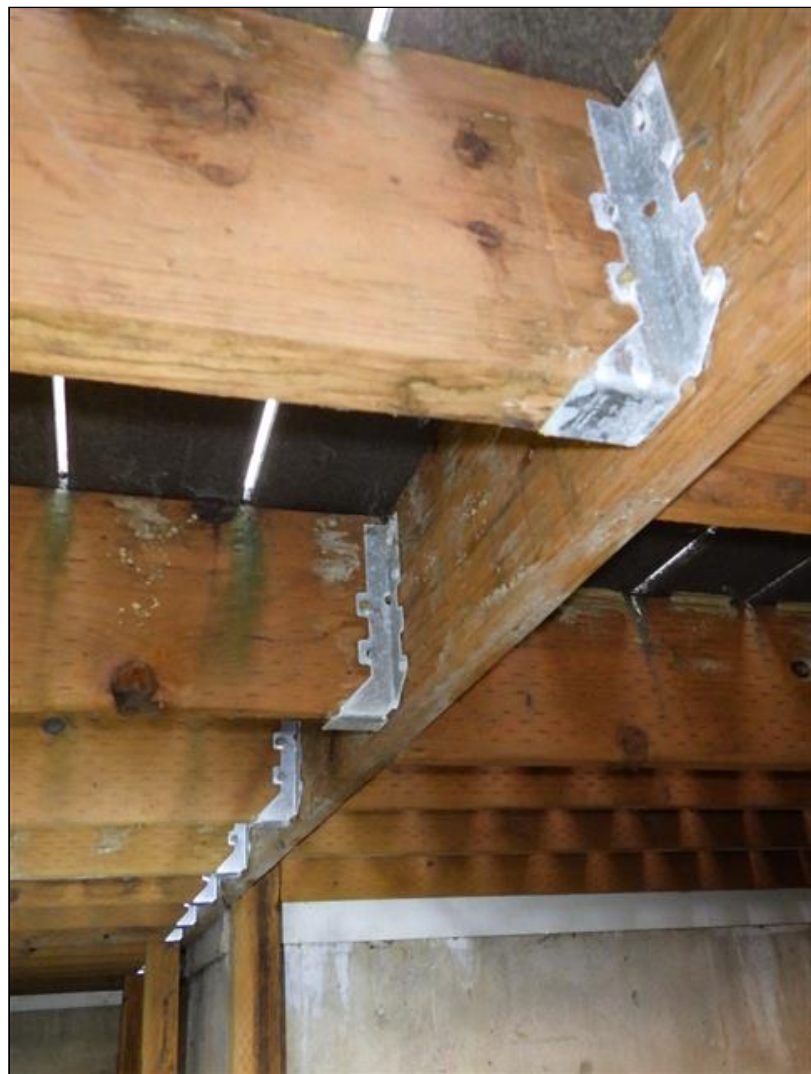
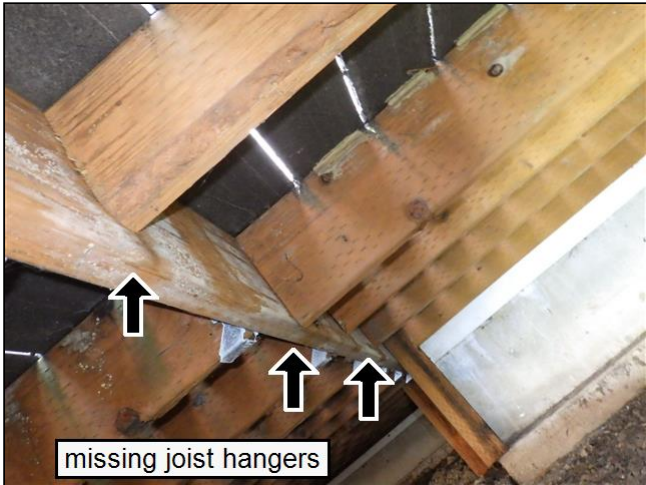
2.3 Item 1(Picture)

The deck structure on the rear of the building were not installed properly. The joist hangers were missing fasteners and were using the wrong fasteners. A qualified contractor should repair or replace as needed.

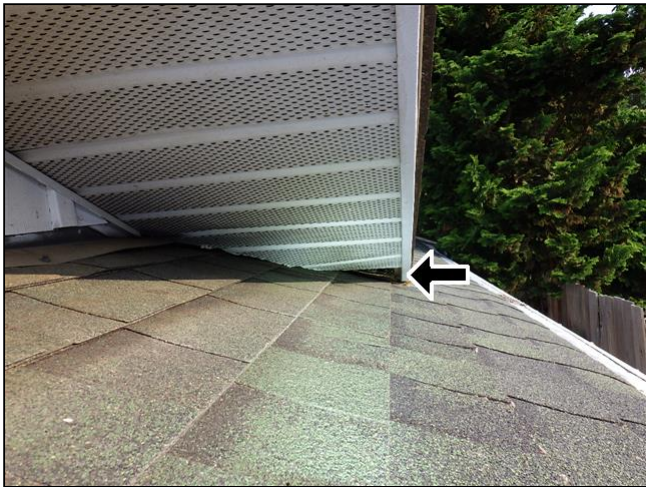
2.5 Item 1(Picture)

(1) A gap between the fascia and roof sheathing exists which may allow vermin to nest in the eave and possibly enter the attic. A licensed professional contractor should seal these openings as necessary.

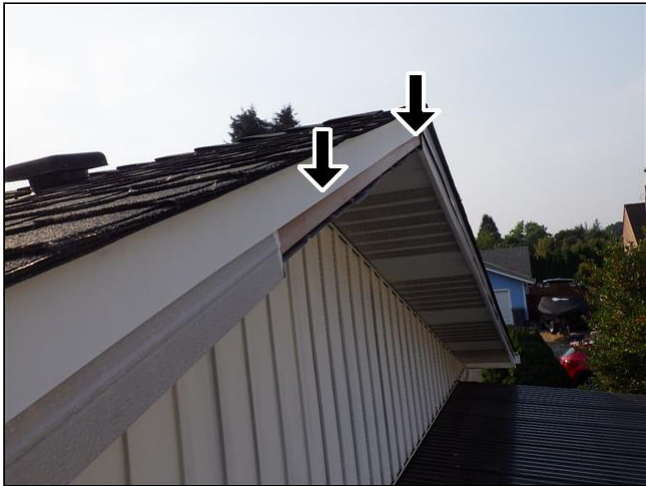
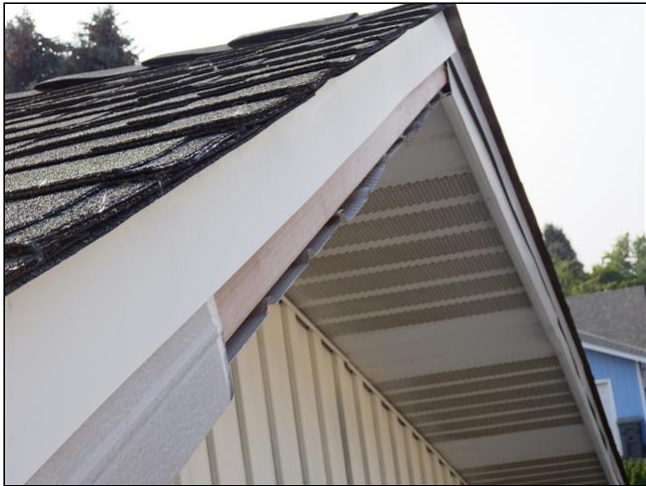
2.5 Item 2(Picture)

(2) The metal trim at eave on the west side of the building was missing. Deterioration may occur if not corrected. A qualified contractor should inspect and repair as needed.

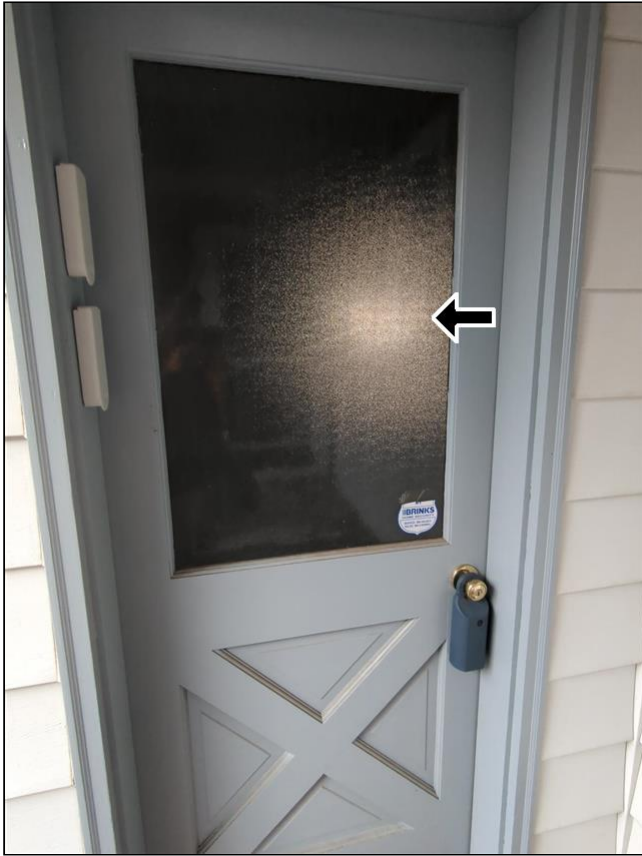
3.3 Item 1(Picture)

(1) The man door at the front of the building has a single pane of glass that does not appear to be tempered. Non tempered glass can be dangerous if broken or damaged. Although this was normal when the home was built, replacing the glass will improve the safety of the home.

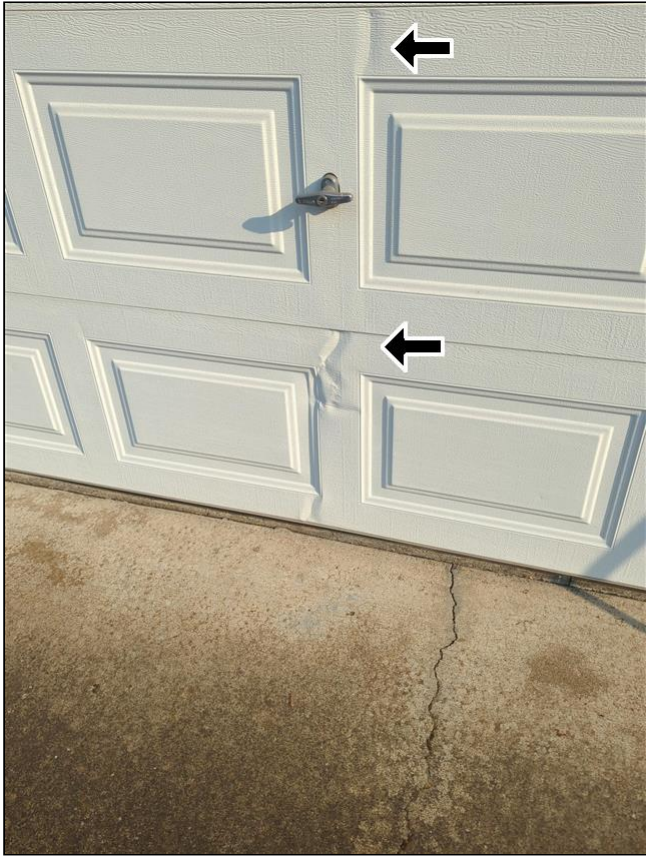
3.3 Item 2(Picture)

🔍 (2) The garage door at the front of the building shows some mechanical damage. This appears to be a cosmetic issue and does not effect the function of the door. I recommend monitoring this issue to determine if repairs are necessary.

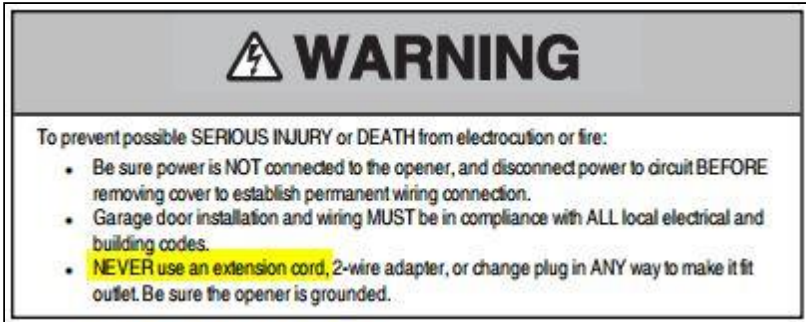
3.5 Item 1(Picture)

🔧 The garage door opener was using an extension cord as permanent wiring, and should have it's own outlet. An outlet should be installed near the opener. A qualified licensed electrician should inspect further and repair as needed.

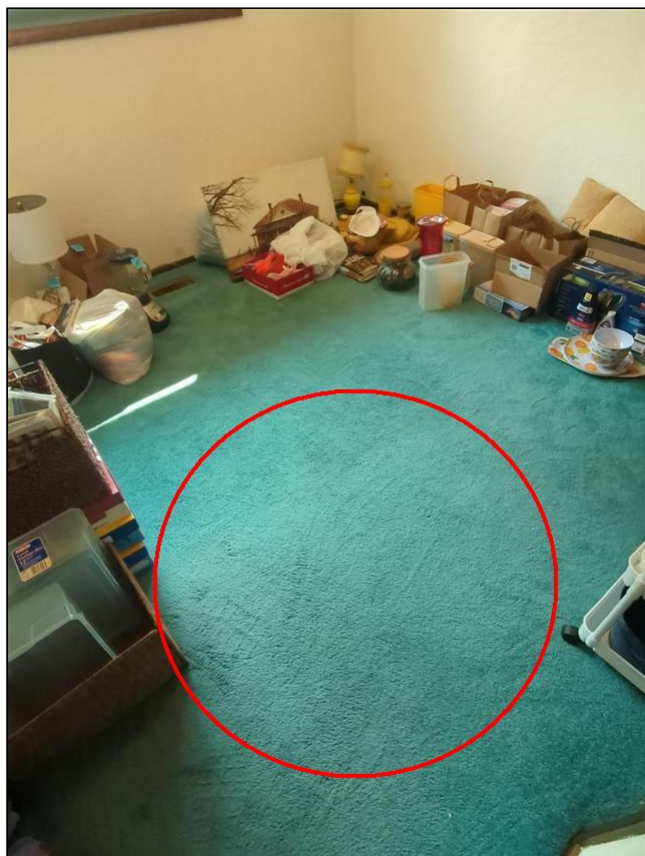
4.2 Item 1(Picture)

- 🔍 The floors squeak in areas. This is mostly a cosmetic issue and is for your information. The floors should be repaired as desired.

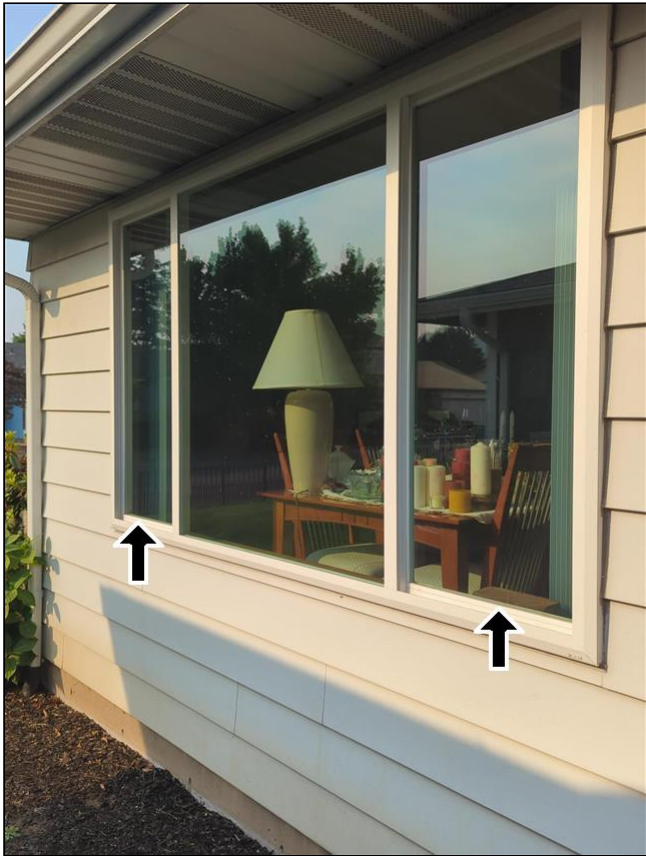
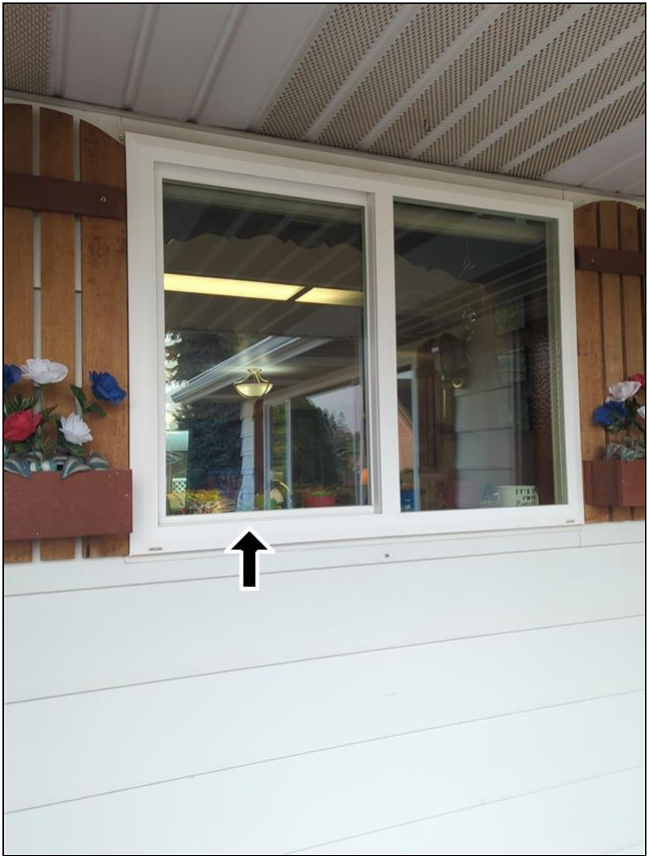
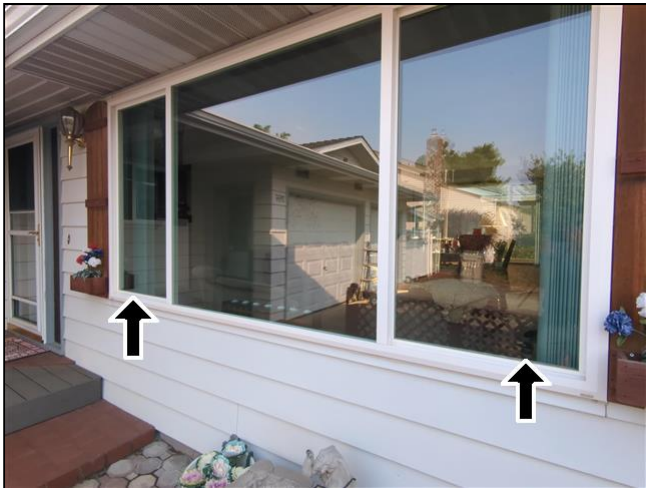
4.6 Item 1(Picture)

(1) Some windows were missing screens. This should be repaired. A qualified person should repair or replace as needed.

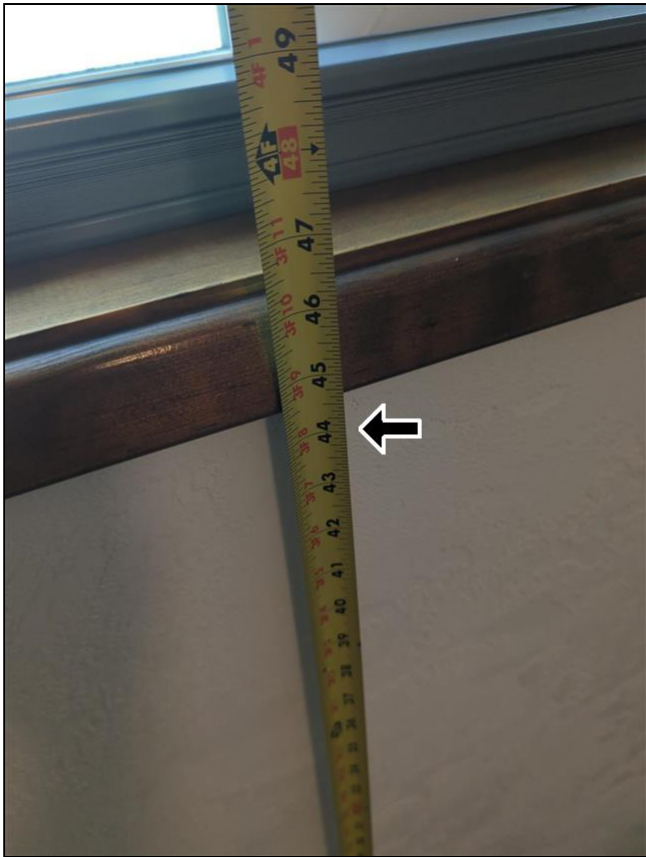
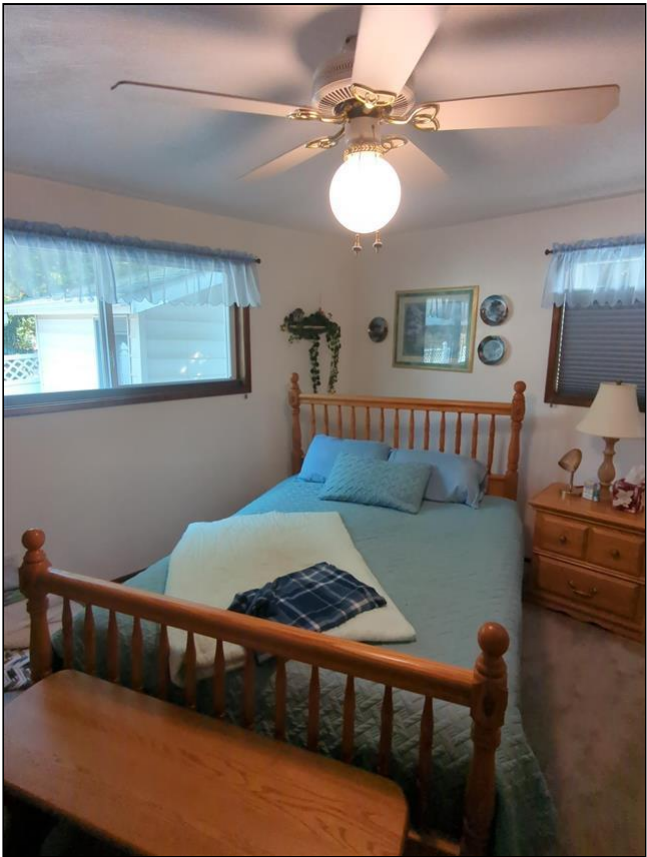
4.6 Item 4(Picture)

(2) The windows were not low enough to be considered egress windows at the bedrooms. This may be a safety concern if a window is needed to escape fire. A qualified contractor should inspect and repair as needed.

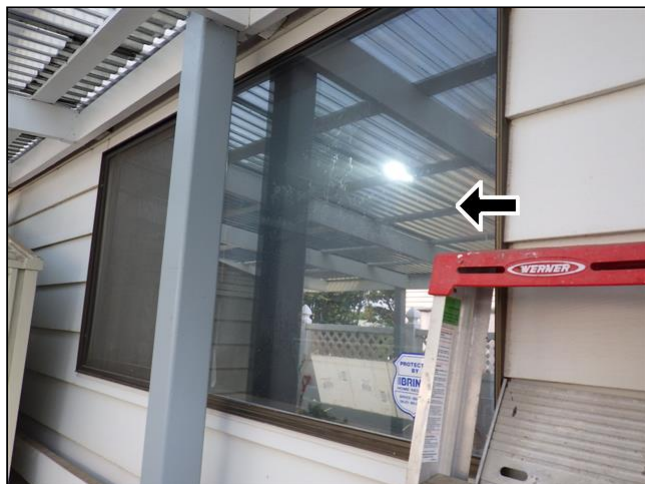
4.6 Item 7(Picture)

- 🔧 (3) One window was cloudy (moisture trapped between the panes) in the garage. In order to correct the cloudy appearance of glass, a replacement of glass pane or the unit will be necessary. A qualified contractor should inspect and repair as needed.

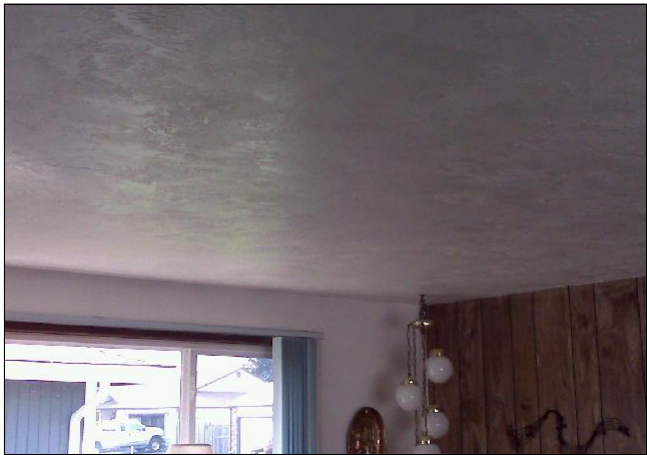
Normal structure

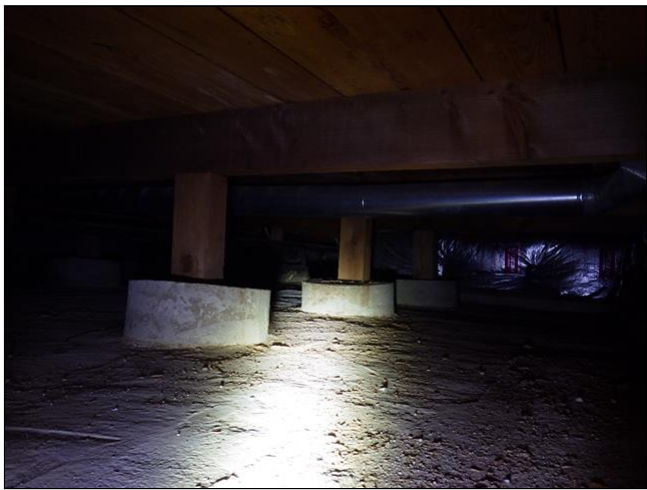
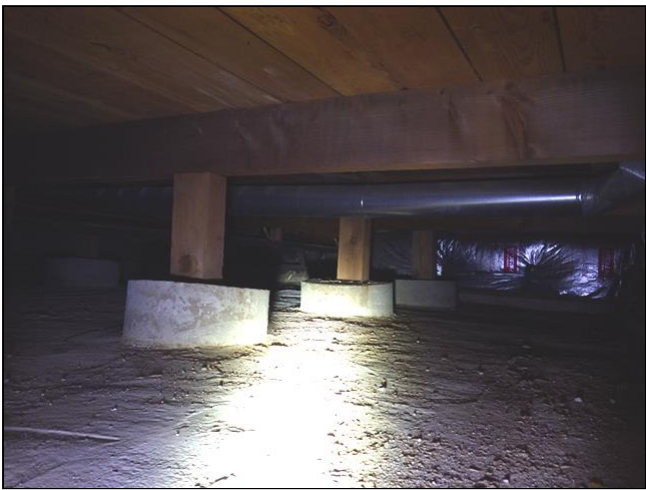
Normal structure

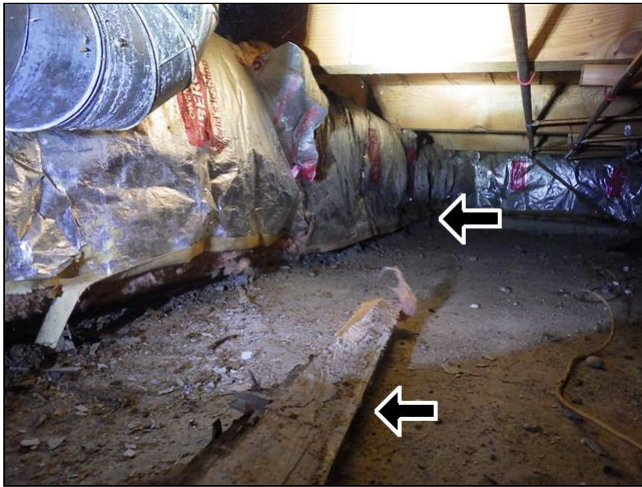
5.0 Item 1(Picture)

- ⚠ The wood/cellulose construction debris should be removed from the crawlspace. The excess wood that is under the building can be an excellent home base for wood destroying organisms, allowing them to multiply. When the wood runs out or the wood destroying organisms start looking for more they may look to your building. In general all pieces large enough to be caught in a garden rake should be removed.

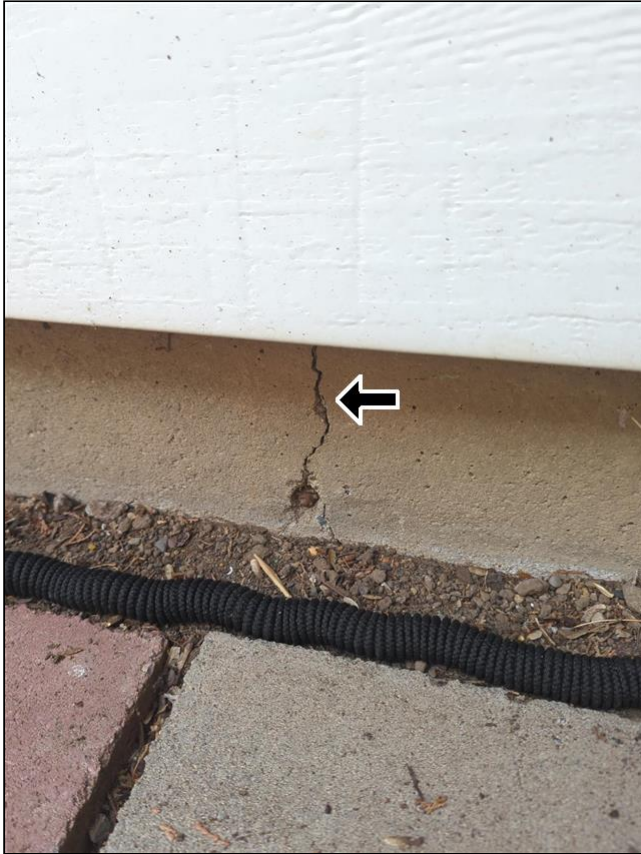
5.2 Item 1(Picture)

The foundation wall has typical shrinkage cracks. These cracks appear to be normal in size and shape and no repairs are needed.

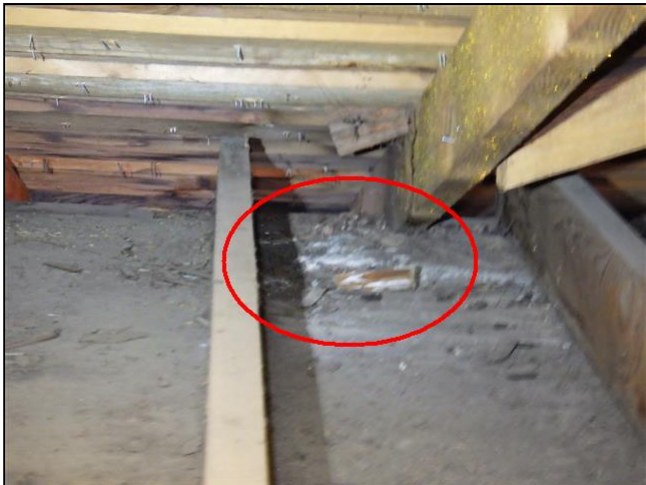
5.6 Item 1(Picture)

🔍 Water stains are on the roofing structure around the the front valley of the garage. The stains appear to be related to the previous roofing and no current leakage was observed at the time of the inspection. It is recommend to monitor after a heavy rain and repair if needed.

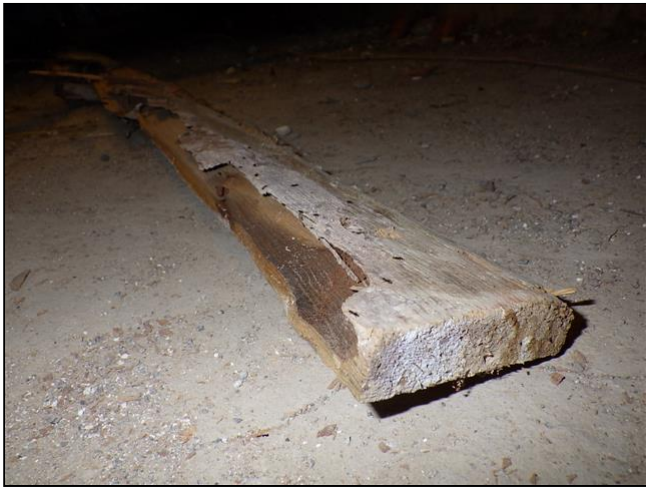
5.7 Item 1(Picture)

Old historic signs of subterranean termites noted in the crawlspace wood debris. No significant, current, ongoing indications of issues within the building however the building should be inspected every year as a matter a maintenance.

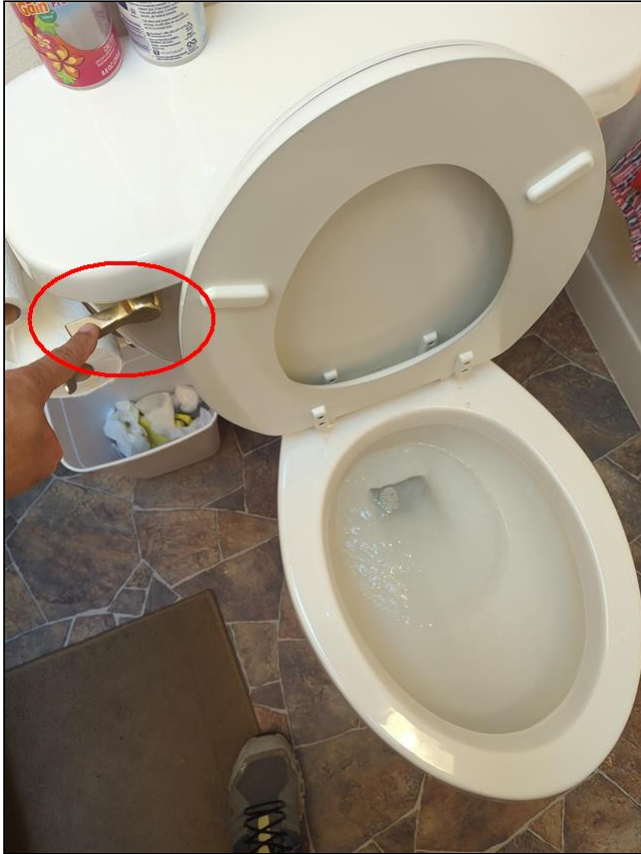
6.0 Item 1(Picture)

- 🔧 (1) The toilet won't flush unless lever is held down briefly at the hall bath. Repairs are needed. I recommend a licensed plumber inspect further and repair as necessary.

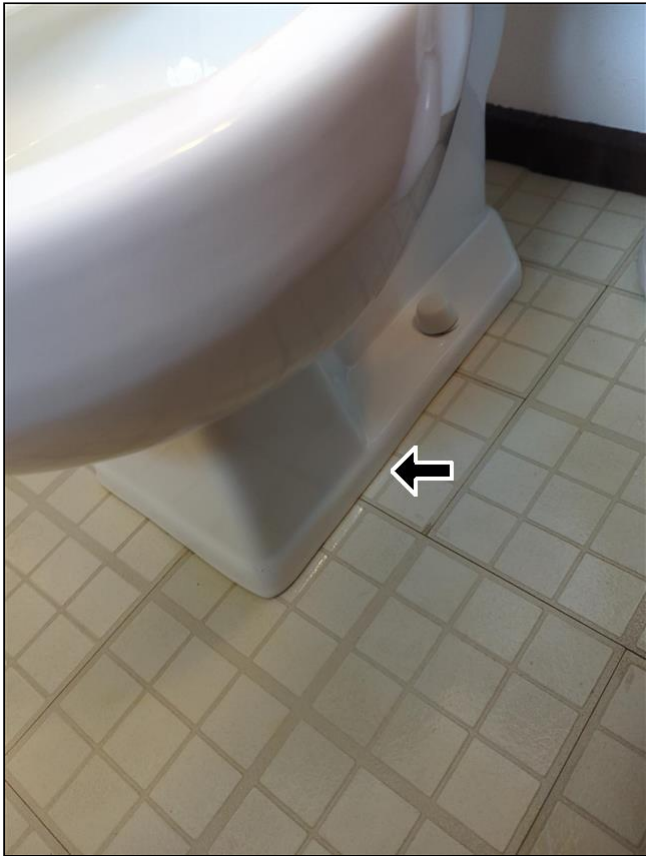
6.0 Item 2(Picture)

- 🔧 (2) The toilet should be caulked at the floor at the master bath. Repairs are needed. I recommend a licensed plumber inspect further and repair as necessary.

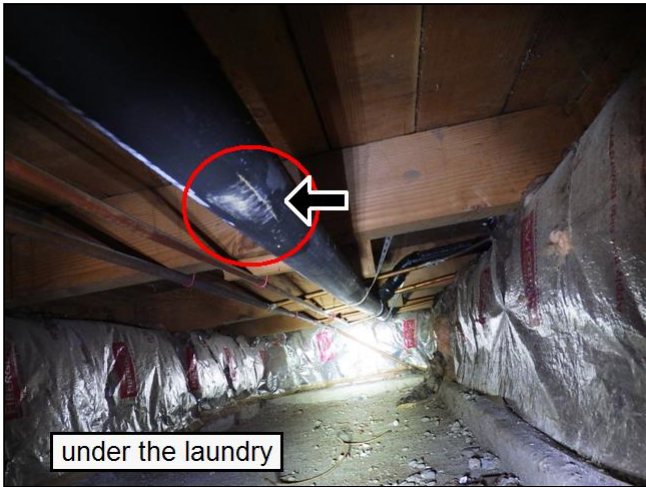
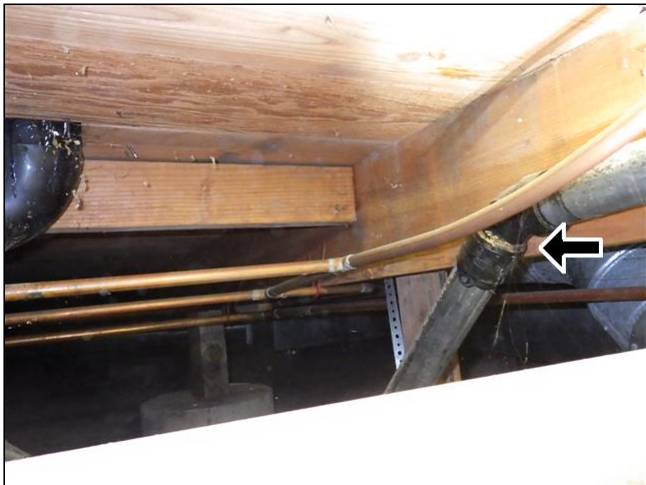
6.0 Item 3(Picture)

- 🔧 (3) The plumbing waste line leaked in the crawlspace (refer to pictures for information). Repairs are needed. I recommend a licensed plumber inspect further and repair as necessary.

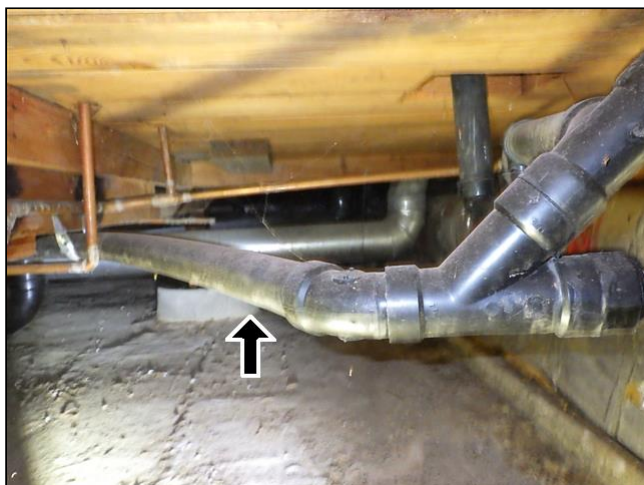
6.0 Item 11(Picture)

- 🔧 (4) The plumbing waste line did not have proper slope in the crawlspace under the master bath. Repairs are needed. I recommend a licensed plumber inspect further and repair as necessary.

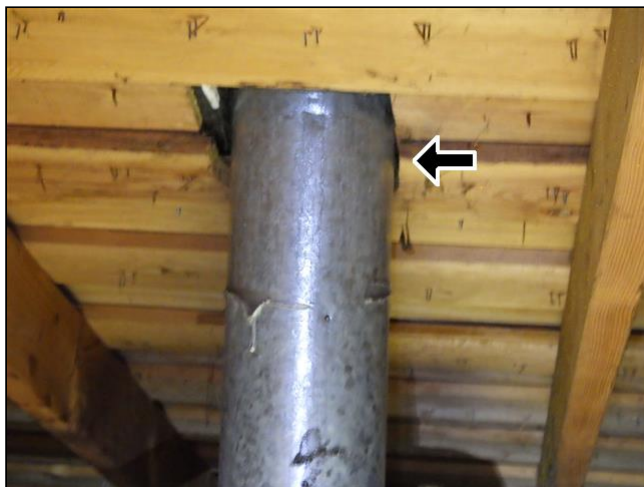
6.2 Item 1(Picture)

- 🔧 The vent pipe for gas water heater needs a 1 inch clearance from combustibles in the attic. This is a safety issue and should be repaired. I recommend a qualified licensed heat contractor inspect further and repair as needed.

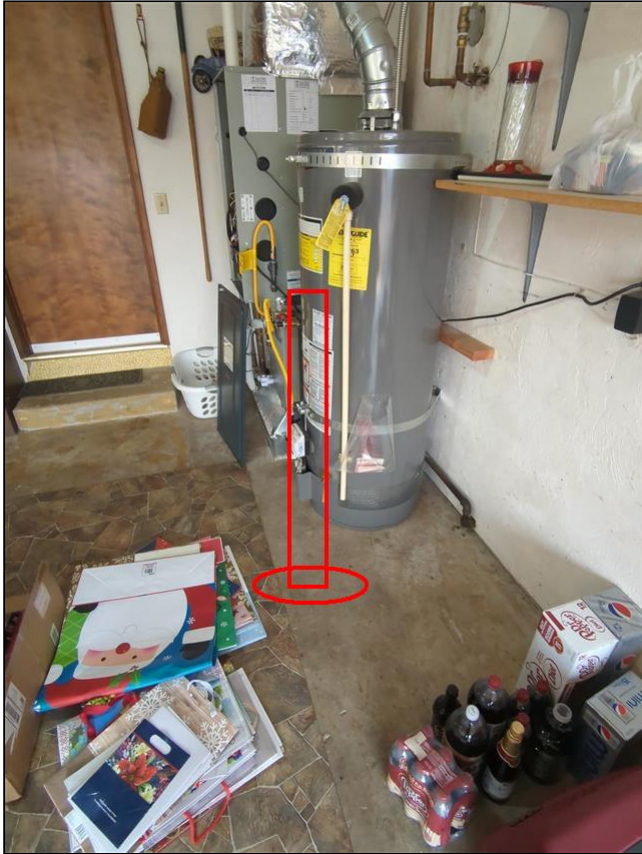
6.4 Item 1(Picture)

- 🔧 The gas lines in the garage should have a steel bollard to protect the lines from accidental contact with a vehicle. A licensed professional contractor should install as necessary.

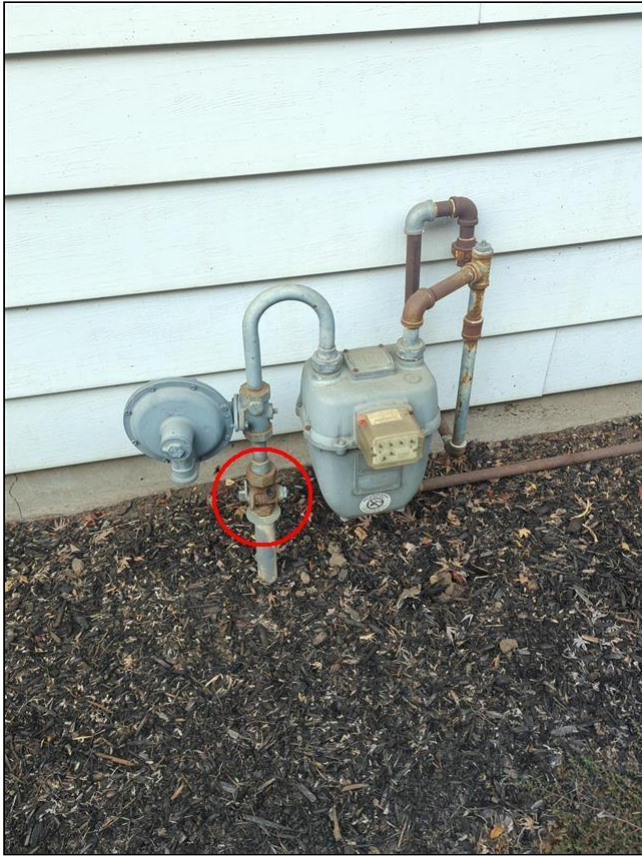
6.5 Item 1(Picture)

The main fuel shut off was at gas meter outside

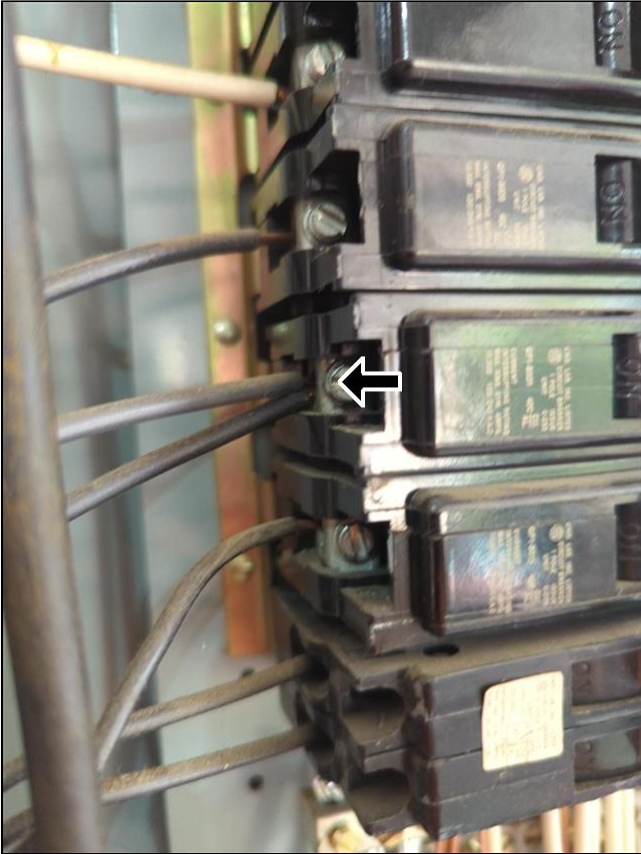
7.2 Item 1(Picture)

(1) Double tap (where two wires share a breaker designed for one) noted on the main panel. A qualified licensed electrician should perform repairs that involve wiring.

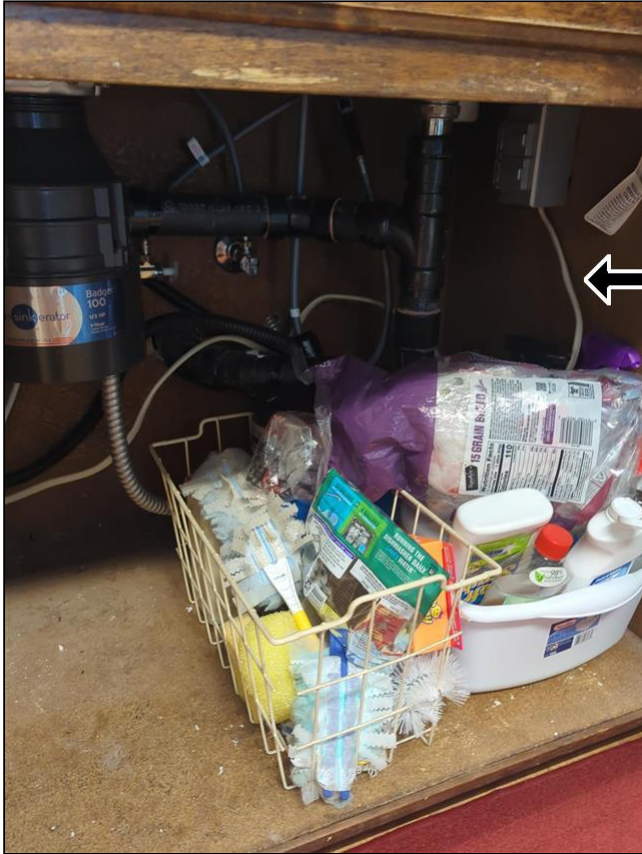
7.3 Item 1(Picture)

- 🔧 (1) Exposed wiring under the sink in the kitchen. This is for your information. I recommend repair as needed.

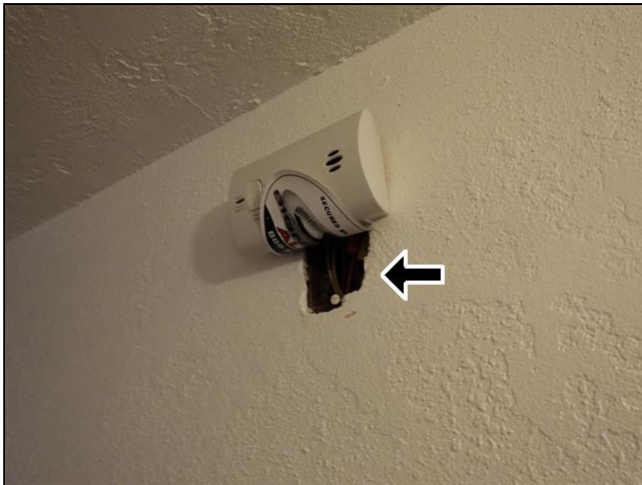
7.3 Item 2(Picture)

- 🔧 (2) Exposed splice(s) at the carbon monoxide detector on wall. This is for your information. A qualified licensed electrician should perform repairs that involve wiring.

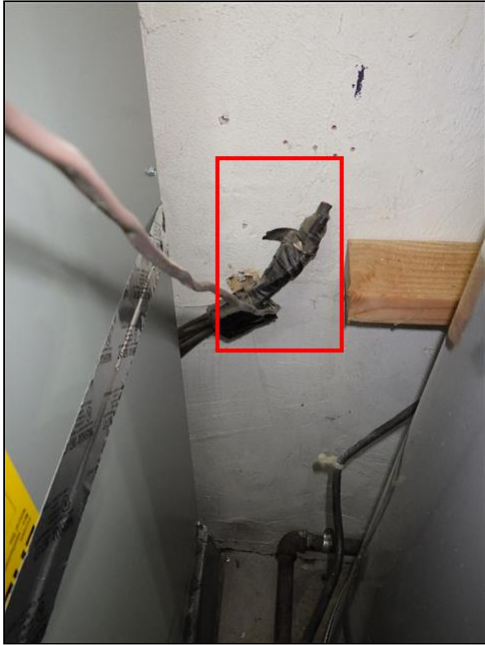
7.3 Item 3(Picture)

- 🔧 (3) Several loose wire ends need placing in boxes with cover-plates in the garage behind the furnace. A qualified licensed electrician should perform repairs that involve wiring.

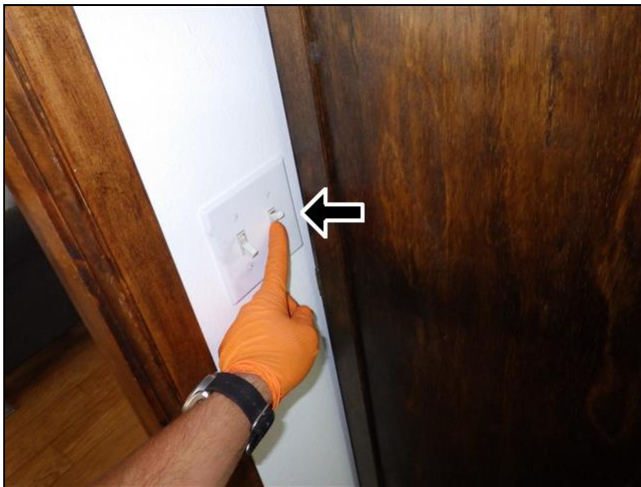
7.3 Item 4(Picture)

- 🔧 (4) The wall switch purpose was unknown (could not identify) at the washer/dryer room. This is for your information. I recommend repair as needed.

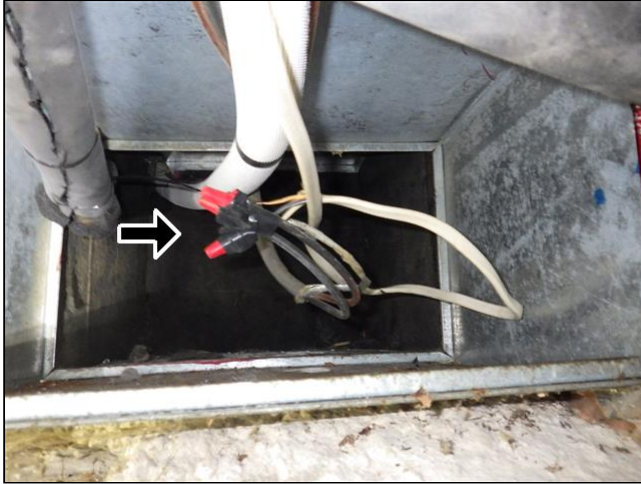
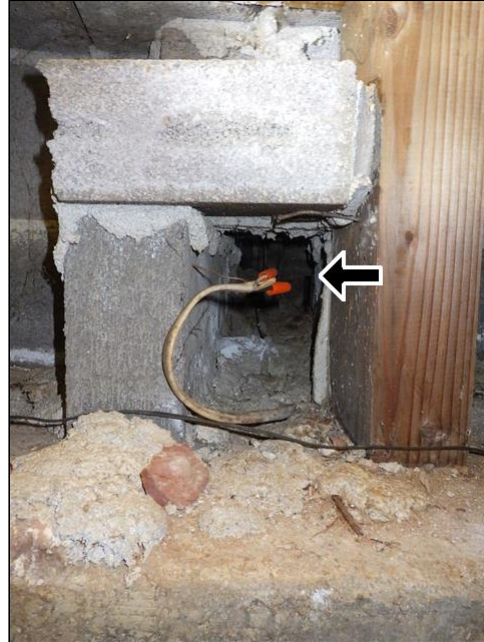
7.3 Item 5(Picture)

- ⚡ (5) Exposed splice(s) near the furnace and under the fireplace in the crawlspace. Electrical issues are considered a hazard until repaired. A qualified licensed electrician should perform repairs that involve wiring.

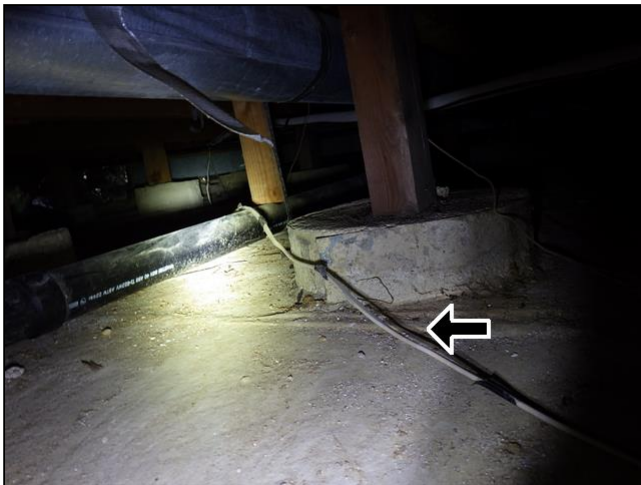
7.3 Item 7(Picture)

- ⚡ (6) Improperly secured wiring in the crawlspace. This is for your information. I recommend repair as needed.

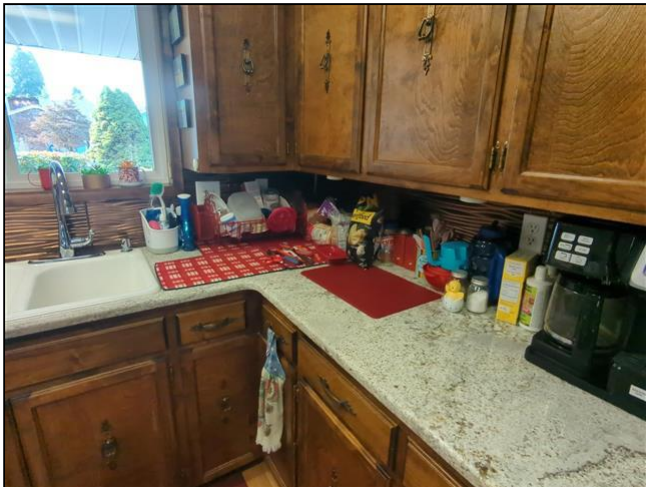
7.5 Item 1(Picture)

🔧 The addition of GFCI's to the building in the exterior, garage and kitchen would be a wise modern safety update.

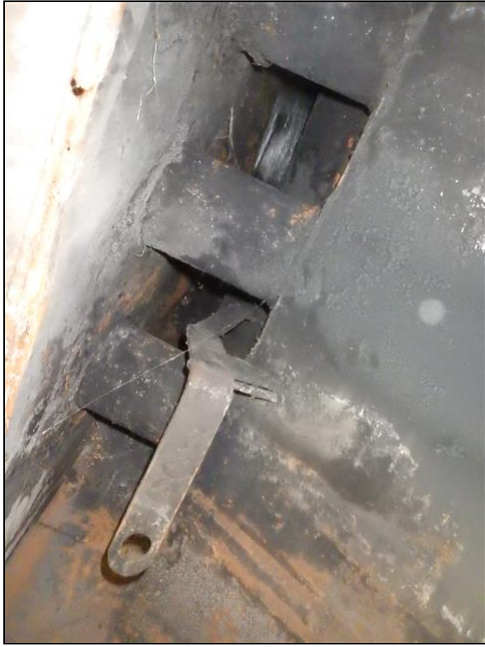
8.6 Item 1(Picture)

- 🔧 Due to the limited view of the flue it is suggested that, before the heating season, you contract a qualified, professional chimney sweep to inspect the flue.

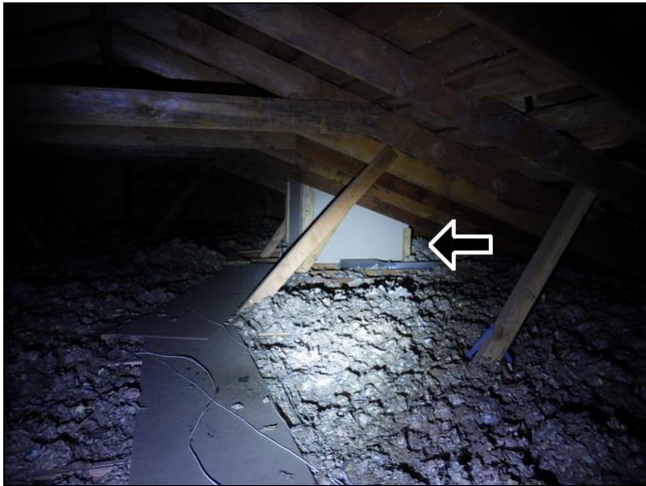
9.0 Item 1(Picture)

🔧 (1) Fiberglass (Batts) insulation was missing in attic around the skylight chase. Heat loss can occur more in this building than from one that is properly insulated. A qualified contractor should inspect and repair as needed.

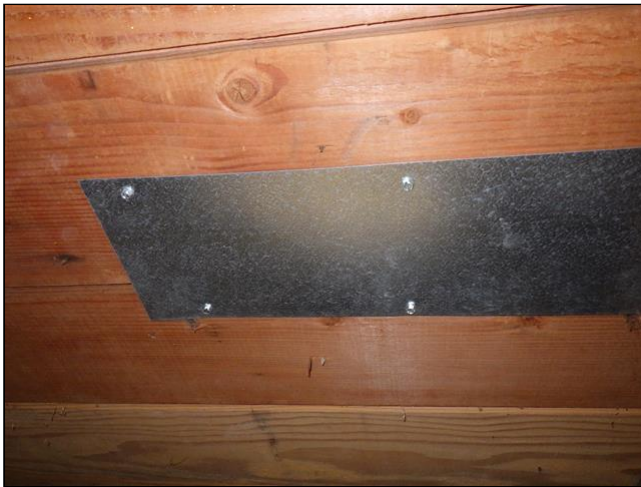
9.3 Item 1(Picture)

The crawlspace was once part of the heating systems return section. The furnace return has been ducted and the crawlspace has been abandoned as part of the ducts. This crawlspace was not ventilated however this crawlspace is conditioned with the ducts in the crawlspace and exterior vents do not appear to be necessary to prevent moisture issues and damage to the wood structure. This is for your information.

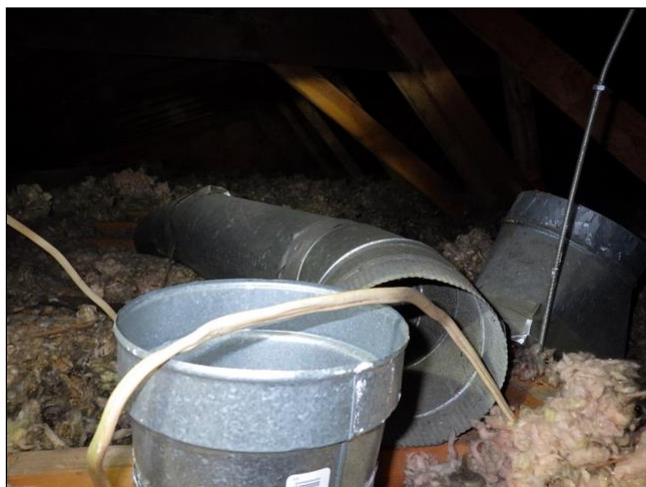
10.3 Item 1(Picture)

The range hood fan vents into the attic space and should vent to the outside. I recommend repair or replace as needed.
