# Perfection<sup>✓</sup> Inspection, Inc

**Property Address:  
1356 Pressler Ct S  
Salem OR 97306**

**12/26/2024**

**Jim Allhiser**

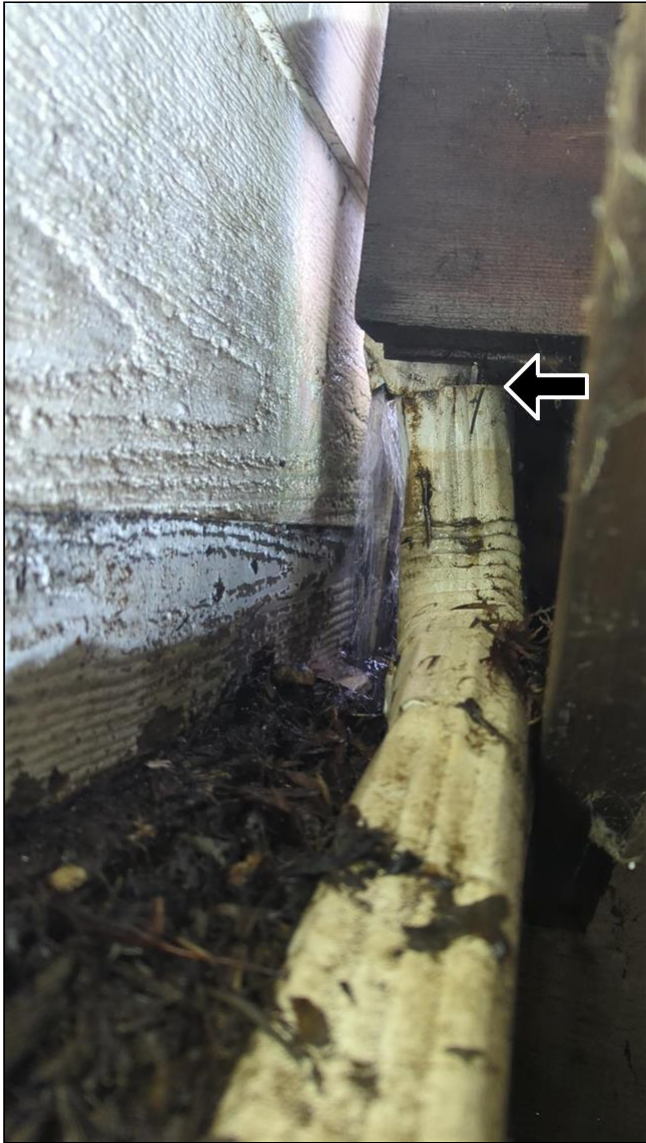
1.3 Item 1(Picture)

🔧 (1) The downspouts were missing/disconnected and showed evidence of leakage at the front and rear of the building. The downspout should be properly secured to ensure proper collection and removal of storm water. A qualified contractor should inspect and repair as needed.

(1) The downspouts were missing/disconnected and showed evidence of leakage at the front and rear of the building. The downspout should be properly secured to ensure proper collection and removal of storm water. A qualified contractor should inspect and repair as needed.
-

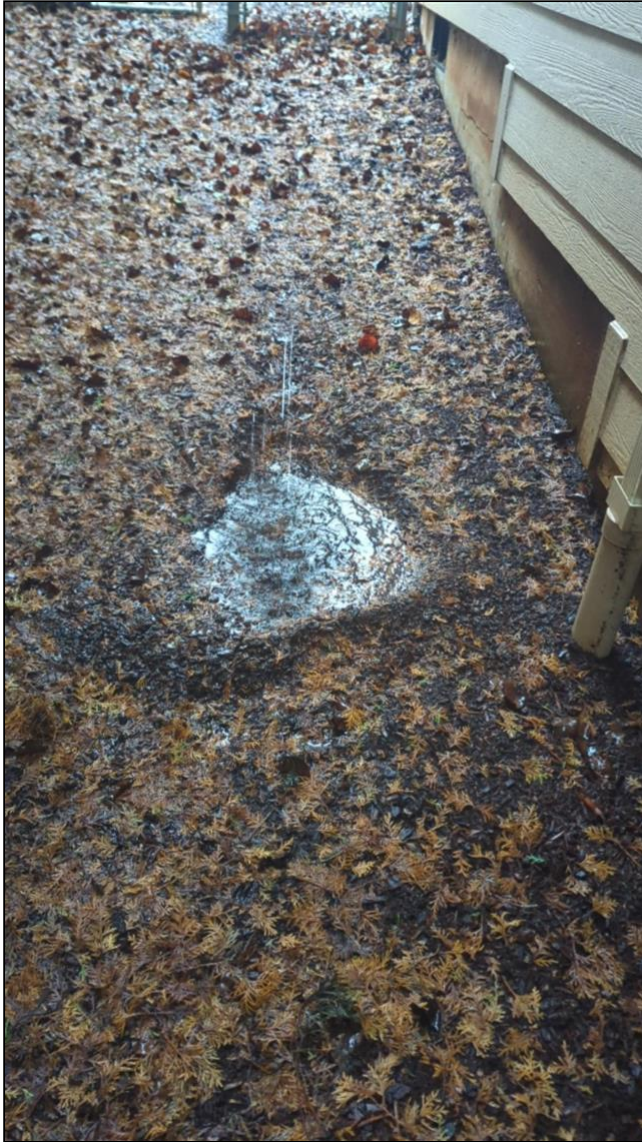
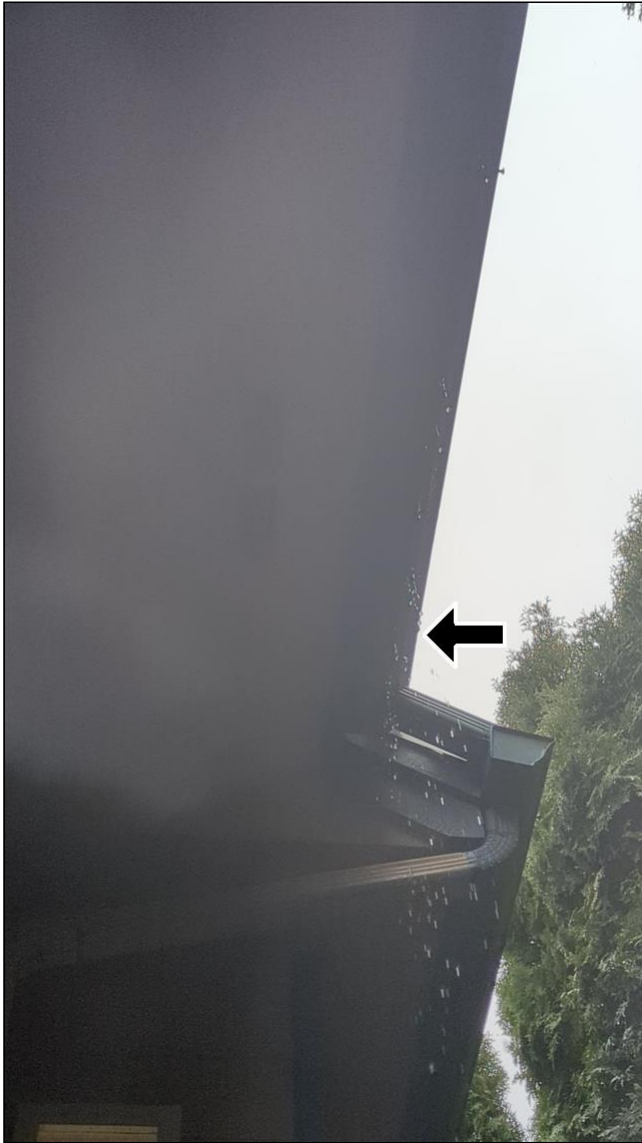
- 🔧 (2) The gutter appeared to overflow at the rear of the building. Gutters that drain poorly or clogged can lead to many costly problems such as deterioration of fascia, soffit or roof edge. It can also cause gutters to pull loose and lead to possible water intrusion. A qualified contractor should inspect and repair as needed.

(2) The gutter appeared to overflow at the rear of the building. Gutters that drain poorly or clogged can lead to many costly problems such as deterioration of fascia, soffit or roof edge. It can also cause gutters to pull loose and lead to possible water intrusion. A qualified contractor should inspect and repair as needed.

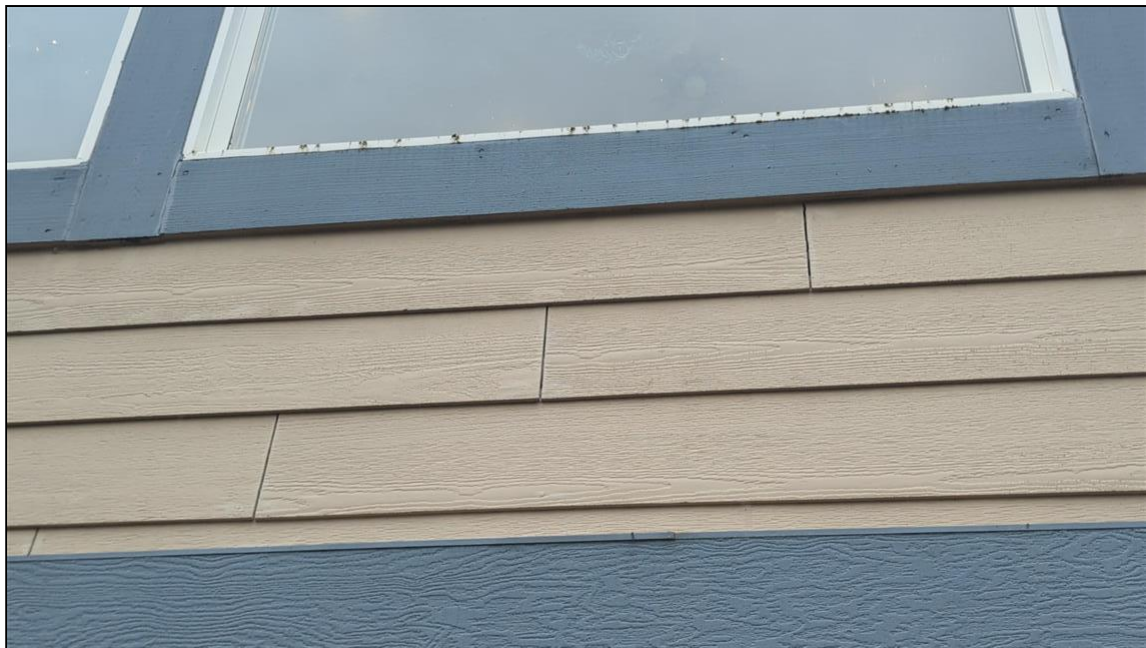
2.0 Item 1(Picture)

(1) The siding at the exterior in areas has open butt joints. The caulking joints will need to be actively maintained to prevent moisture intrusion in these areas. A qualified contractor should inspect and repair as needed.

(1) The siding at the exterior in areas has open butt joints. The caulking joints will need to be actively maintained to prevent moisture intrusion in these areas. A qualified contractor should inspect and repair as needed.

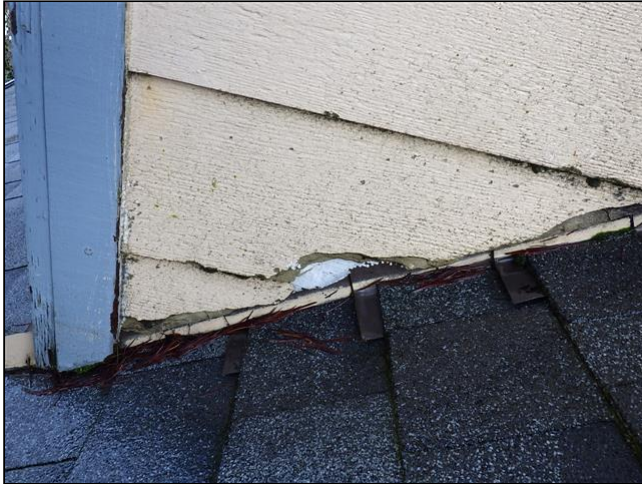
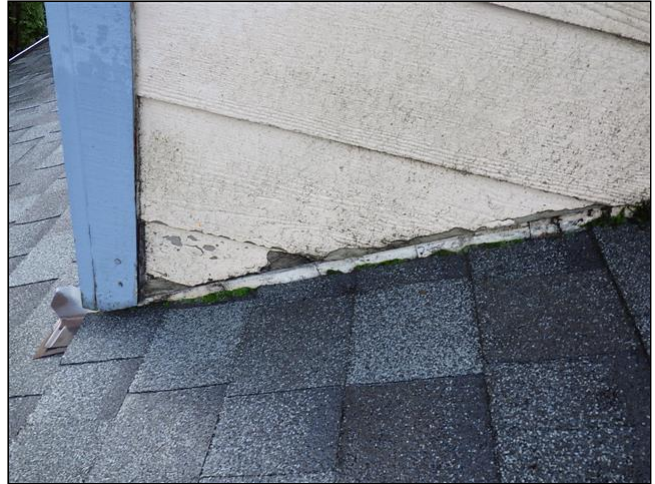
2.0 Item 2(Picture)

- 🔧 (2) The cement board siding at the exterior in areas (refer to picture(s)) was damaged. Further deterioration can occur if not corrected. A qualified contractor should inspect and repair as needed.

(2) The cement board siding at the exterior in areas (refer to picture(s)) was damaged. Further deterioration can occur if not corrected. A qualified contractor should inspect and repair as needed.
-

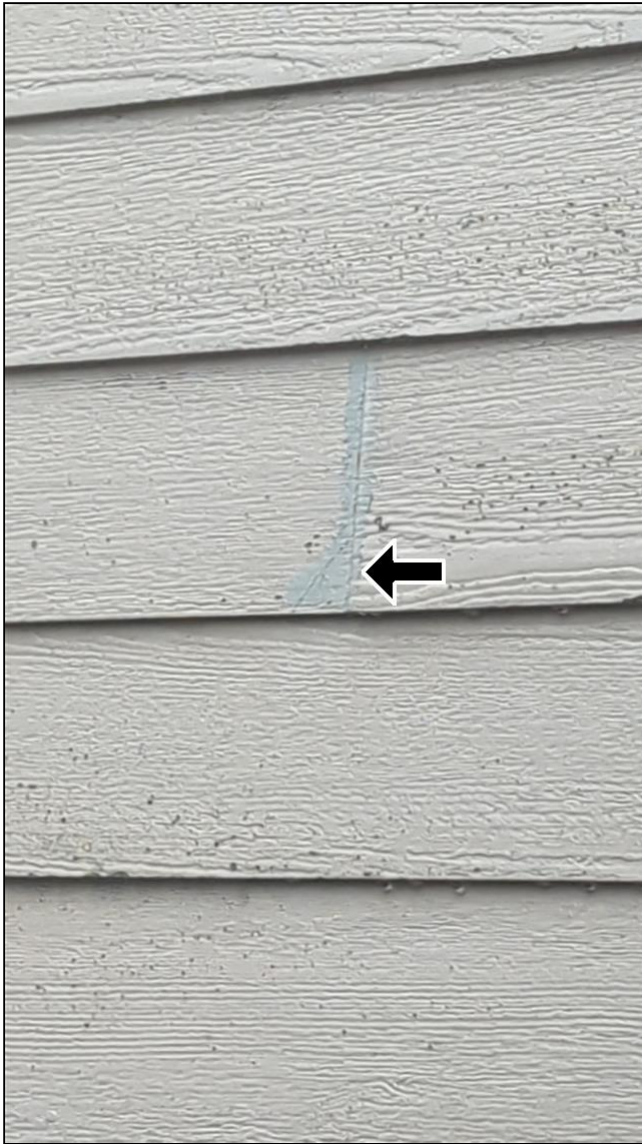
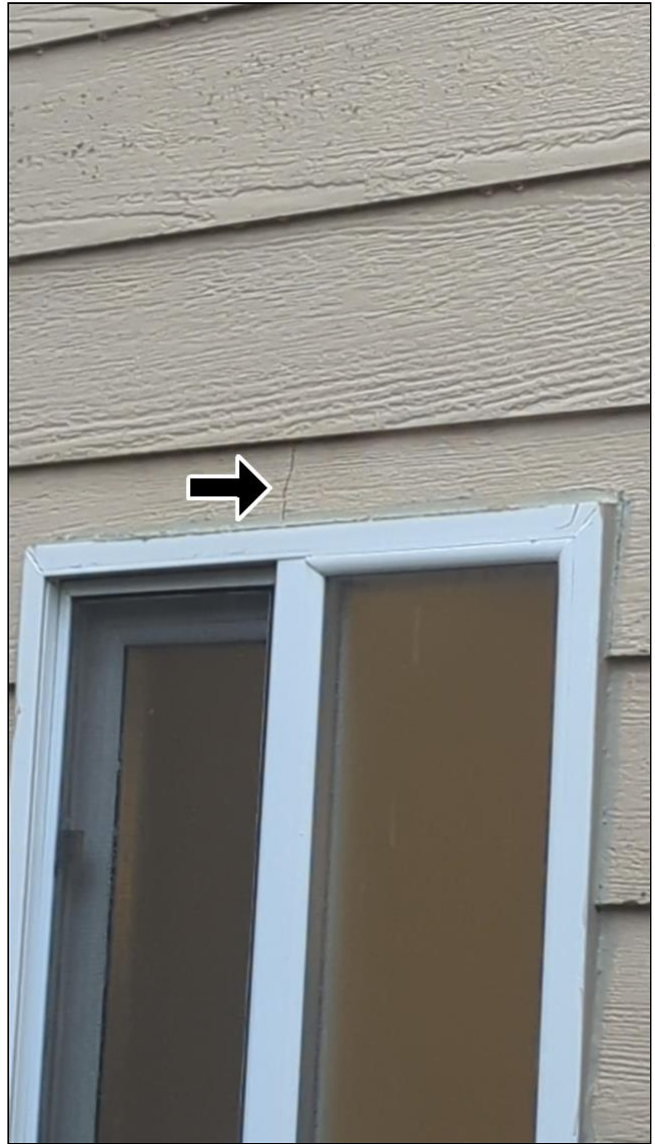
2.0 Item 4(Picture)

- 🔍 (3) The siding on the building shows signs of cracking, shrinkage and damage. This siding appears to be a product manufactured by Certainteed that has had a class action settlement in relation to this type of siding and damage. Repairs are needed, please refer to this site for more information:

(3) The siding on the building shows signs of cracking, shrinkage and damage. This siding appears to be a product manufactured by CertainTeed that has had a class action settlement in relation to this type of siding and damage. Repairs are needed, please refer to this site for more information:

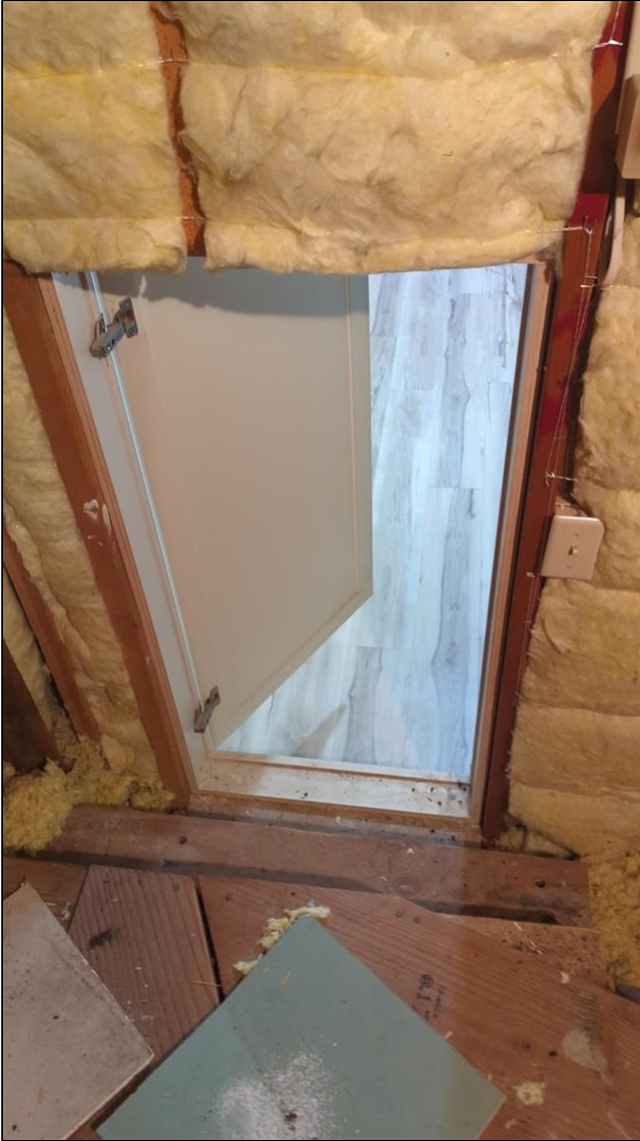
2.1 Item 1(Picture)

- 🔧 The door to attic was not an insulated, fire resistant and weather stripped door. This is an energy conservation and fire spread resistance issue. A qualified contractor should inspect and repair as needed.

The door to attic was not an insulated, fire resistant and weather stripped door. This is an energy conservation and fire spread resistance issue. A qualified contractor should inspect and repair as needed.

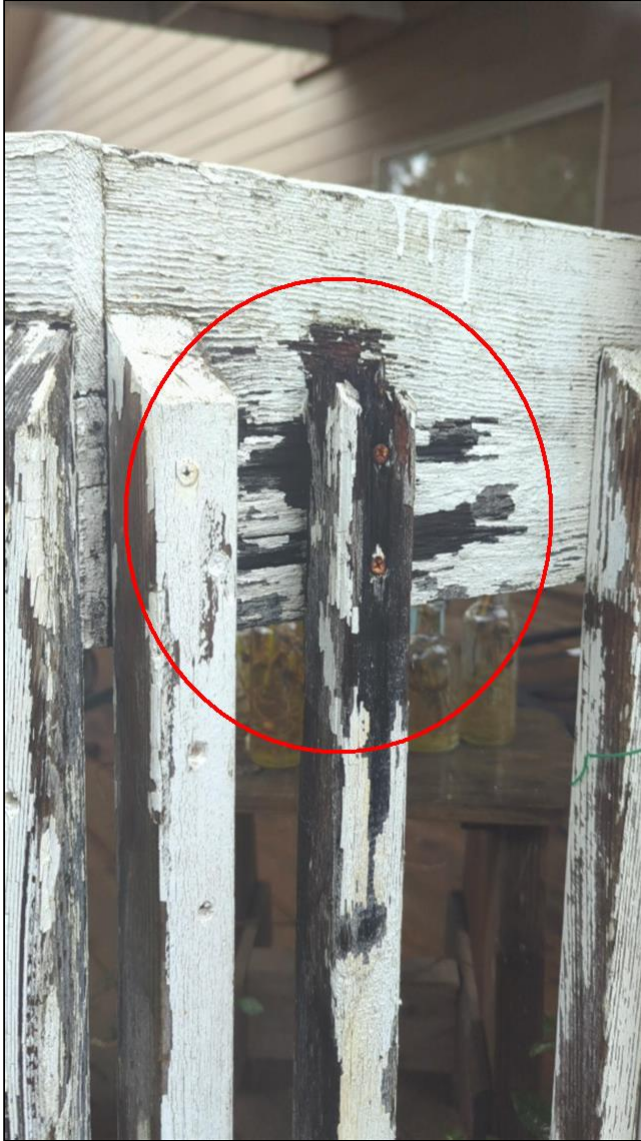
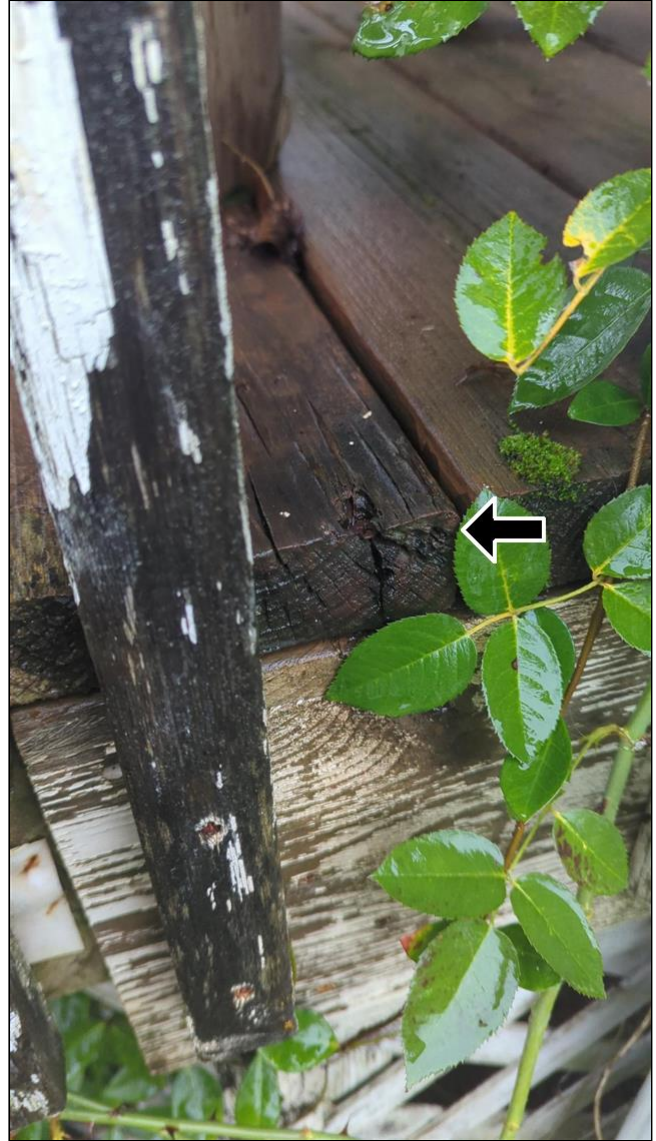
2.3 Item 5(Picture)

- (3) The wood floor on the deck at the left side (facing front from the inside) had some boards that were deteriorated. Further deterioration can occur if not repaired. A qualified contractor should repair or replace as needed.

(3) The wood floor on the deck at the left side (facing front from the inside) had some boards that were deteriorated. Further deterioration can occur if not repaired. A qualified contractor should repair or replace as needed.
-

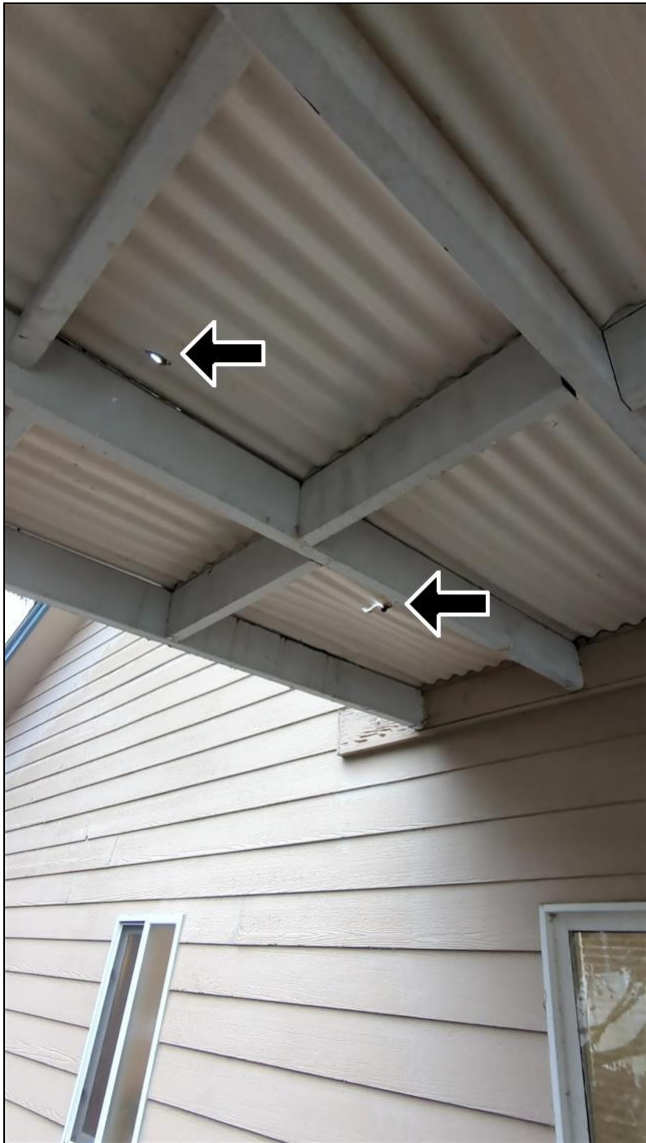
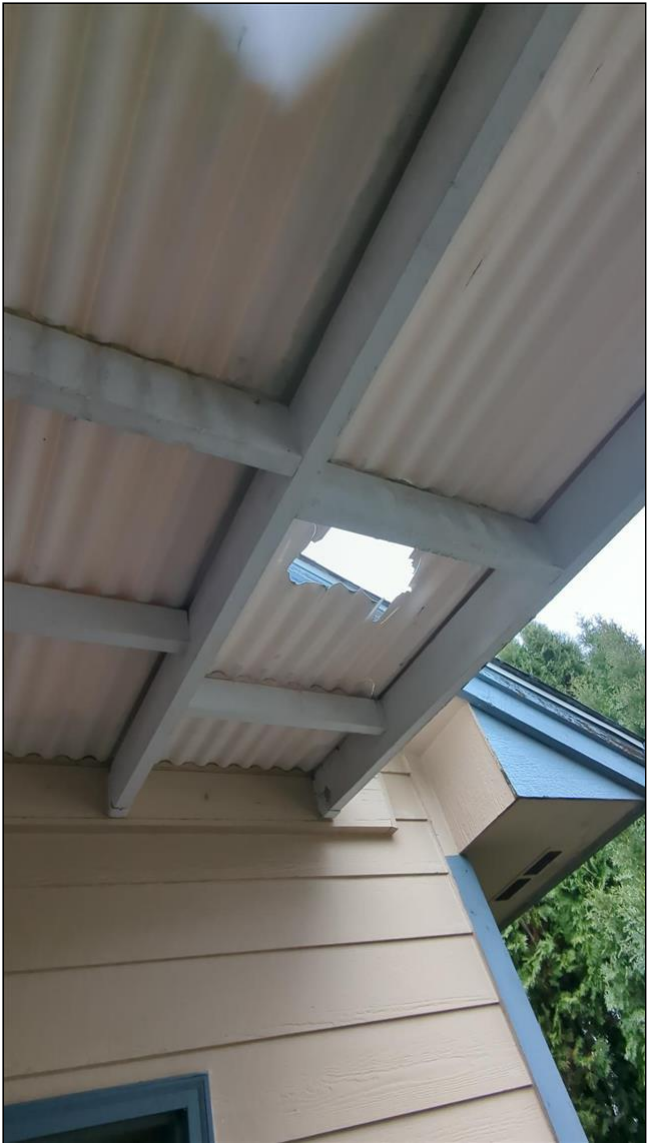
2.3 Item 7(Picture)

🔧 (4) The patio roof cover was damaged at the left side (facing front). This damage should be repaired or replaced. A qualified contractor should inspect and repair as needed.

(4) The patio roof cover was damaged at the left side (facing front). This damage should be repaired or replaced. A qualified contractor should inspect and repair as needed.
-

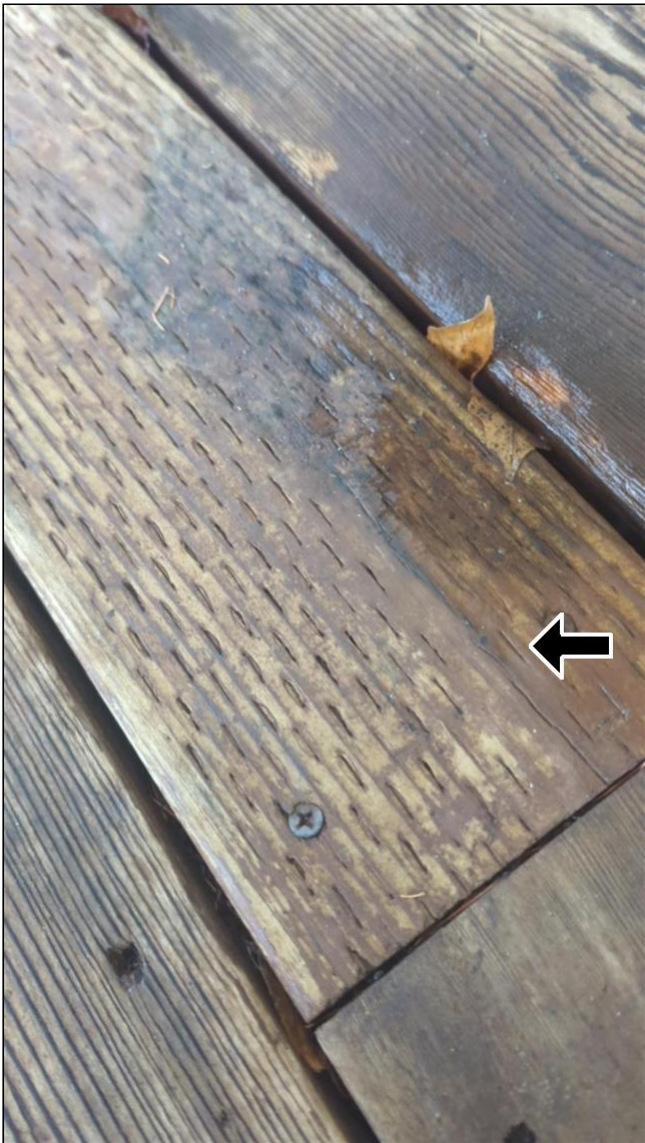
2.3 Item 9(Picture)

🔧 (5) The wood floor on the deck at the left side (facing front from the inside) was a pressure treated wood. Pressure treated wood should only be used for deck structure, as the chemicals and heavy metals that are used for treatment are toxic and should not come in direct contact with skin. A qualified contractor should repair or replace as needed.

(5) The wood floor on the deck at the left side (facing front from the inside) was a pressure treated wood. Pressure treated wood should only be used for deck structure, as the chemicals and heavy metals that are used for treatment are toxic and should not come in direct contact with skin. A qualified contractor should repair or replace as needed.

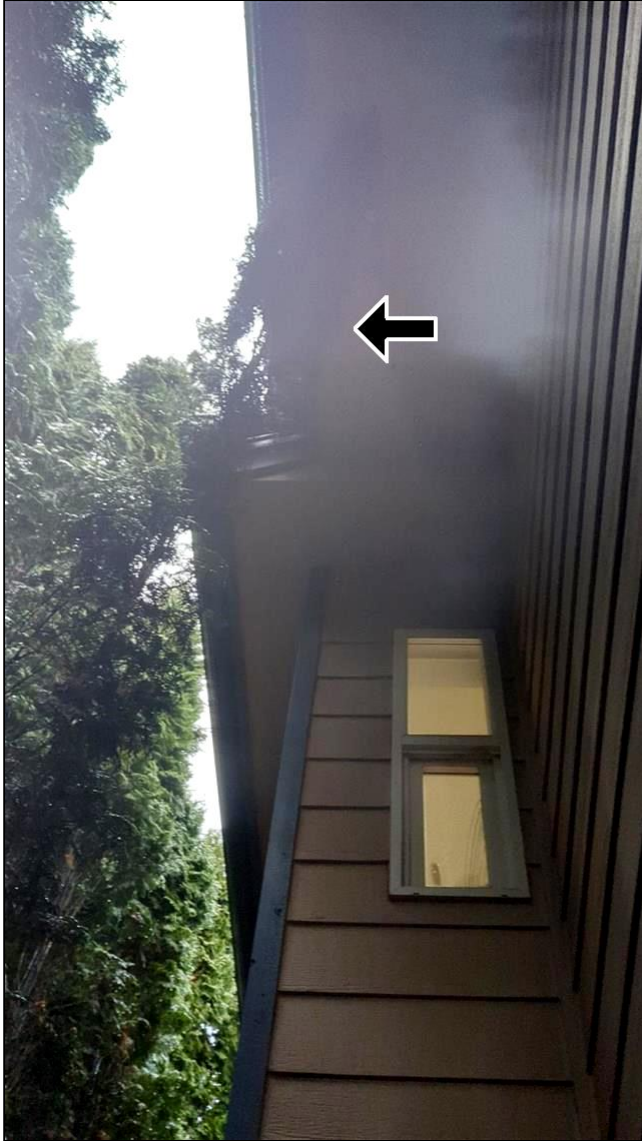
2.4 Item 1(Picture)

- 🔧 The tree limbs that were in contact with roof or hanging near roof should be trimmed. The surface of the roofing may be damaged under the branches. This issue should be repaired by a licensed professional contractor.

The tree limbs that were in contact with roof or hanging near roof should be trimmed. The surface of the roofing may be damaged under the branches. This issue should be repaired by a licensed professional contractor.

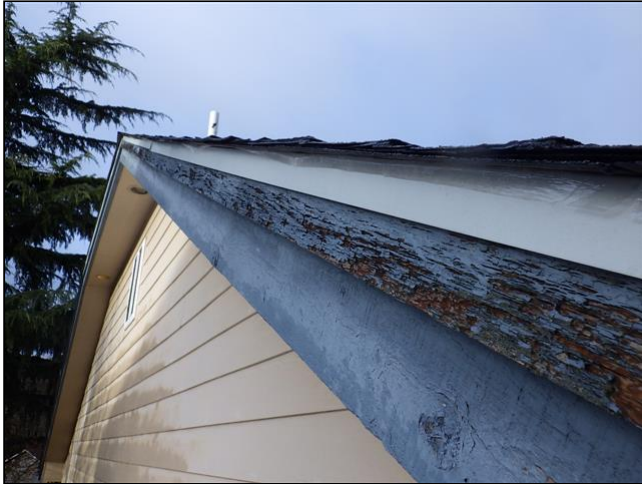
2.5 Item 1(Picture)

- 🔧 (1) The paint on eave was failing. I recommend prep and paint at the exterior in areas (refer to picture(s)).

(1) The paint on eave was failing. I recommend prep and paint at the exterior in areas (refer to picture(s)).
-

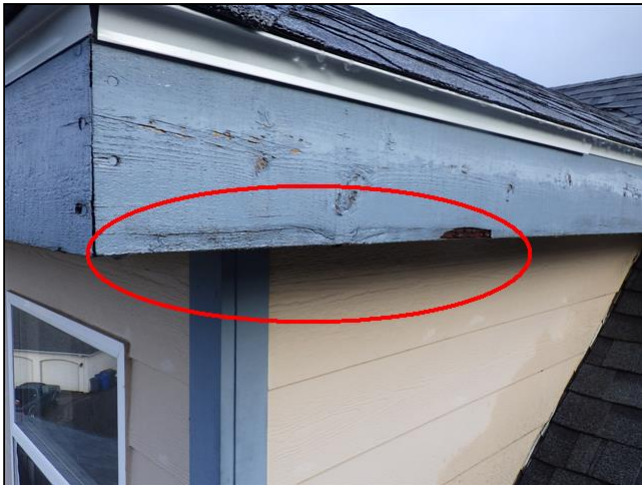
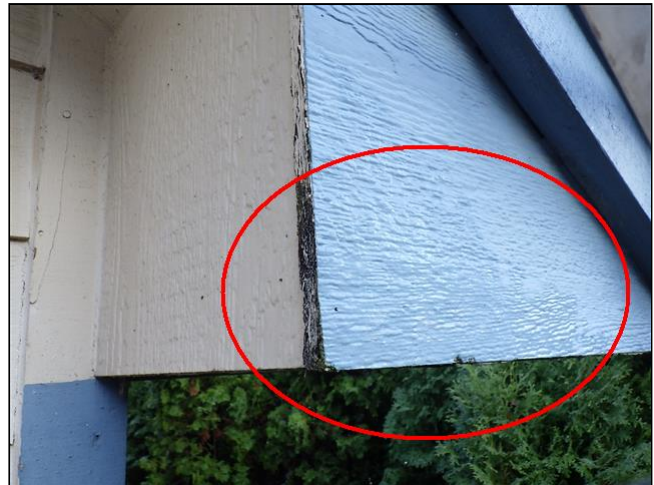
2.5 Item 2(Picture)

- 🔧 (2) The fascia board at eave on the exterior in areas (refer to picture(s)) were deteriorated. Further deterioration may occur if not repaired. A qualified contractor should inspect and repair as needed.

(2) The fascia board at eave on the exterior in areas (refer to picture(s)) were deteriorated. Further deterioration may occur if not repaired. A qualified contractor should inspect and repair as needed.

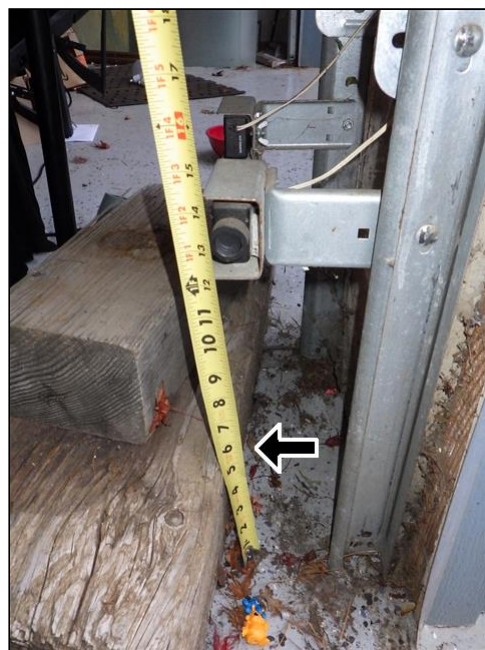
3.5 Item 1(Picture)

The automatic opener for garage door has electric eyes that have been installed higher than 6 inches off the ground. This is considered unsafe, is contrary to manufactures directions and needs correcting. A qualified contractor should inspect and repair as needed.

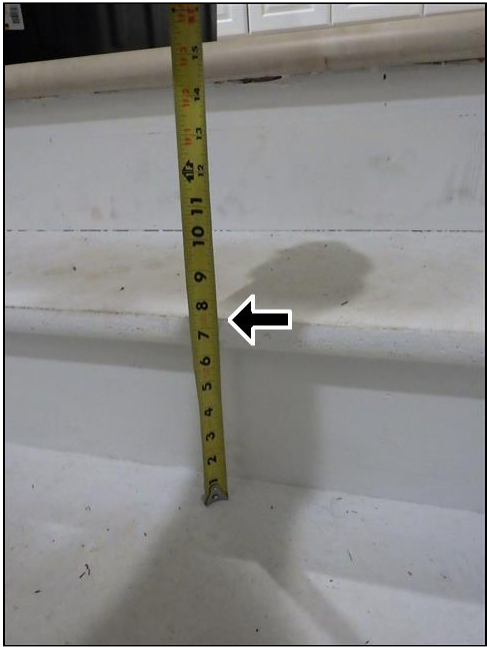
4.3 Item 1(Picture)

The stairs to the garage/laundry were not uniform in "riser height" and were a tripping hazard. A fall or injury could occur if not corrected. A qualified contractor should inspect and repair as needed.

The stairs to the garage/laundry were not uniform in "riser height" and were a tripping hazard. A fall or injury could occur if not corrected. A qualified contractor should inspect and repair as needed.

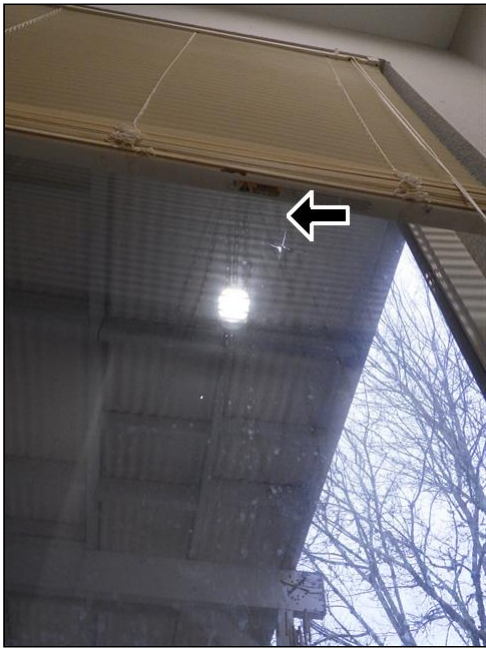
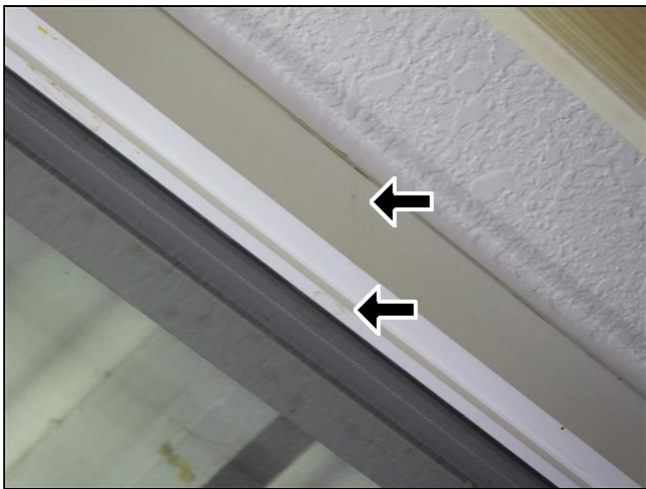
4.6 Item 1(Picture)

🔧 One window was showed water stains/drip marks at the garage stairs. This may indicate chronic leakage at this window. Although the stains are subtle they may indicate a continued building envelope breach and the water in the wall cavity may be causing structural deterioration. A qualified contractor should inspect and repair as needed.

One window was showed water stains/drip marks at the garage stairs. This may indicate chronic leakage at this window. Although the stains are subtle they may indicate a continued building envelope breach and the water in the wall cavity may be causing structural deterioration. A qualified contractor should inspect and repair as needed.

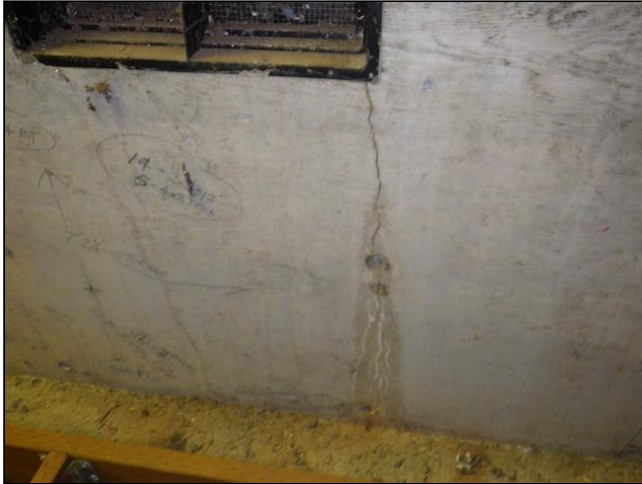
5.2 Item 1(Picture)

- 🔍 The foundation wall has typical shrinkage cracks. These cracks appear to be normal in size and shape and no repairs are needed.

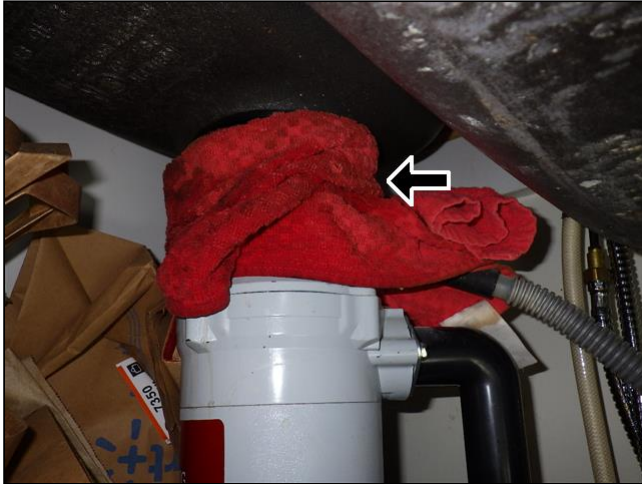
6.0 Item 2(Picture)

- 🔧 (3) The waste line was leaking at the kitchen sink. Repairs are needed. I recommend a licensed plumber inspect further and repair as necessary.

(3) The waste line was leaking at the kitchen sink. Repairs are needed. I recommend a licensed plumber inspect further and repair as necessary.

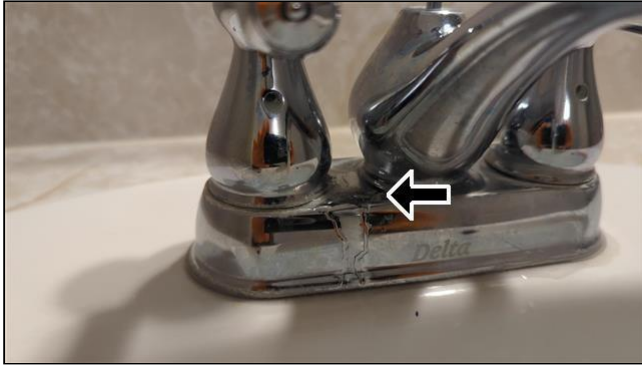
6.1 Item 1(Picture)

- 🔧 (1) The sink faucet leaked at the upstairs hall bath. Repairs are needed. I recommend a licensed plumber inspect further and repair as necessary.

(1) The sink faucet leaked at the upstairs hall bath. Repairs are needed. I recommend a licensed plumber inspect further and repair as necessary.

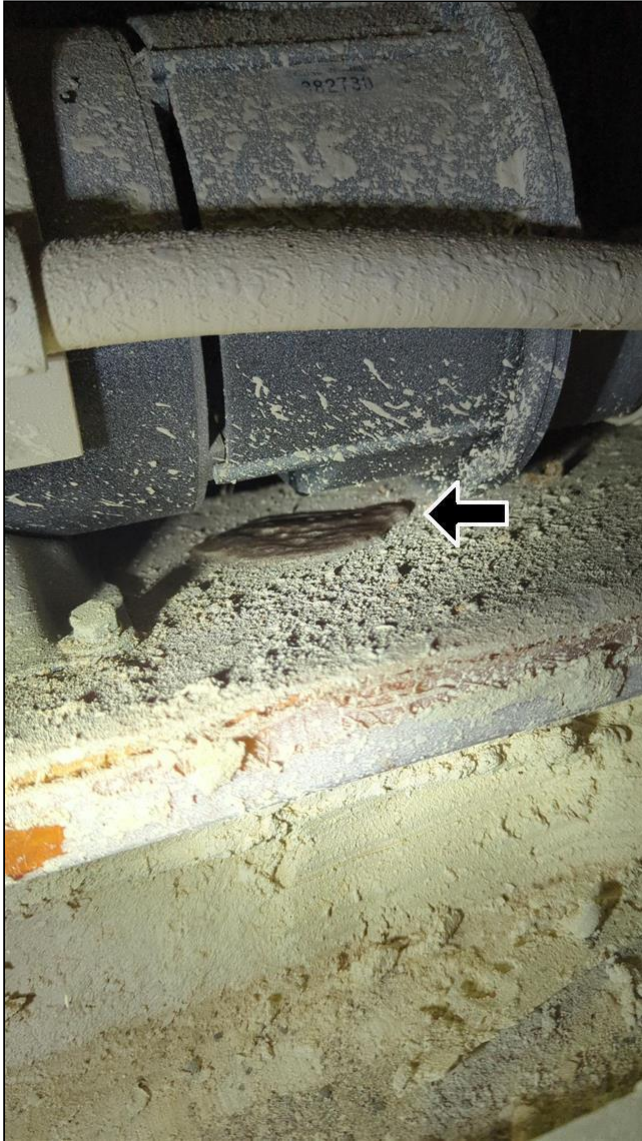
6.1 Item 3(Picture)

- 🔧 (2) The jetted tub was leaking at the master bath. Repairs are needed A qualified, licensed professional contractor should repair as necessary.

(2) The jetted tub was leaking at the master bath. Repairs are needed A qualified, licensed professional contractor should repair as necessary.

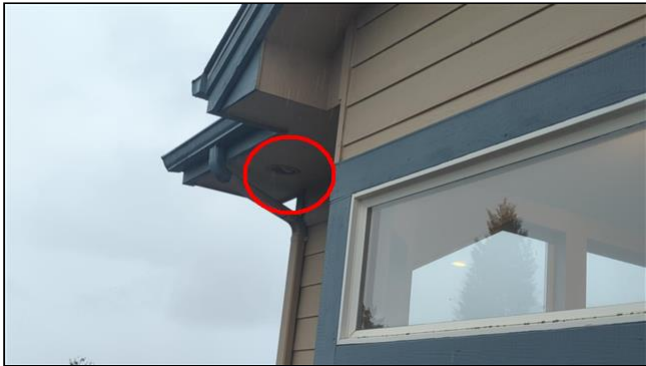
7.3 Item 1(Picture)

🔧 (1) The light fixtures did not work in various locations. This is for your information. Check the bulbs first and if the bulbs are not the issue an electrician should be consulted.

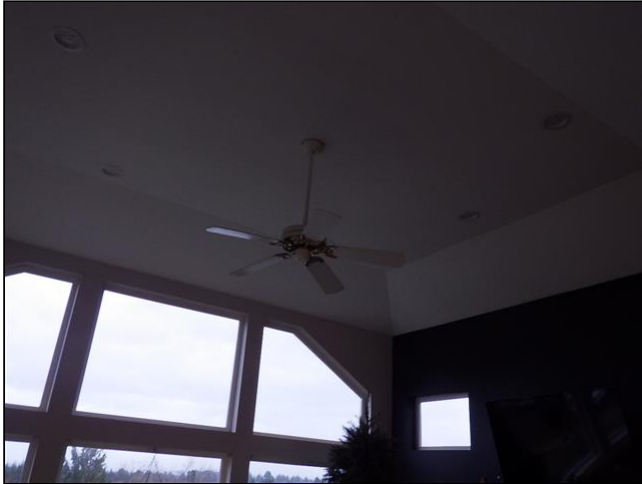
7.3 Item 6(Picture)

- 🔧 (2) The ceiling fan is controlled by a pull chain only in the living room. This is for your information. I recommend repair as needed.

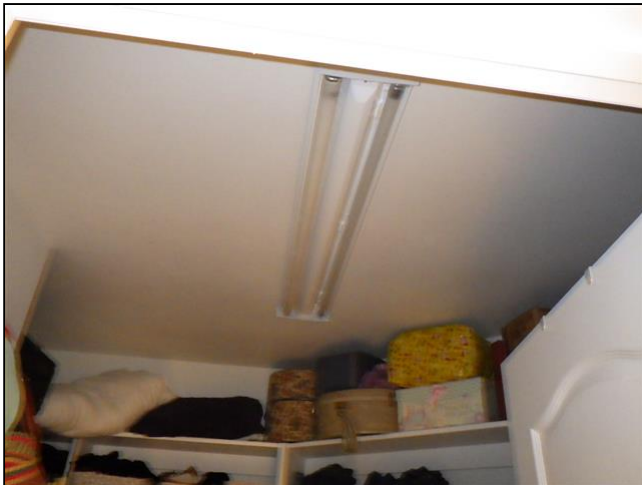
7.3 Item 7(Picture)

- 🔧 (3) The light fixture was missing cover at the master bedroom closet. This is for your information. I recommend repair as needed.

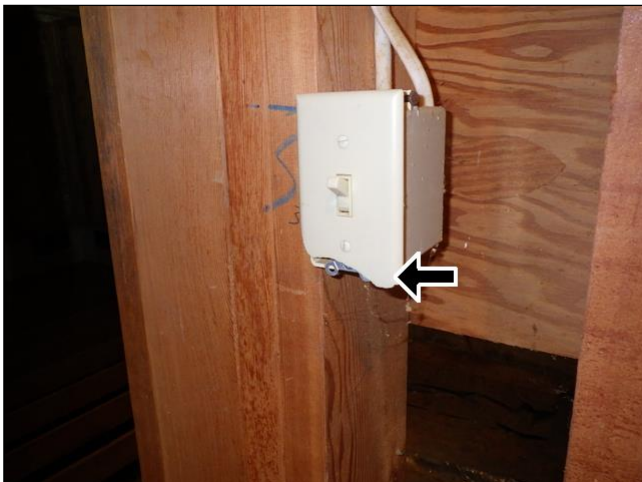
7.3 Item 8(Picture)

- 🔧 (4) The wall switch had a damaged "cover-plate" at the crawlspace. This is for your information. A qualified licensed electrician should perform repairs that involve wiring.

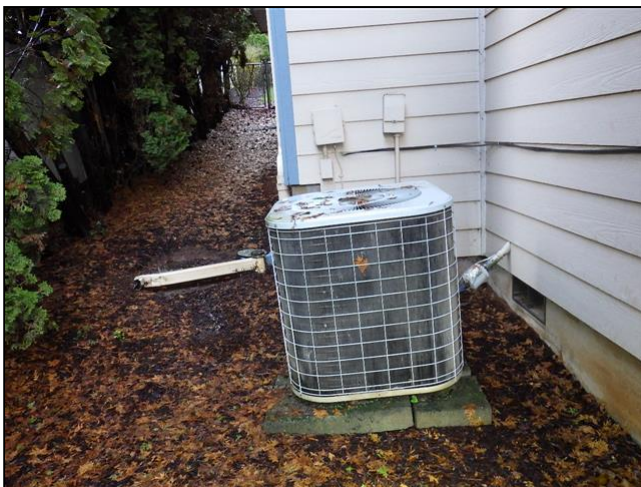
8.8 Item 1(Picture)

- 🔍 (1) The A/C was not tested for proper operation due to the outside air temperature was 65 degrees or less. Testing at low temperatures can damage the unit. We did not inspect this unit(s).
- 🔧 (2) The compressor was not level. This can cause damage to the unit or shorten its life span. I recommend service or repair as needed.

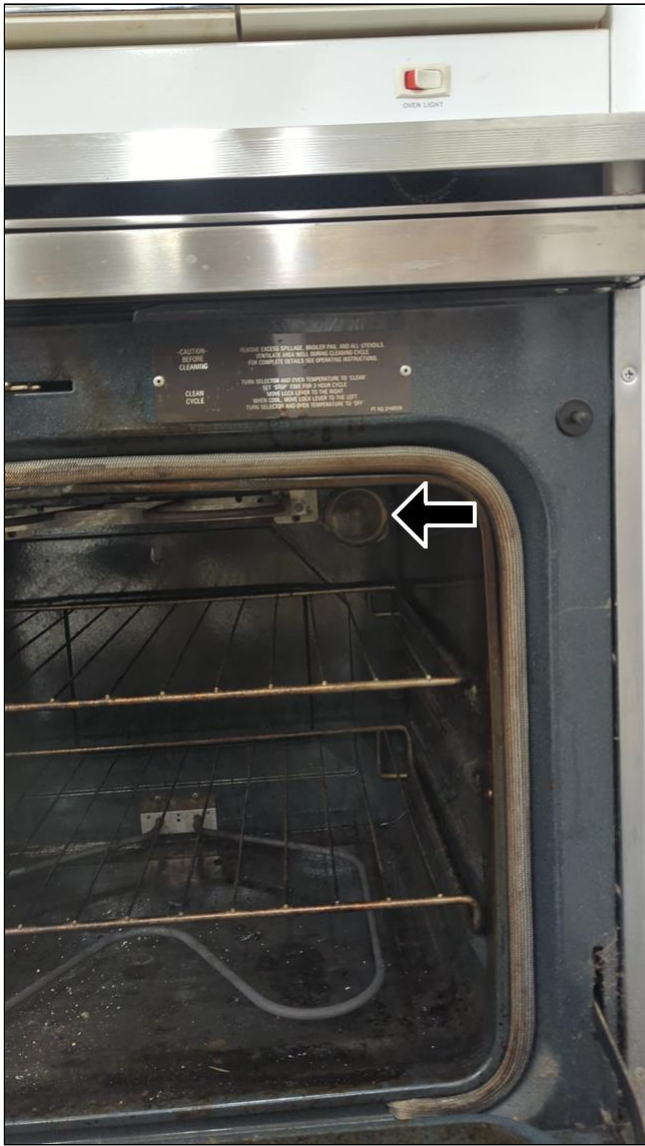
10.2 Item 1(Picture)

The light bulb for oven did not work when tested. I recommend repair as needed.

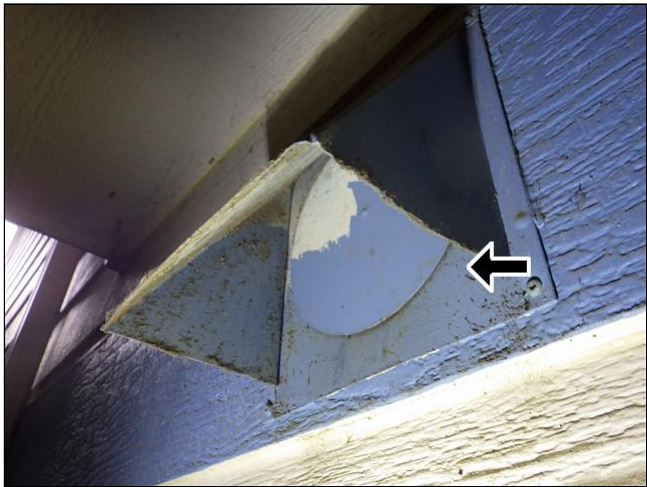
10.3 Item 1(Picture)

(1) The downdraft fan exhaust hood was missing its screen. I recommend repair or replace as needed.

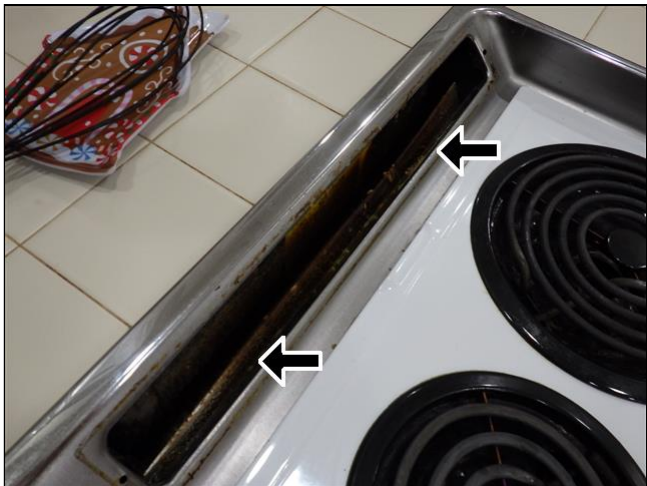
10.3 Item 2(Picture)

(2) The grease filter had crust or grime build-up. I recommend repair or replace as needed.
