# Perfection Inspection, Inc

**Property Address:  
4473 Hayesville Dr NE  
Salem OR 97305**

**12/2/2024**

**Jim Allhiser**

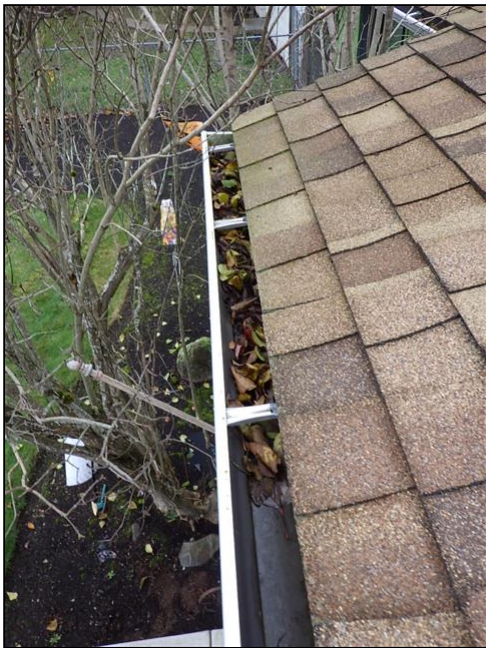
1.3 Item 3(Picture)

(2) The gutters had debris in areas and need to be cleaned. This is a maintenance issue and is important to prevent storm water issues around the building.

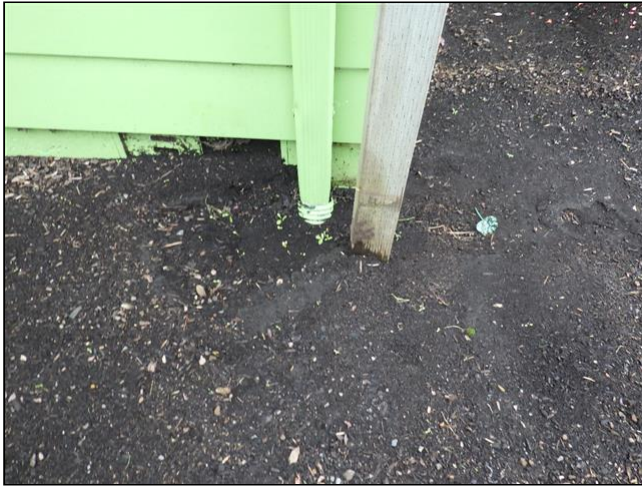
1.3 Item 5(Picture)

- 🔧 (3) The downspouts are connected to a drain lines that are most likely no longer functional. Downspouts that drain poorly or are clogged can lead to many costly problems such as water in the crawlspace, structural movement and rot cause by storm water. A qualified contractor should inspect and repair as needed.

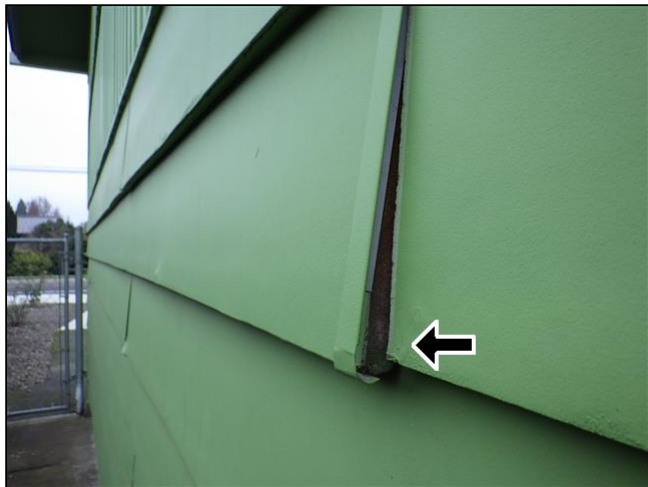
2.0 Item 1(Picture)

(1) The wood composite siding at the front, rear and sides of the building (refer to picture(s)) had areas of deterioration. Further deterioration can occur if not corrected. A qualified contractor should inspect and repair as needed.

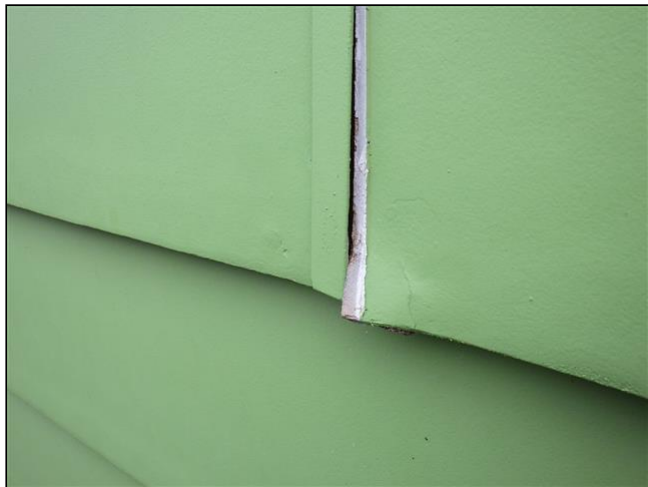
2.0 Item 2(Picture)

(1) The wood composite siding at the front, rear and sides of the building (refer to picture(s)) had areas of deterioration. Further deterioration can occur if not corrected. A qualified contractor should inspect and repair as needed.
-

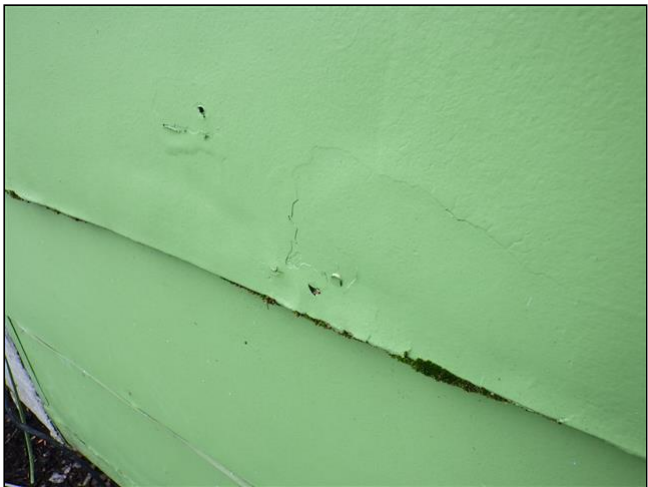
2.0 Item 10(Picture)

(2) The siding at the exterior in areas has open butt joints. The caulking joints will need to be actively maintained to prevent moisture intrusion in these areas. A qualified contractor should inspect and repair as needed.

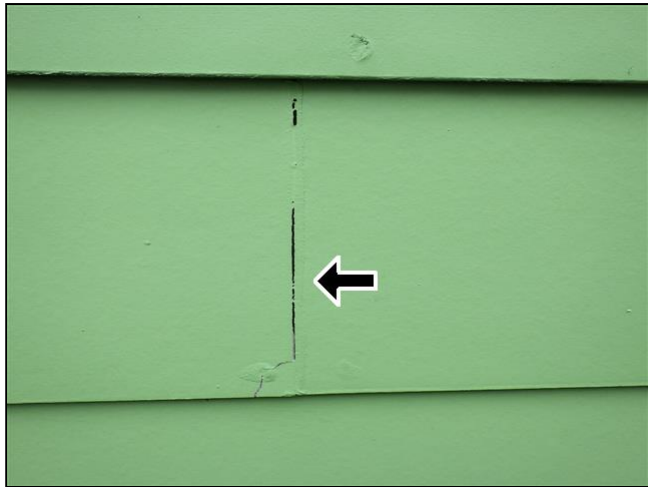
2.0 Item 11(Picture)

(2) The siding at the exterior in areas has open butt joints. The caulking joints will need to be actively maintained to prevent moisture intrusion in these areas. A qualified contractor should inspect and repair as needed.

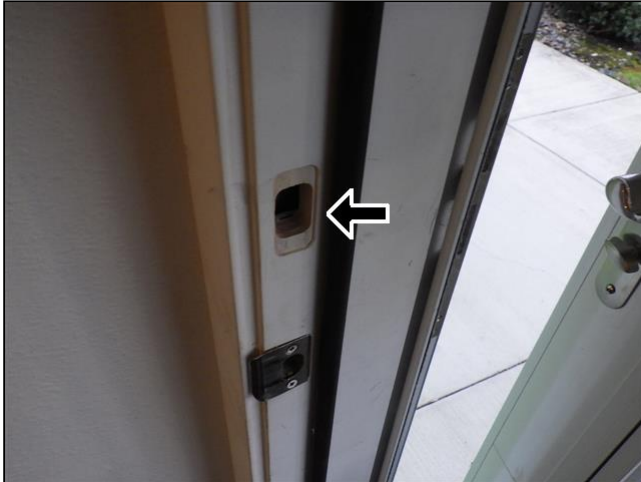
2.1 Item 1(Picture)

- 🔧 The main entry door was missing the dead bolt strike plate. This should be repaired/replaced. A qualified contractor should inspect and repair as needed.

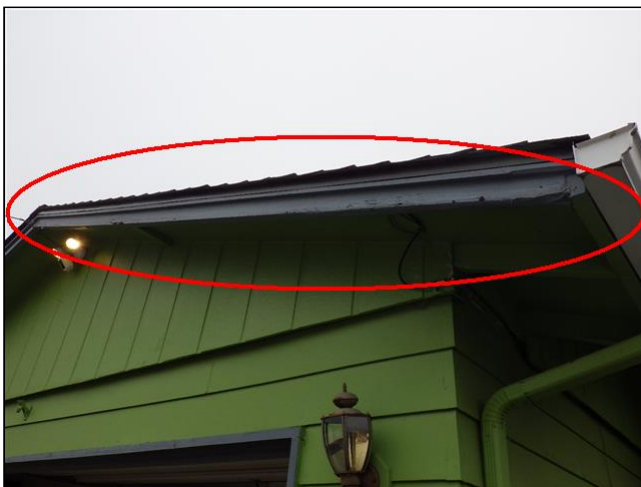
2.5 Item 1(Picture)

- 🔧 (1) The rake rafter and fascia on the roof slope show signs of deterioration. These should be repaired to prevent further damage to related components.

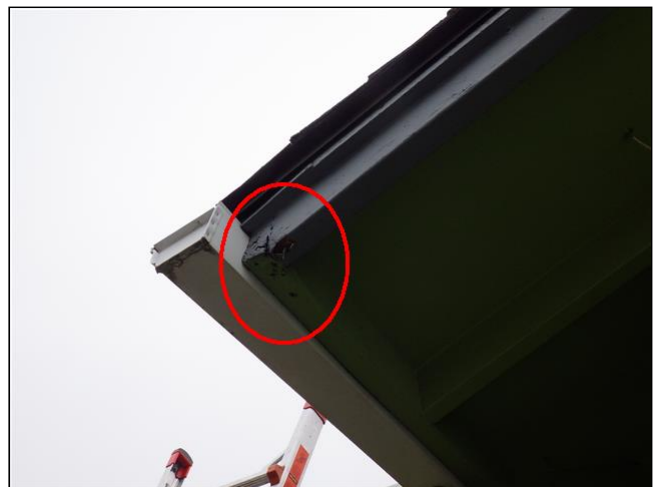
2.5 Item 2(Picture)

(1) The rake rafter and fascia on the roof slope show signs of deterioration. These should be repaired to prevent further damage to related components.
-

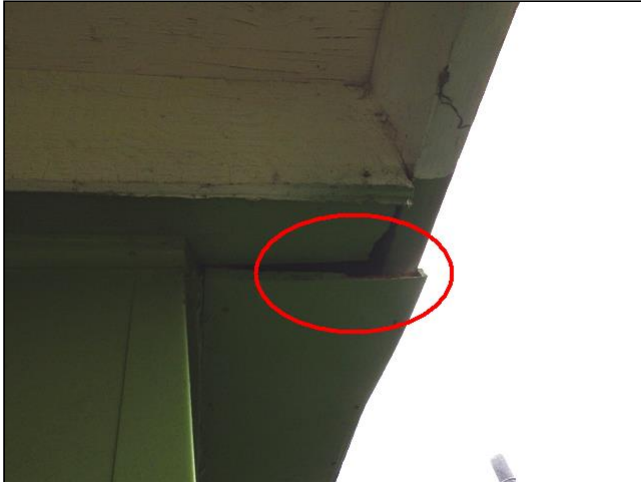
2.5 Item 3(Picture)

- 🔧 (2) A gap between the fascia and soffit exists which may allow vermin to nest in the eave and possibly enter the attic. A licensed professional contractor should seal these openings as necessary.

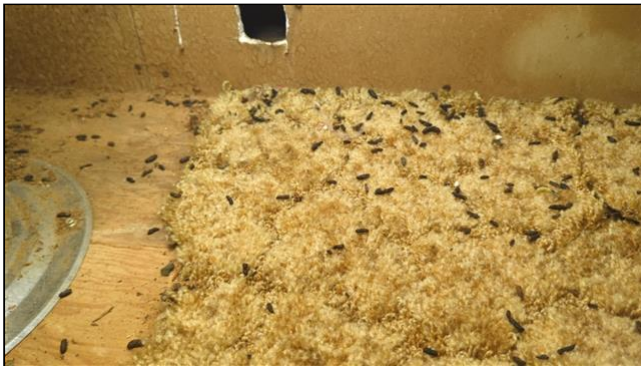
2.6 Item 1(Picture)

- 🔧 Evidence of pest activity noted in the garage, crawlspace and attic. Some evidence is not unusual, however you should consider a pest control consultation regarding the control of their entry into the building. Pests should be excluded from these areas.

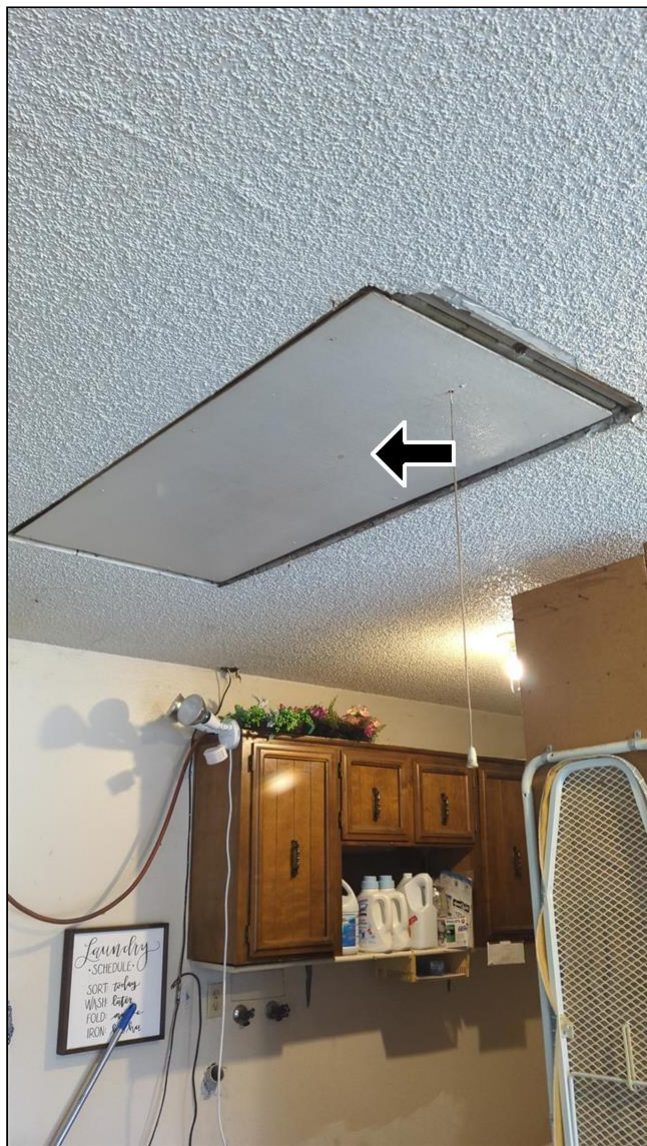
3.0 Item 1(Picture)

- 🔧 The attic access was missing a fire resistant cover. The door is a very important part of the fire barrier between the home and the garage. The door should be replaced with a material that will provide at least an hour worth of fire rating.

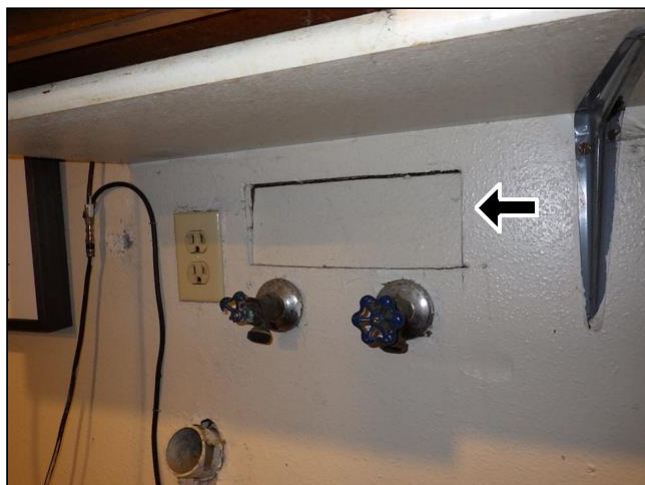
3.1 Item 1(Picture)

- 🔧 The wall that separates garage from heated space was compromised. This is considered unsafe until corrected. A qualified person should correct for safety.

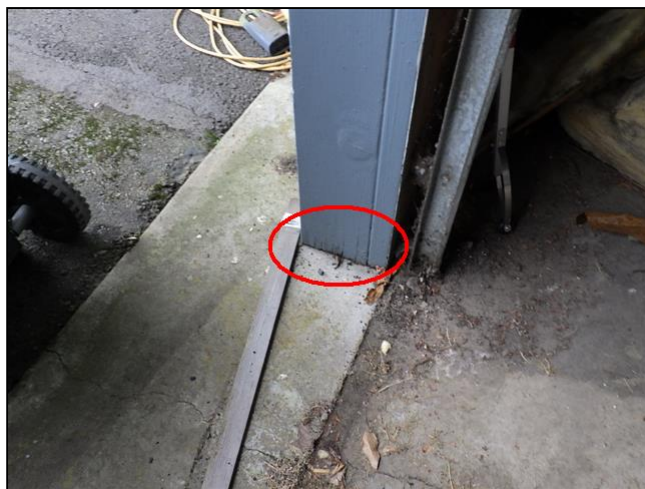
3.3 Item 1(Picture)

- 🔧 (1) The garage door at the front of the building shows deterioration on bottom of side jambs. This should be repaired. A qualified contractor should inspect and repair as needed.

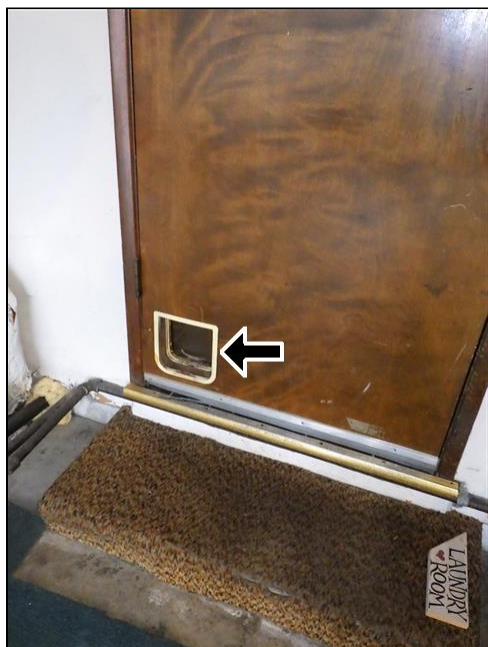
3.4 Item 1(Picture)

- 🔧 The occupant door from inside garage to inside the home was not at least an 1 3/8" solid door. This means that the door may not be a good seal to prevent exhaust or other fumes from entering the home and it may not provide at least 20 minutes of fire resistance. A licensed professional contractor should install a proper solid core, fire resistant door.

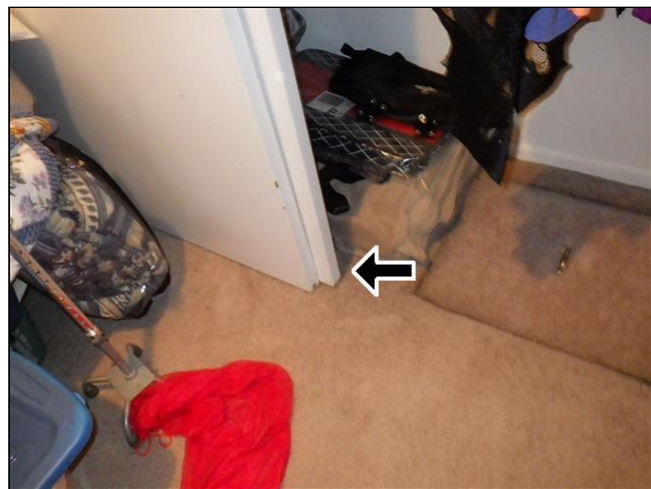
4.5 Item 1(Picture)

The closet door was missing the center retaining strip at the bottom. This is a maintenance issue and is for your information. A qualified contractor should inspect and repair as needed.

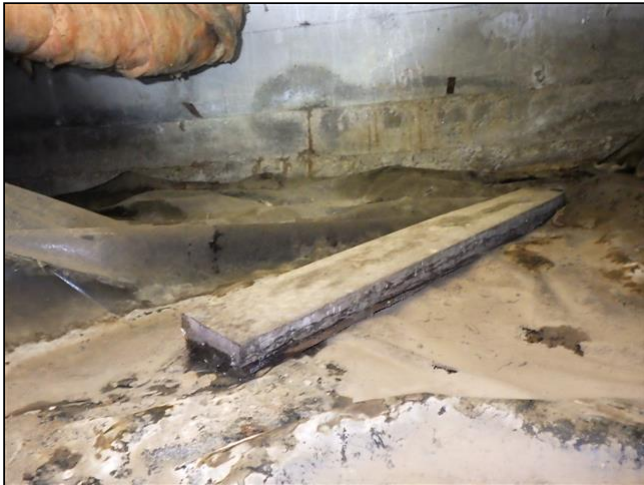
5.0 Item 1(Picture)

The wood/cellulose construction debris should be removed from the crawlspace. The excess wood that is under the building can be an excellent home base for wood destroying organisms, allowing them to multiply. When the wood runs out or the wood destroying organisms start looking for more they may look to your building. In general all pieces large enough to be caught in a garden rake should be removed.

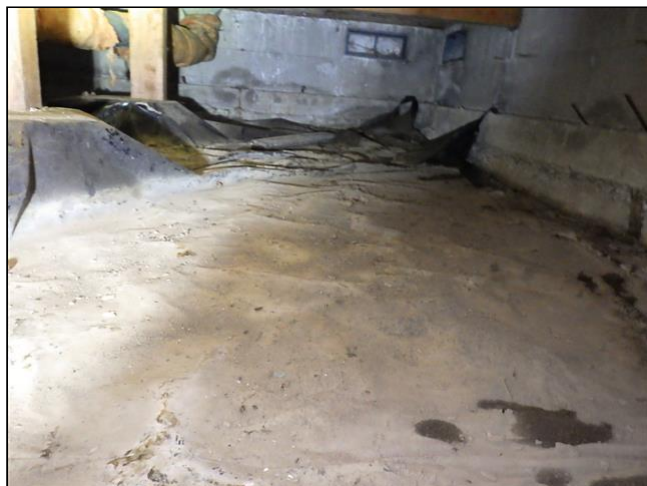
5.1 Item 1(Picture)

- 🔍 Visible signs of water intrusion in the crawlspace are present from water stains on the plastic vapor barrier. I am unable to determine the extent of intrusion or how often it occurs. I recommend closely monitor and seek further consultation if the moisture becomes a chronic issue.

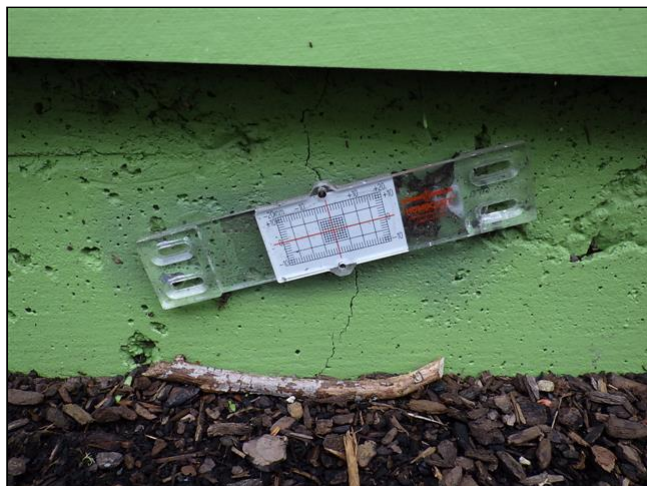
5.2 Item 1(Picture) This is a crack monitor

- 🔍 The foundation wall has typical shrinkage cracks. These cracks appear to be normal in size and shape and no repairs are needed.

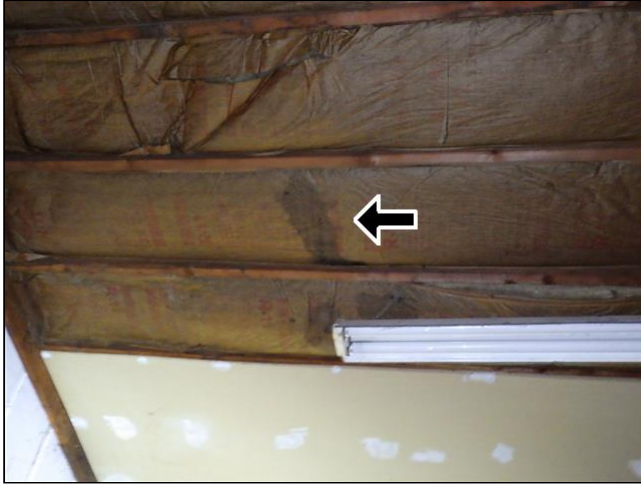
5.6 Item 7(Picture)

- 🔍 (3) Water stains are on the roofing structure in the converted car port. The stains appear to be related to the previous roofing and no current leakage was observed at the time of the inspection. It is recommend to monitor after a heavy rain and repair if needed.

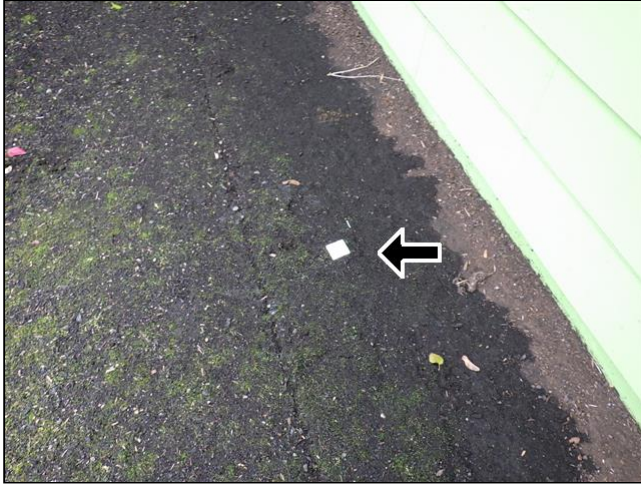
6.0 Item 1(Picture)

- 🔧 (1) You should strongly consider having the sewer line scoped. Issues with the main underground waste line can be common and the repairs can be costly. The main underground soil pipe could not be viewed and was not inspected.

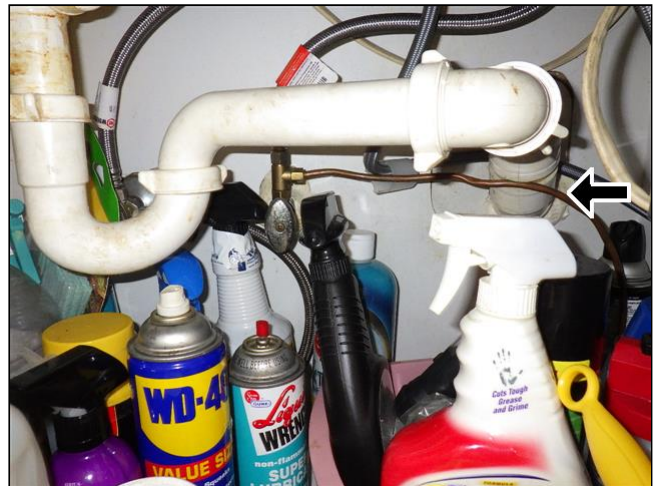
6.0 Item 3(Picture)

(2) The waste line has a S-trap, and should be changed to a P-trap at the kitchen. S-traps can sometimes gurgle (struggling for air when draining water), or if not used for long periods can evaporate the water in the trap and cause sewer odors to leak out. S-traps can sometimes lose the water in the trap through a pressure drop in the sewage system (outside the house). I recommend a licensed plumber inspect further and repair as necessary.

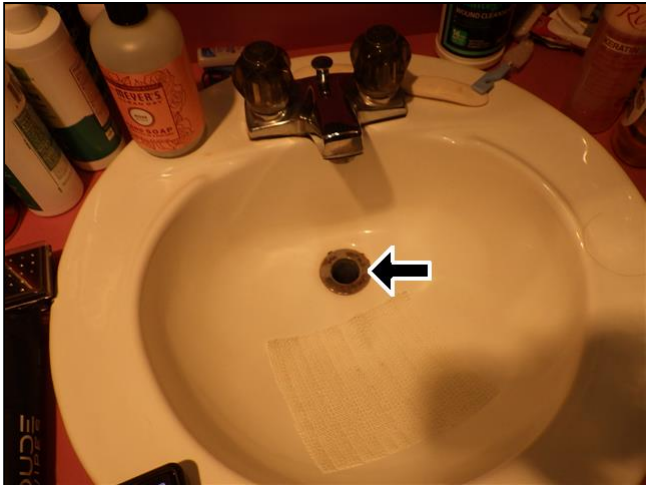
6.0 Item 5(Picture)

🔧 (3) The stop-valve does not work properly at the master bath sink. Repairs are needed. A qualified licensed plumber should repair or correct as needed.

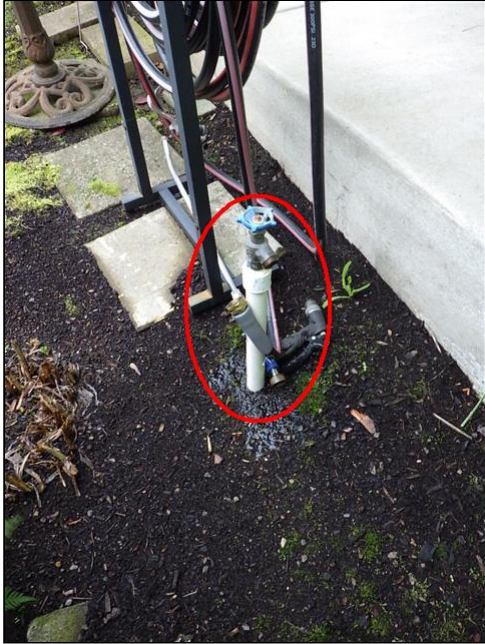
6.1 Item 2(Picture)

- 🔧 (2) The outside water faucet Had a pipe that was exposed at the rear of the building. This pipe should be repaired or winterized to prevent damage. A licensed professional plumbing contractor should repair as needed. Repairs are needed. I recommend a licensed plumber inspect further and repair as necessary.

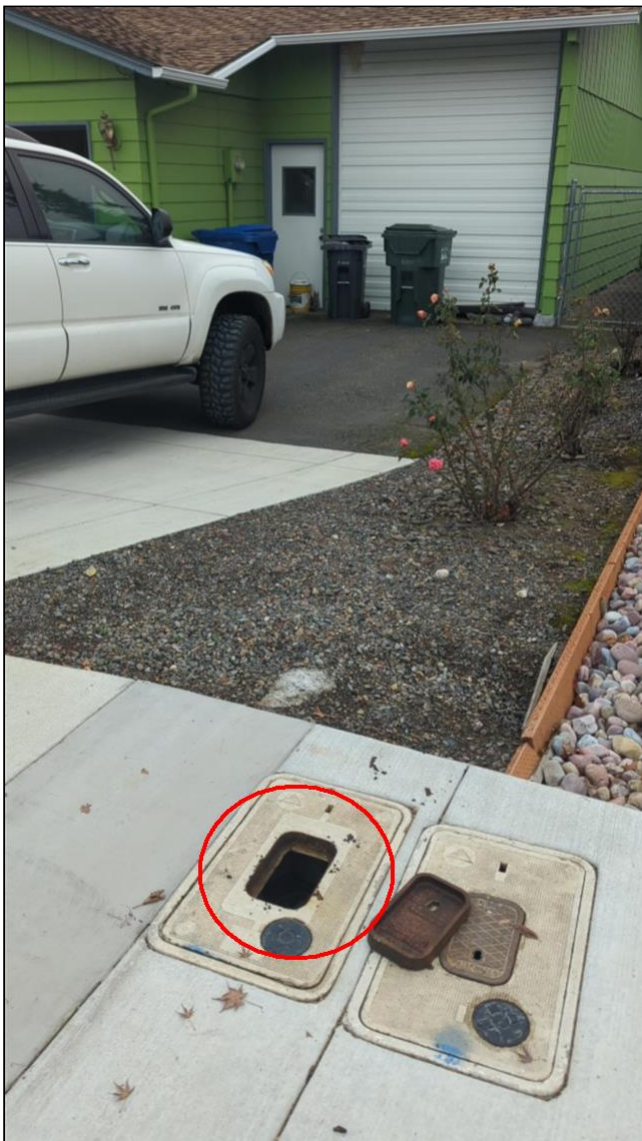
6.3 Item 1(Picture)

The main shut off was located outside in the ground.

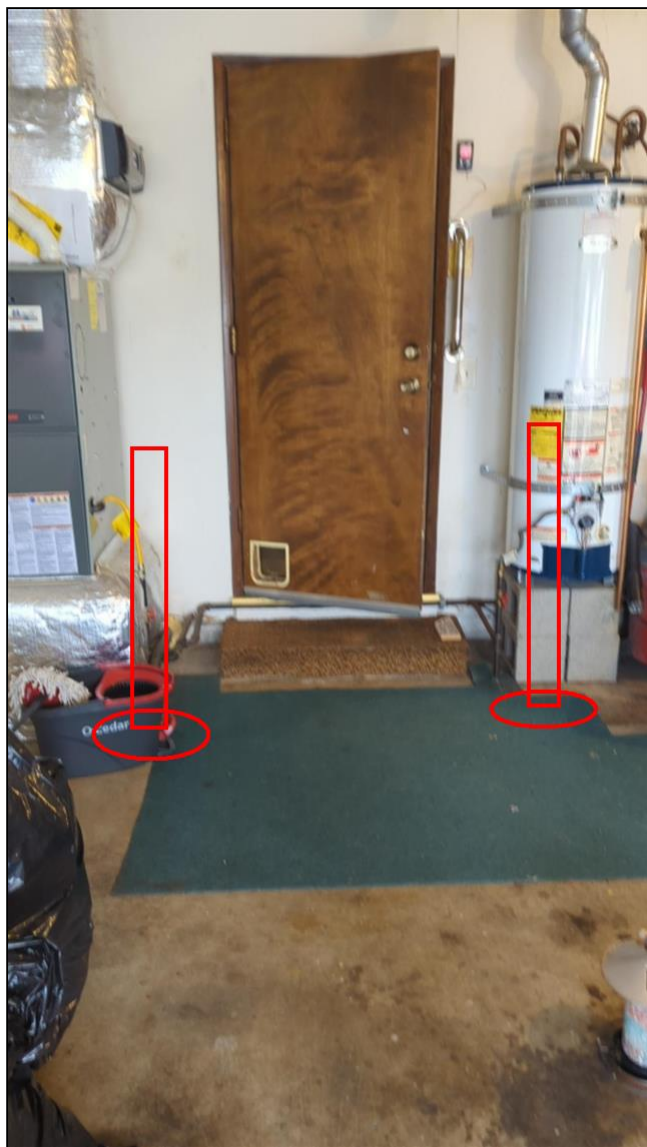
6.4 Item 1(Picture)

- 🔧 (1) The gas lines in the garage should have a steel bollard to protect the lines from accidental contact with a vehicle. A licensed professional contractor should install as necessary.

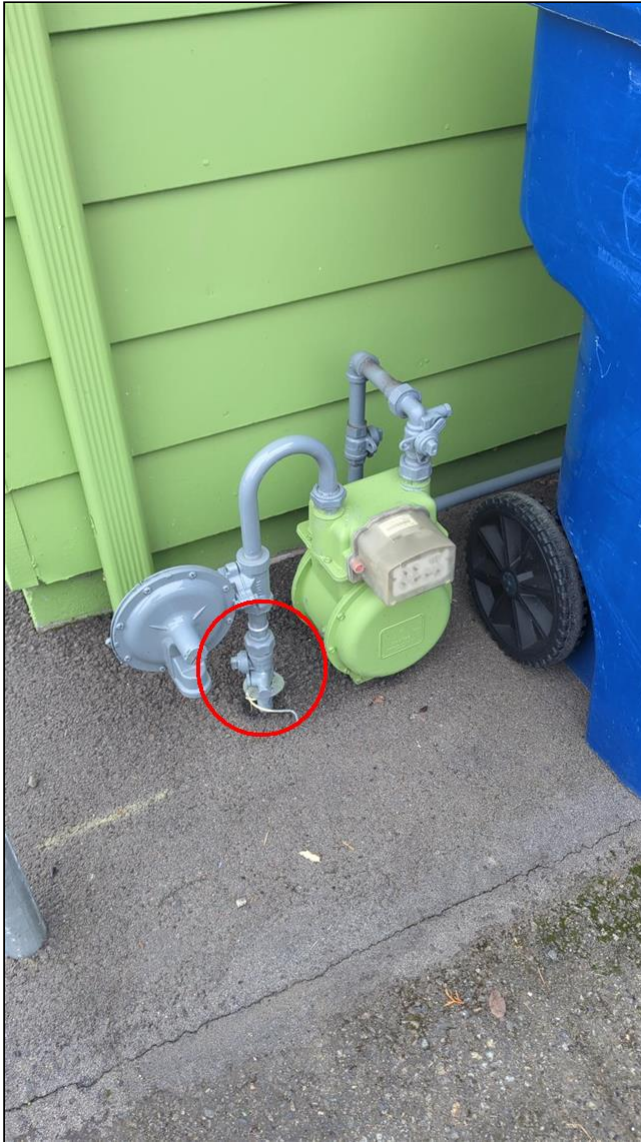
6.5 Item 1(Picture)

The main fuel shut off was at gas meter outside

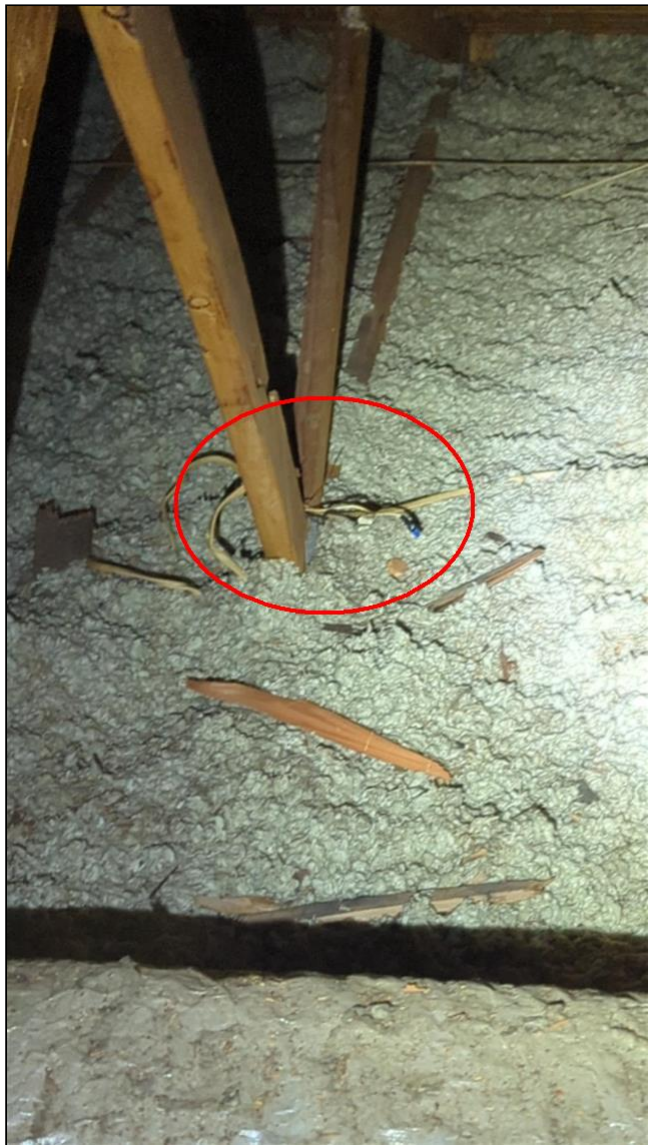
7.3 Item 1(Picture)

🔧 (1) One open splices needs placing inside a box with a cover-plate in the attic space and the enclosed car port. A qualified licensed electrician should perform repairs that involve wiring.

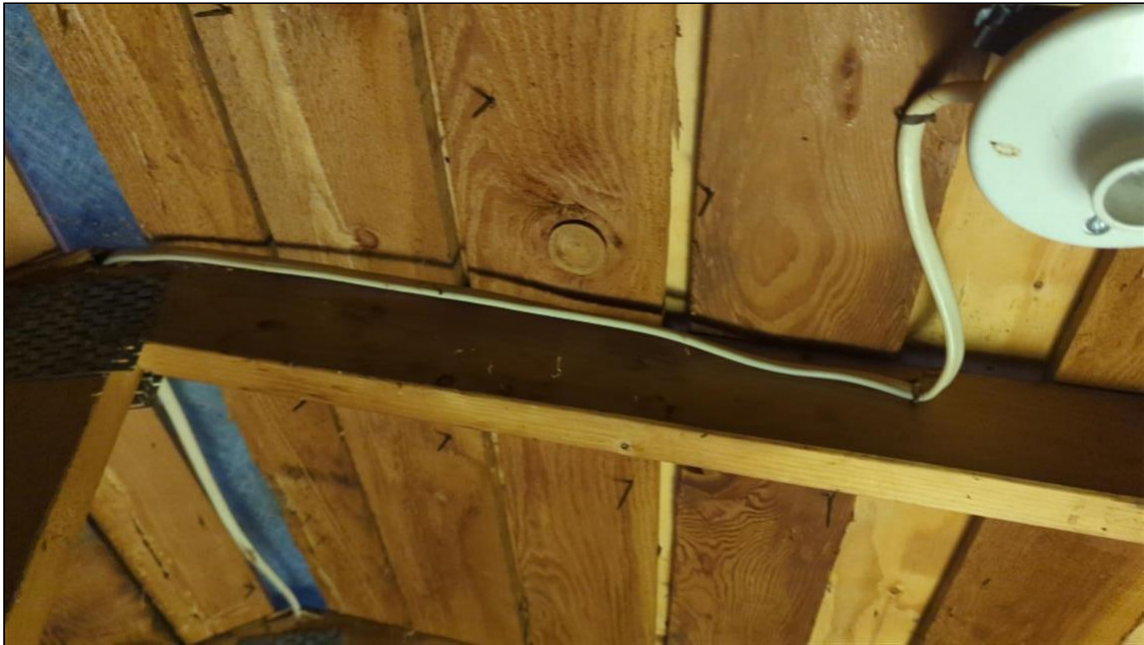
7.3 Item 3(Picture)

🔧 (2) Exposed wiring at the attic access in the garage. This is a safety issue that needs to be corrected. A qualified licensed electrician should perform repairs that involve wiring.

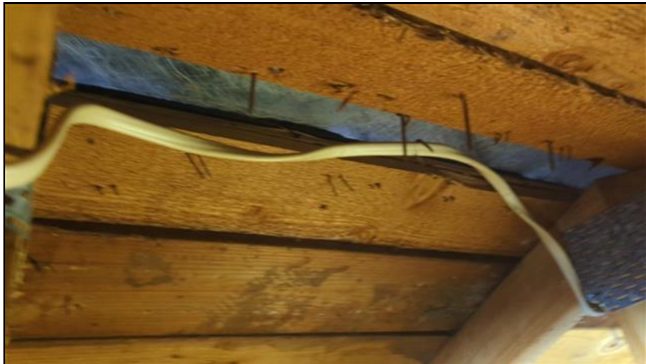
7.3 Item 5(Picture)

- 🔧 (3) One needs a cover-plate above the garage in attic. Electrical issues are considered a hazard until repaired. I recommend a qualified licensed electrician correct.

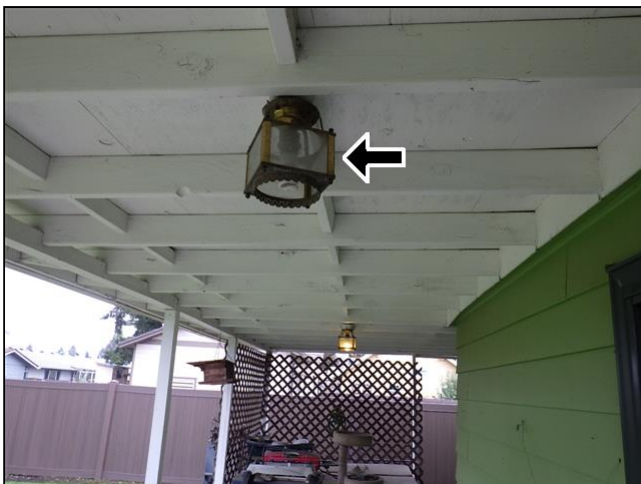
7.3 Item 7(Picture)

- 🔧 (4) The light fixtures did not work in various locations. This is for your information. Check the bulbs first and if the bulbs are not the issue an electrician should be consulted.

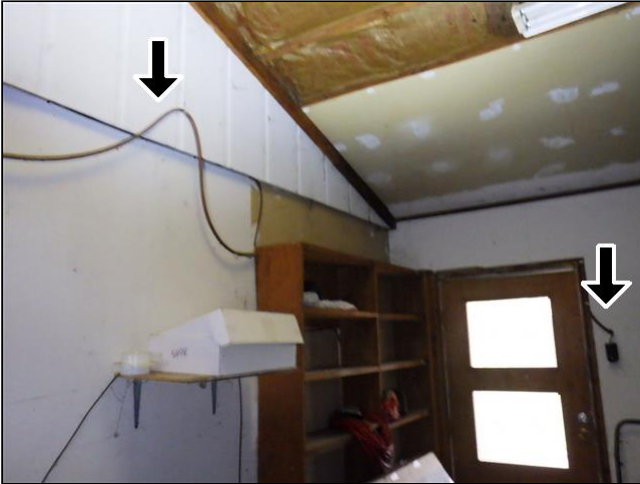
7.3 Item 8(Picture)

- 🔧 (5) Exposed wiring in the enclosed carport. Electrical issues are considered a hazard until repaired. A qualified licensed electrician should perform repairs that involve wiring.

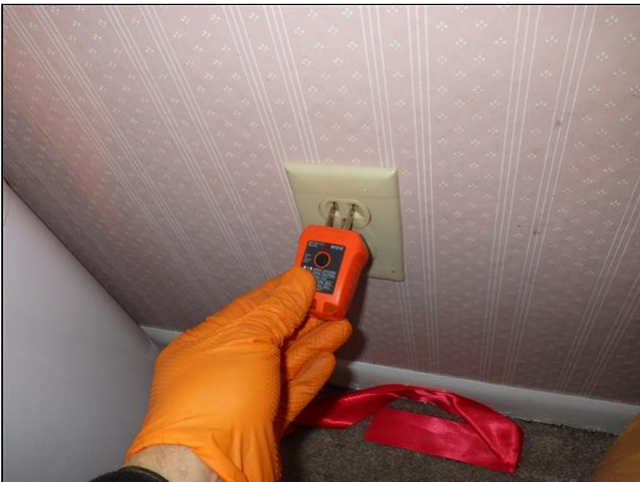
7.3 Item 10(Picture)

- 🔧 (7) The "three-prong" outlet was damaged (foreign object blocking prong holes) in the front corner bedroom. This is for your information. A qualified licensed electrician should perform repairs that involve wiring.

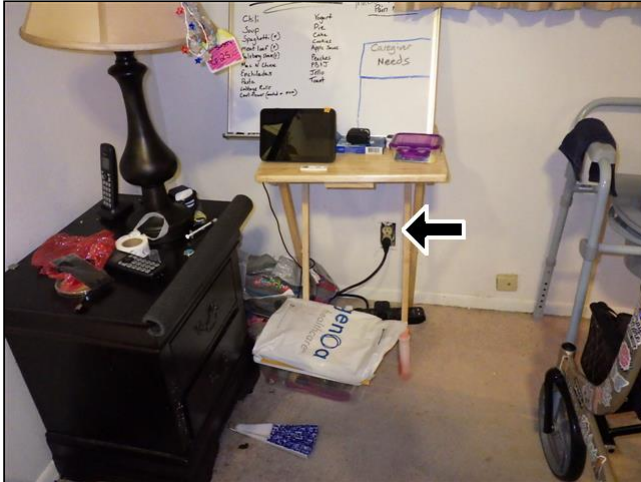
7.3 Item 11(Picture)

- 🔧 (8) The "three-prong" outlets were missing cover-plate in the bedrooms. This is for your information. I recommend repair as needed.

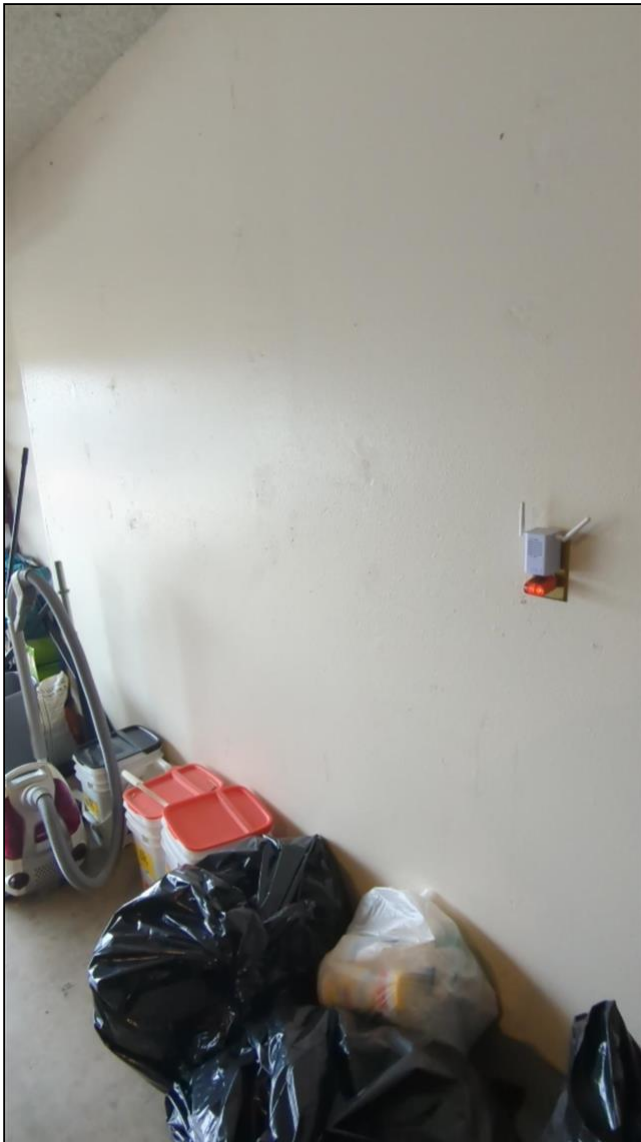
7.5 Item 1(Picture)

- 🔧 (1) The addition of GFCI's to the building in the exterior, garage and kitchen would be a wise modern safety update.

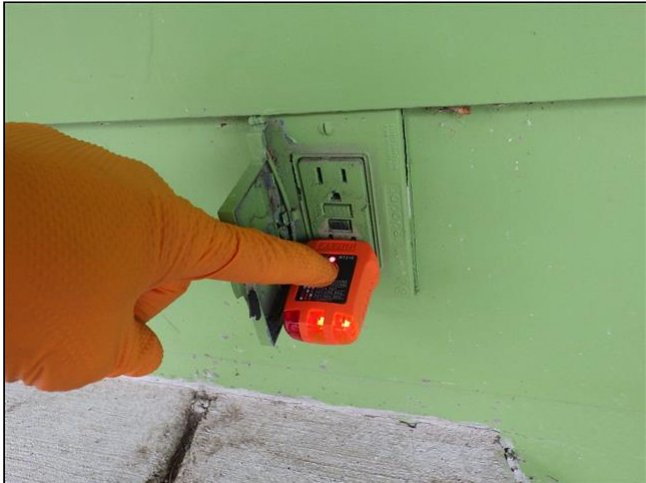
7.5 Item 3(Picture)

🔧 (2) The GFCI (Ground Fault Circuit Interrupter) outlet at the front exterior would not "trip" when tested. Electrical issues are considered a hazard until repaired. A qualified licensed electrician should perform repairs that involve wiring.

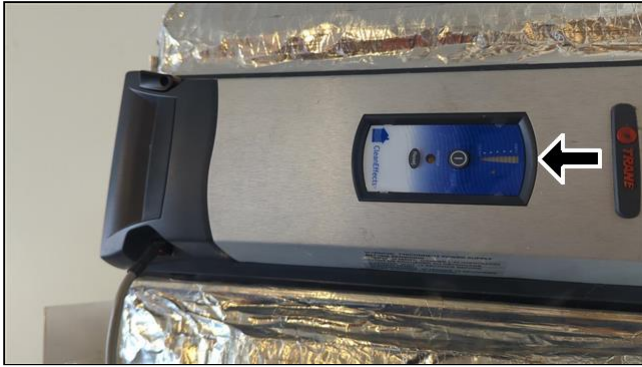
8.3 Item 1(Picture)

- 🔧 (1) The electronic air cleaner did not operate properly at time of inspection. Electronic air cleaners are expensive and further inspection and repair by a licensed HVAC person is recommended.

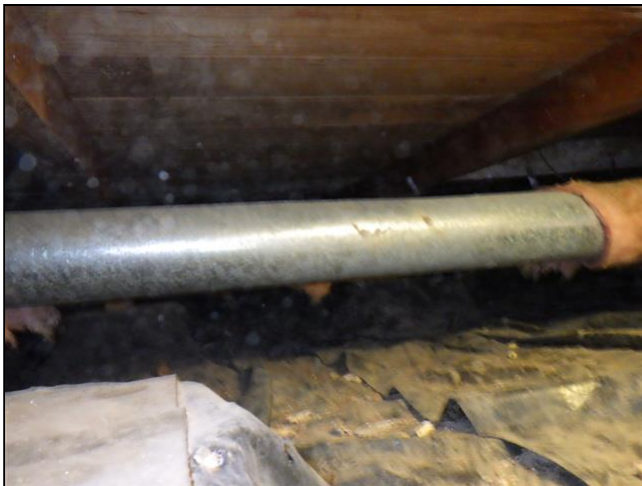
8.3 Item 2(Picture)

- 🔧 (3) The supply duct pipe was missing insulation in areas in the crawlspace. The ducts will not be as efficient as fully insulated ducts. A qualified HVAC person should inspect further and repair or replace as needed.

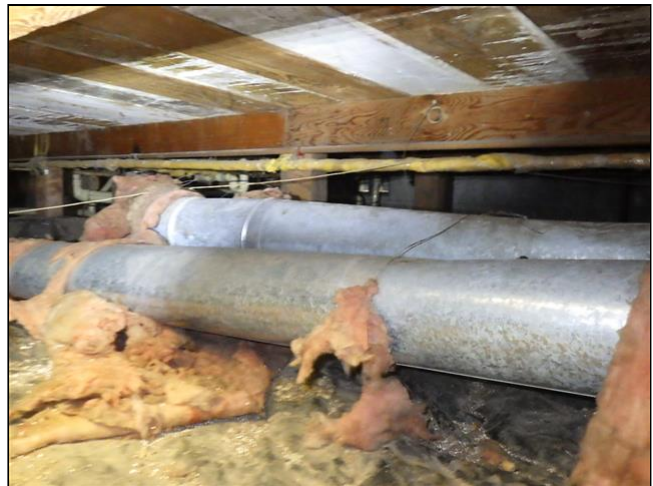
8.3 Item 3(Picture)

- 🔧 (4) The supply duct pipe needs support straps in the crawlspace. A qualified HVAC person should inspect further and repair or replace as needed.

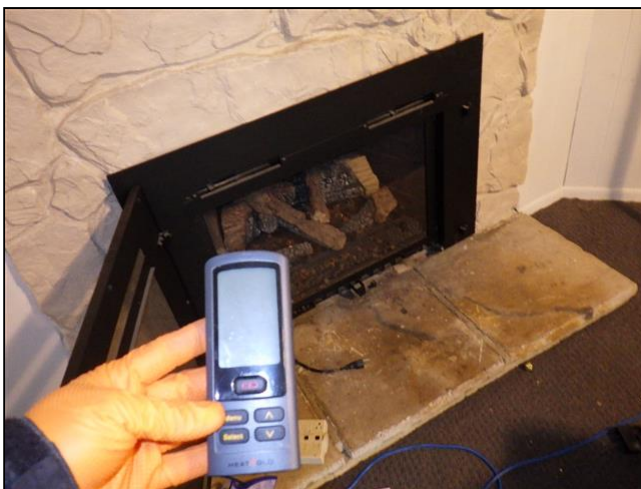
8.7 Item 1(Picture)

- 🔧 (1) The vented fire logs in the family room was not operable. Repairs should be made so unit works properly. A qualified contractor should inspect and repair as needed.

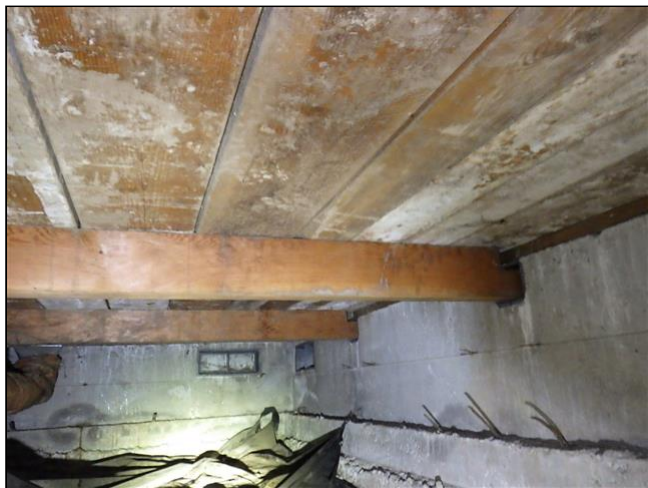
9.1 Item 1(Picture)

The floor system was not insulated. Although this was normal when the building was built, we now know that heat loss can occur more on this building than on one that is properly insulated.

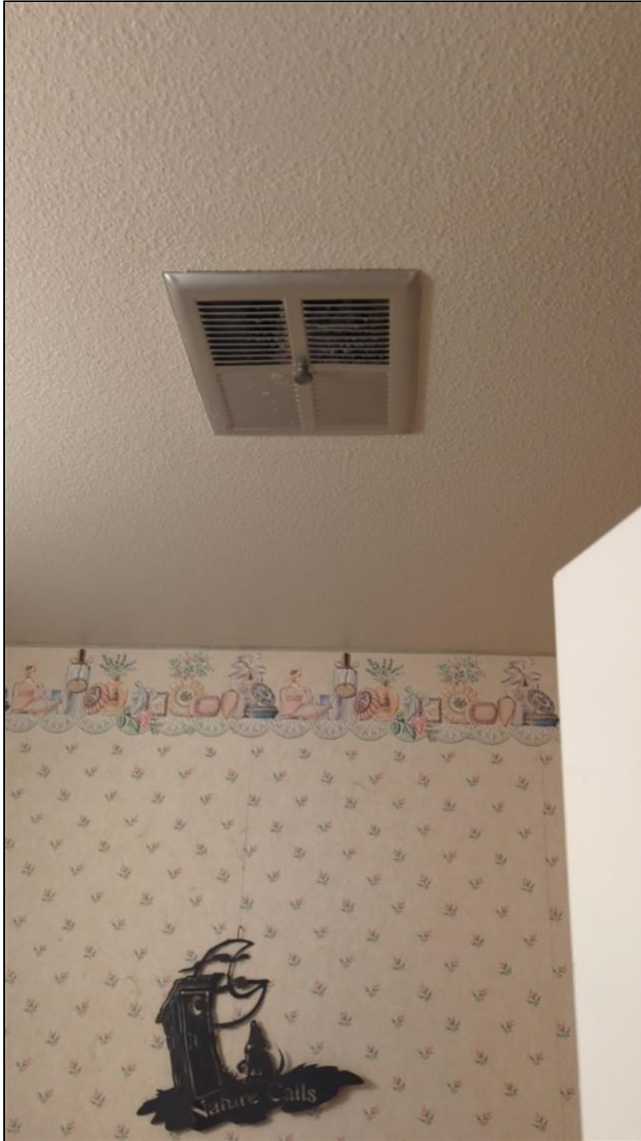
9.4 Item 1(Picture)

- 🔧 (1) The exhaust fans were very noisy at the bathrooms. Vent fans are an important part of moisture management. A qualified person should clean as needed.

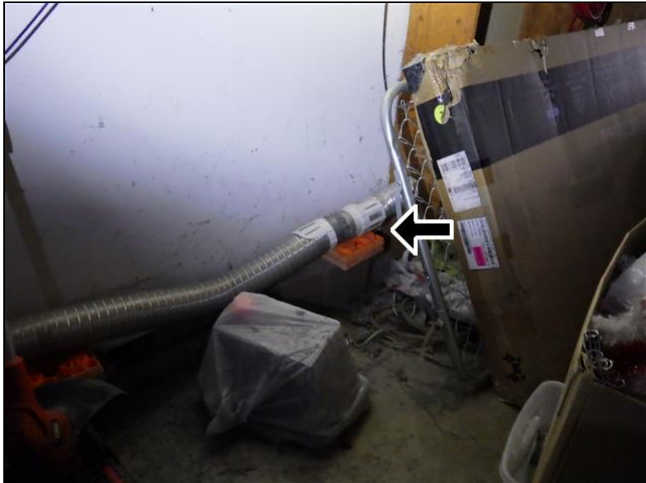
9.4 Item 3(Picture)

(2) The dryer vent piping was a flexible duct. The dryer duct should be a "hard duct," installed properly by a licensed professional contractor who is familiar with dryer duct installation. I recommend repair as needed.
