# Perfection<sup>✓</sup> Inspection, Inc

**Property Address:  
5257 Waconda Rd NE  
Salem OR 97305**

**6/4/2025**

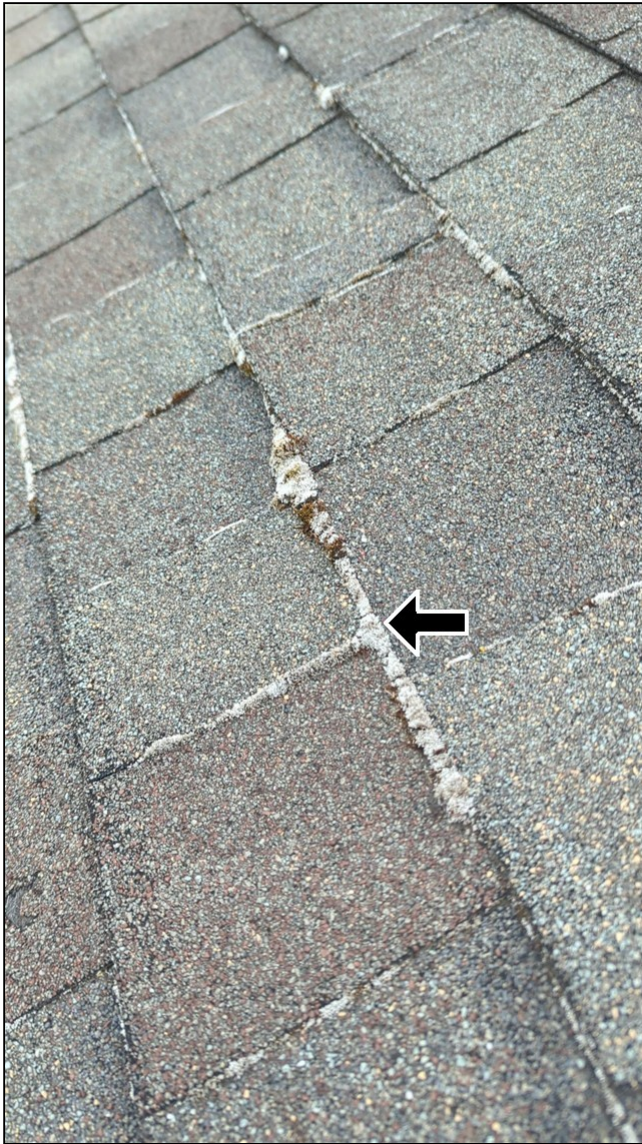
1.0 Item 1(Picture)

(2) The roof covering has areas of damage in areas at the front of the building (refer to pictures). These areas should be monitored for future performance and repaired if necessary.

(2) The roof covering has areas of damage in areas at the front of the building (refer to pictures). These areas should be monitored for future performance and repaired if necessary.

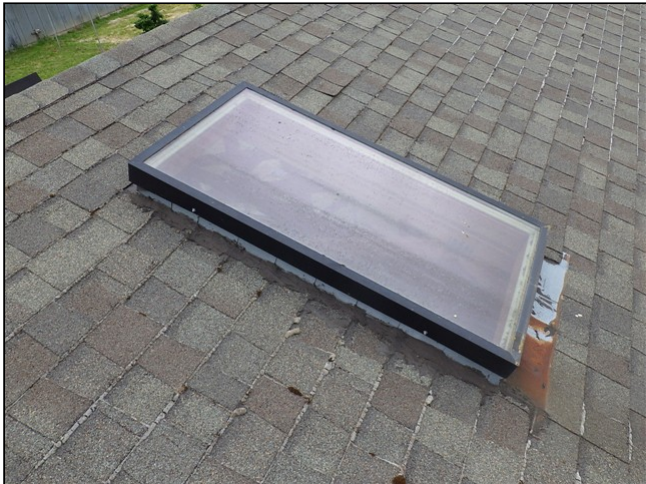
1.2 Item 1(Picture)

(1) One skylight shows repair signs suggesting a leak does or did exist at the rear of the building. No current leakage could be noted. I recommend monitor and repair if needed.

(1) One skylight shows repair signs suggesting a leak does or did exist at the rear of the building. No current leakage could be noted. I recommend monitor and repair if needed.
-

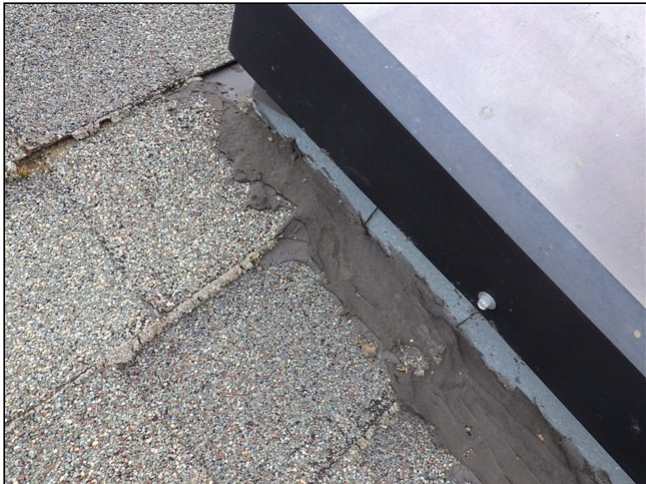
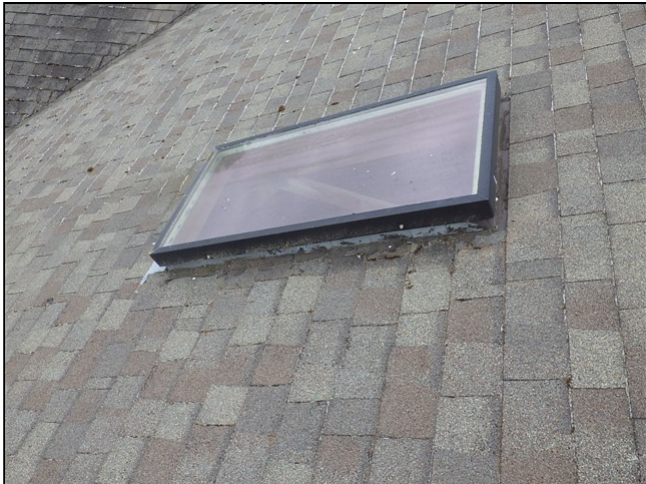
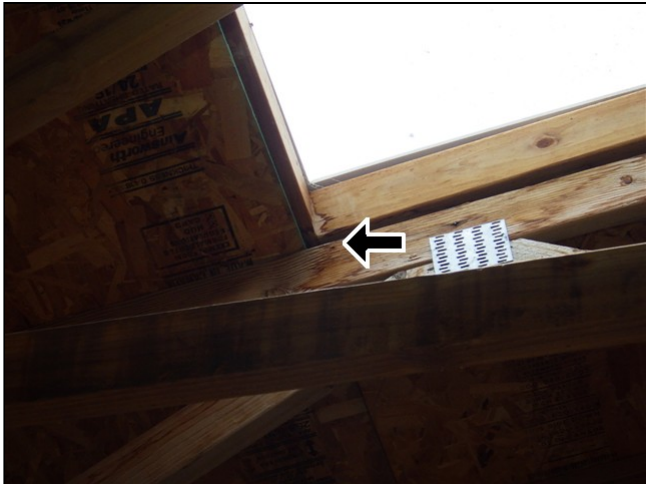
(2) The roof had penetrations with the installation of the dish/antennae. No current leakage could be noted however it is recommended that you monitor these penetrations and repair if damage or leakage is observed.

(2) The roof had penetrations with the installation of the dish/antennae. No current leakage could be noted however it is recommended that you monitor these penetrations and repair if damage or leakage is observed.

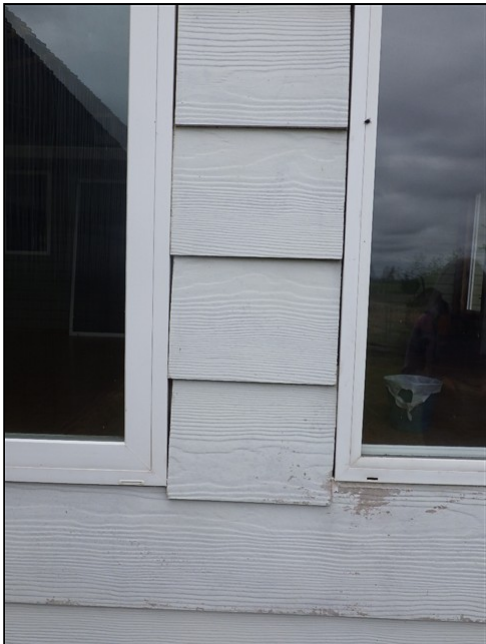
2.0 Item 4(Picture)

🔧 (2) The cement board siding and wood trim at the rear of the building (refer to picture(s)) was installed improperly or not according to standard workmanlike practices. Further deterioration can occur if not corrected. A qualified contractor should inspect and repair as needed.

(2) The cement board siding and wood trim at the rear of the building (refer to picture(s)) was installed improperly or not according to standard workmanlike practices. Further deterioration can occur if not corrected. A qualified contractor should inspect and repair as needed.
-

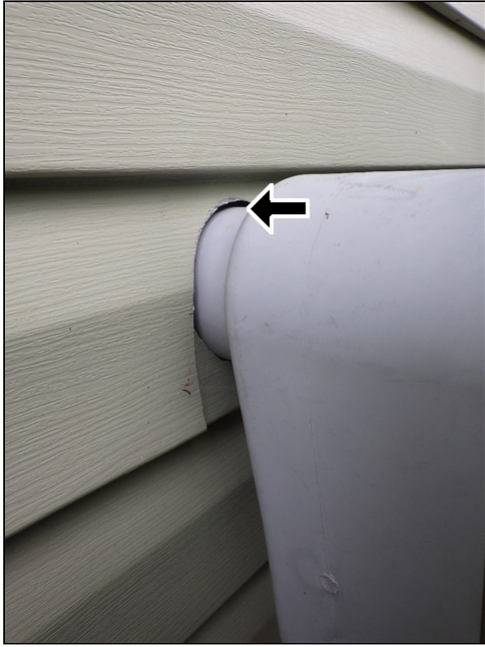
2.0 Item 6(Picture)

- 🔧 (3) The hole(s) in siding need to be properly filled/caulked/painted at the front of the building (refer to picture(s)) where the pipes/wires penetrate the building envelope.

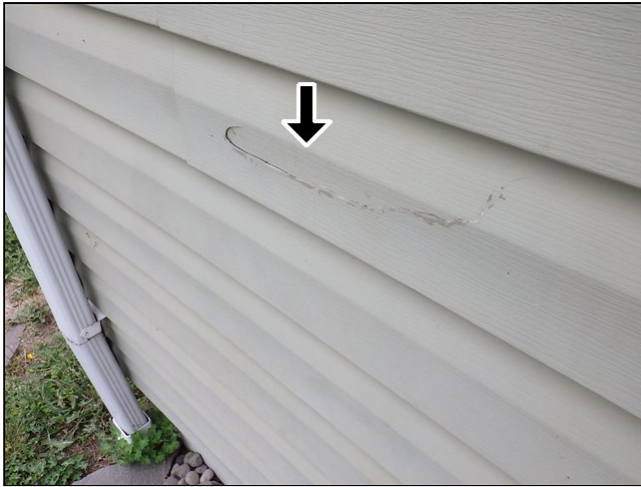
2.0 Item 7(Picture)

- 🔧 (4) The vinyl siding at the front of the building (refer to picture(s)) was damaged. Further deterioration can occur if not corrected. A qualified contractor should inspect and repair as needed.

(4) The vinyl siding at the front of the building (refer to picture(s)) was damaged. Further deterioration can occur if not corrected. A qualified contractor should inspect and repair as needed.

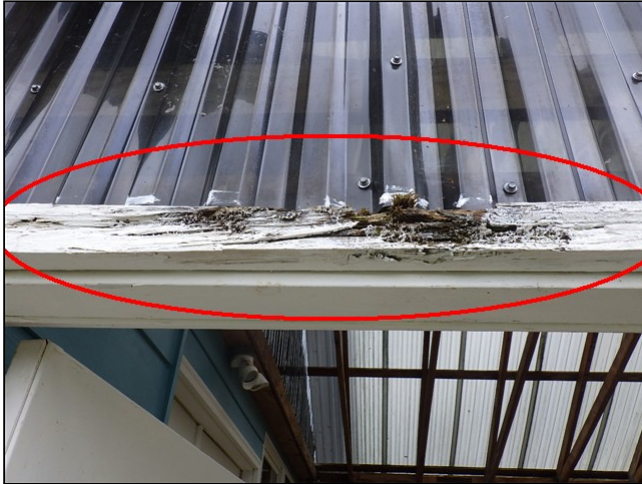
2.1 Item 1(Picture)

- 🔧 (1) The rear entry door has deteriorated at trim (exterior). This should be repaired/replaced. A qualified contractor should inspect and repair as needed.

(1) The rear entry door has deteriorated at trim (exterior). This should be repaired/replaced. A qualified contractor should inspect and repair as needed.
-

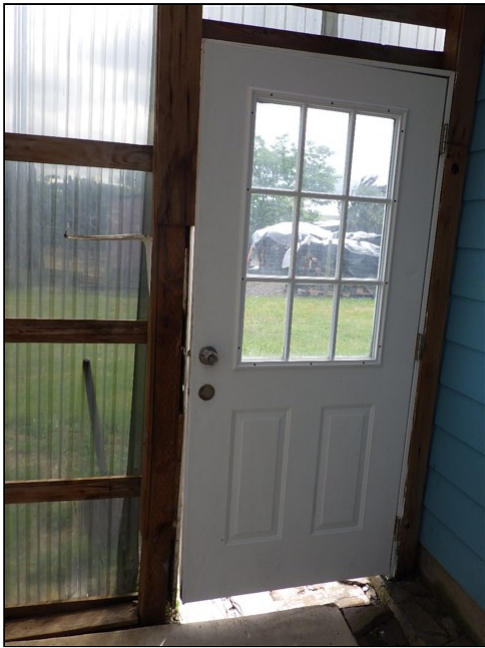
2.1 Item 2(Picture)

- 🔧 (2) The rear entry door did not latch properly. This should be repaired/replaced. A qualified contractor should inspect and repair as needed.

(2) The rear entry door did not latch properly. This should be repaired/replaced. A qualified contractor should inspect and repair as needed.

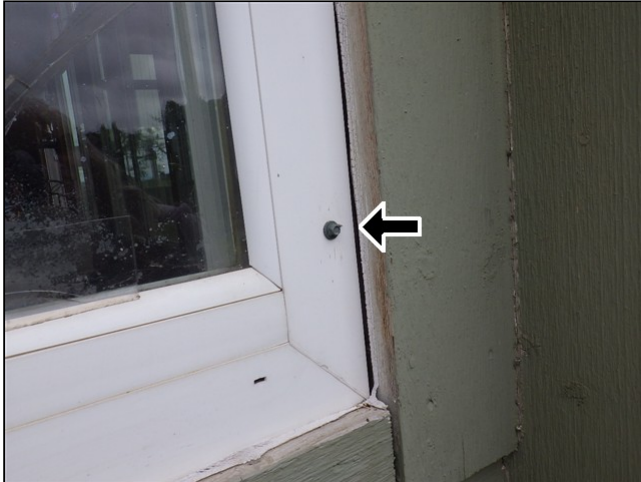
2.2 Item 1(Picture)

- The window was unusually installed at rear of the building. Deterioration may occur if not corrected. A qualified contractor should inspect and repair as needed.

The window was unusually installed at rear of the building. Deterioration may occur if not corrected. A qualified contractor should inspect and repair as needed.

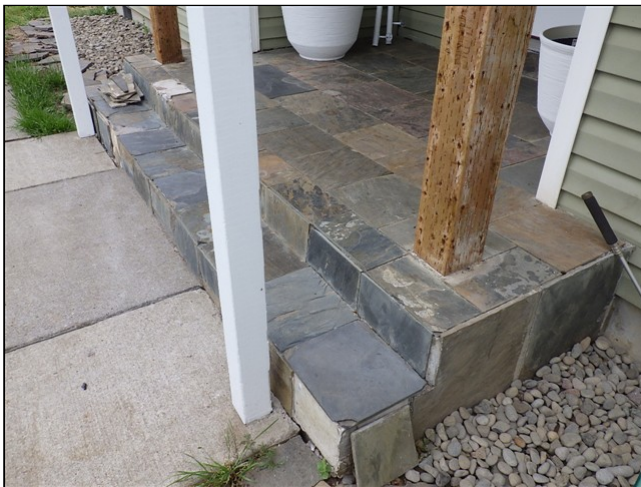
2.3 Item 1(Picture)

- (1) The stone tile at the front steps was delaminating and failing. This should be repaired as necessary.

(1) The stone tile at the front steps was delaminating and failing. This should be repaired as necessary.

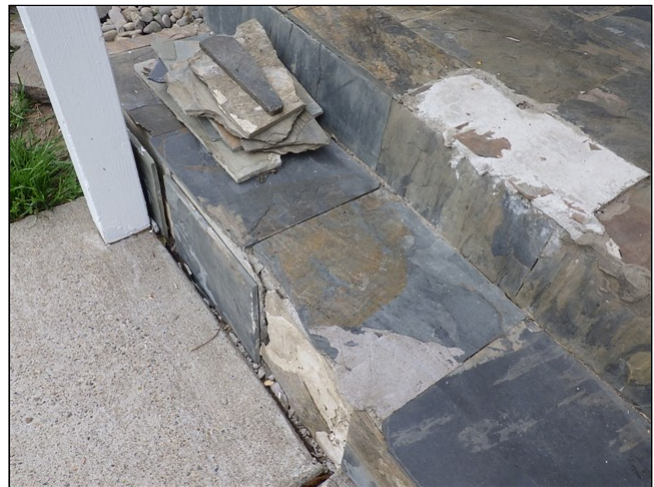
2.3 Item 2(Picture)

- (2) The hand/guard rail for the stairs was missing. A qualified contractor should repair or replace as needed.

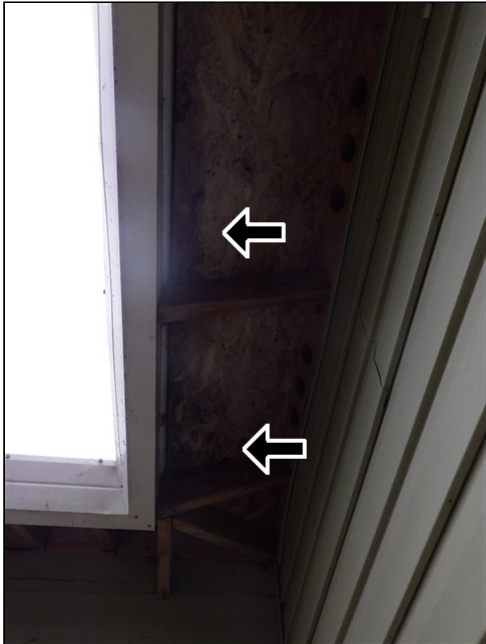
2.5 Item 1(Picture)

🔧 (1) The roof sheathing at eave on the exterior in areas (refer to picture(s)) shows evidence of moisture absorption. Further deterioration may occur if not repaired. A qualified contractor should inspect and repair as needed.

(1) The roof sheathing at eave on the exterior in areas (refer to picture(s)) shows evidence of moisture absorption. Further deterioration may occur if not repaired. A qualified contractor should inspect and repair as needed.
-

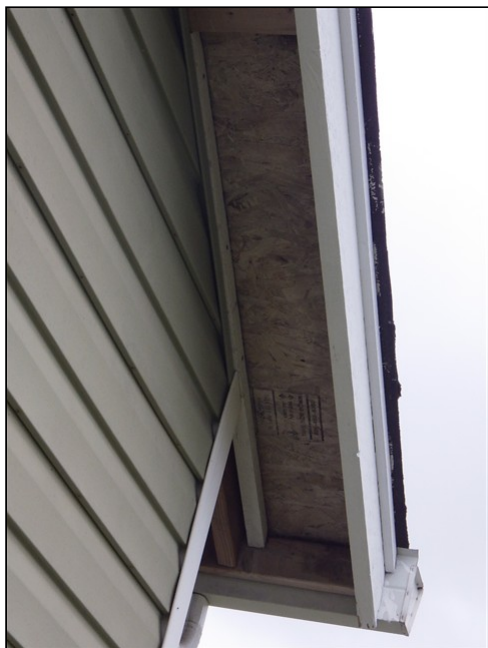
2.5 Item 8(Picture)

🔧 (2) The exposed eave needs primer and paint at the exterior.

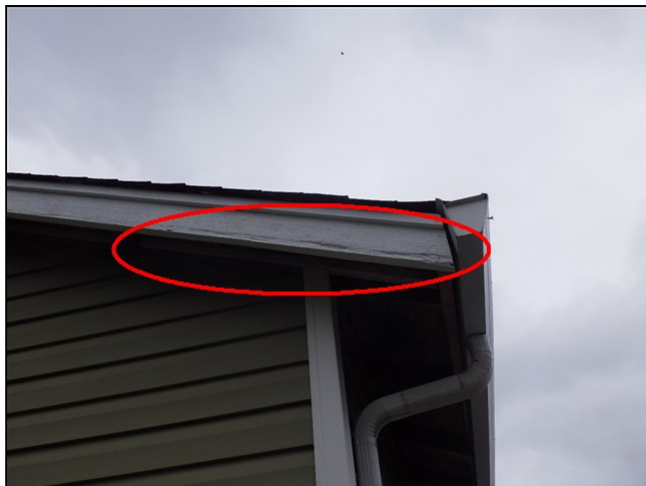
2.5 Item 9(Picture)

🔧 (3) The rake rafters on the roof slope show signs of deterioration. These should be repaired to prevent further damage to related components.

(3) The rake rafters on the roof slope show signs of deterioration. These should be repaired to prevent further damage to related components.

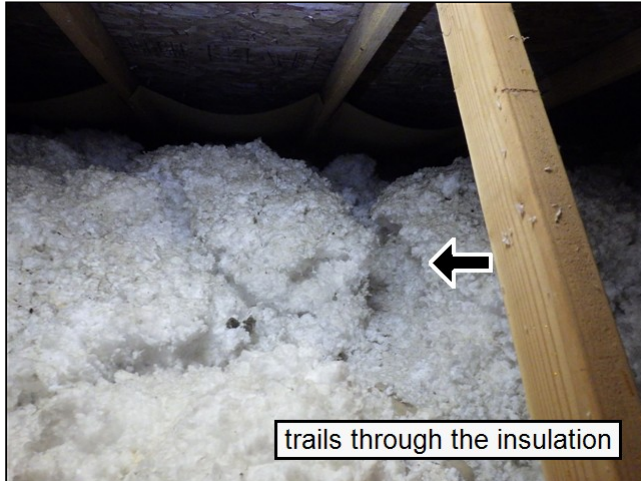
2.6 Item 1(Picture)

- 🔧 Evidence of pest activity noted in the crawlspace and attic. Some evidence is not unusual, however you should consider a pest control consultation regarding the control of their entry into the building. Pests should be excluded from these areas.

Evidence of pest activity noted in the crawlspace and attic. Some evidence is not unusual, however you should consider a pest control consultation regarding the control of their entry into the building. Pests should be excluded from these areas.

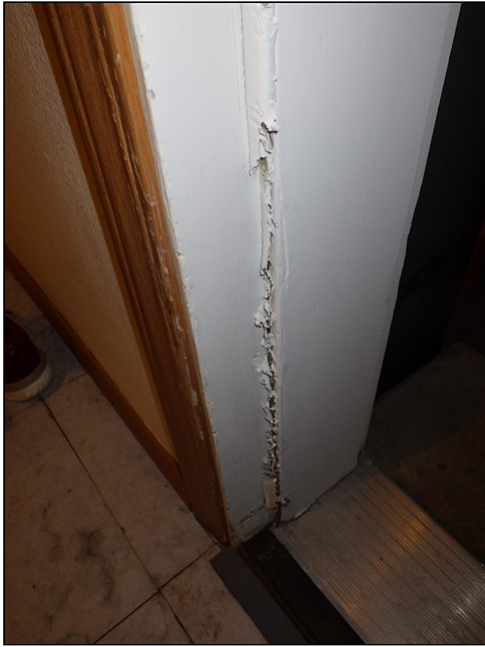
3.4 Item 1(Picture)

- 🔧 The door between the home and the garage should have new weather stripping installed.

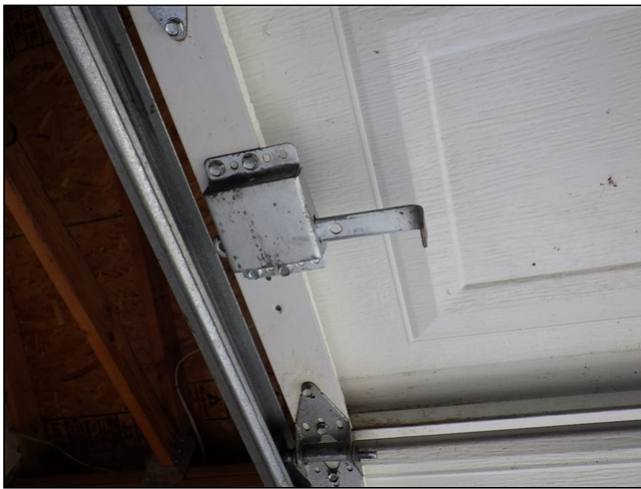
3.5 Item 1(Picture)

- 🔧 The garage door at the front of the building had the manual lock in place with the power opener. The lock can cause significant damage if it is engaged and the door opener is operated. A qualified person should remove or disable the manual lock.

The garage door at the front of the building had the manual lock in place with the power opener. The lock can cause significant damage if it is engaged and the door opener is operated. A qualified person should remove or disable the manual lock.

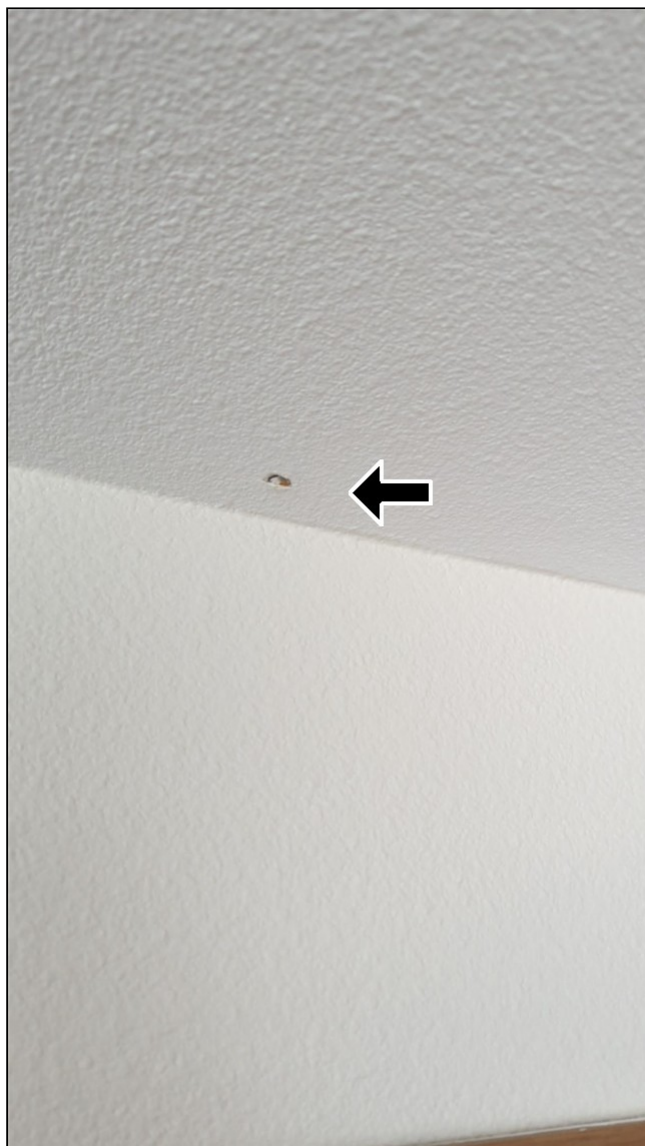
4.0 Item 1(Picture)

🏠 The drywall on the ceiling has some "nail pops." This damage is not unusual. A qualified person should repair or replace as needed.

The drywall on the ceiling has some "nail pops." This damage is not unusual. A qualified person should repair or replace as needed.

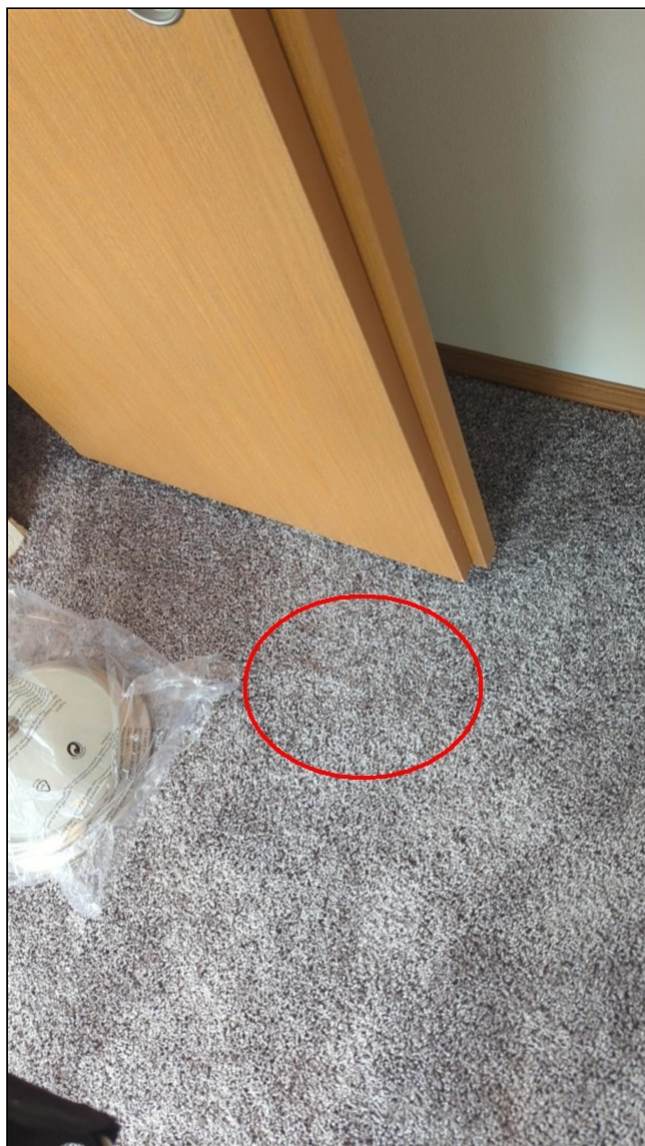
4.5 Item 1(Picture)

- 🔧 (1) The closet door was missing the center retaining strip at the bottom. This is a maintenance issue and is for your information. A qualified contractor should inspect and repair as needed.

(1) The closet door was missing the center retaining strip at the bottom. This is a maintenance issue and is for your information. A qualified contractor should inspect and repair as needed.
-

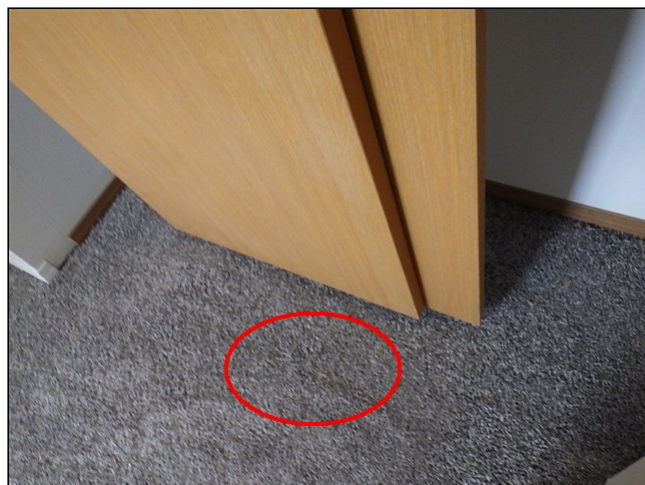
4.5 Item 2(Picture)

- 🔧 (2) The entry door was damaged by pet at the front corner bedroom. This should be repaired/replaced. A qualified contractor should inspect and repair as needed.

(2) The entry door was damaged by pet at the front corner bedroom. This should be repaired/replaced. A qualified contractor should inspect and repair as needed.
-

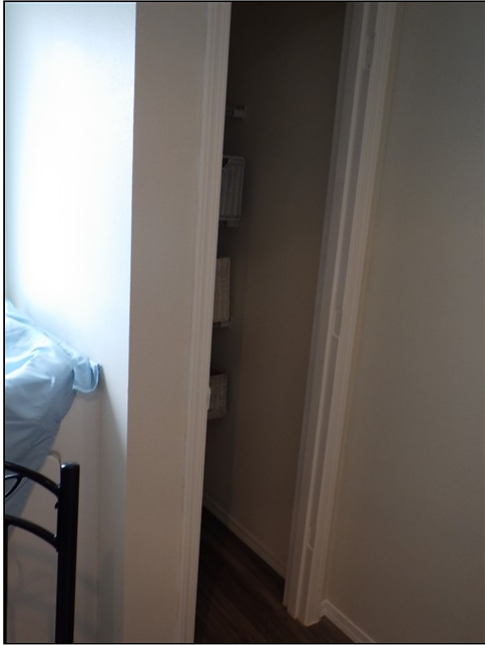
4.5 Item 4(Picture)

- 🔧 (3) The closet door was missing at the master bath. This should be repaired/replaced. A qualified contractor should inspect and repair as needed.

(3) The closet door was missing at the master bath. This should be repaired/replaced. A qualified contractor should inspect and repair as needed.

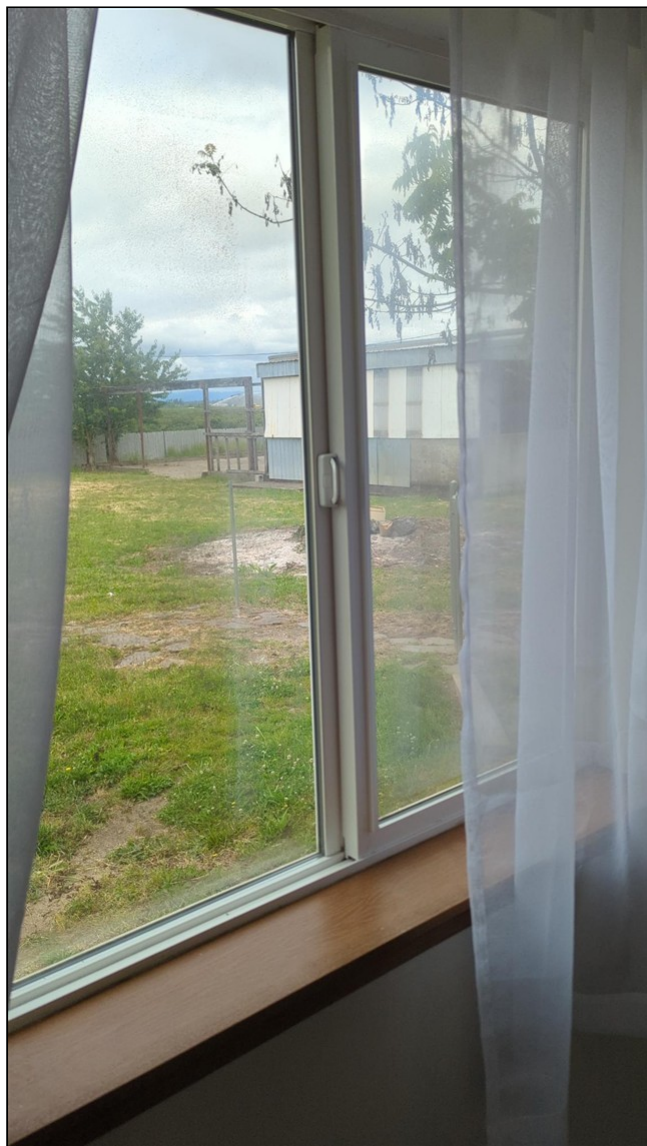
4.6 Item 1(Picture) front corner bedroom

- 🔧 (1) Some windows were cloudy (moisture trapped between the panes). In order to correct the cloudy appearance of glass, a replacement of glass pane or the unit will be necessary. A qualified contractor should inspect and repair as needed.

(1) Some windows were cloudy (moisture trapped between the panes). In order to correct the cloudy appearance of glass, a replacement of glass pane or the unit will be necessary. A qualified contractor should inspect and repair as needed.
-

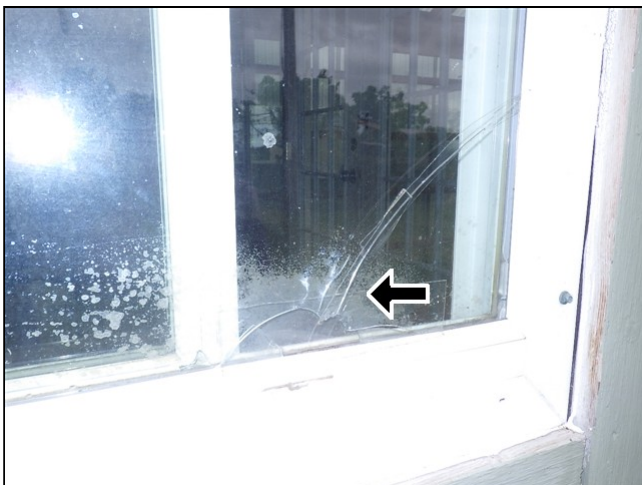
4.6 Item 4(Picture)

- 🔧 (2) One window was cracked at glass pane at the rear of the building. This should be repaired. A qualified contractor should inspect and repair as needed.

(2) One window was cracked at glass pane at the rear of the building. This should be repaired. A qualified contractor should inspect and repair as needed.

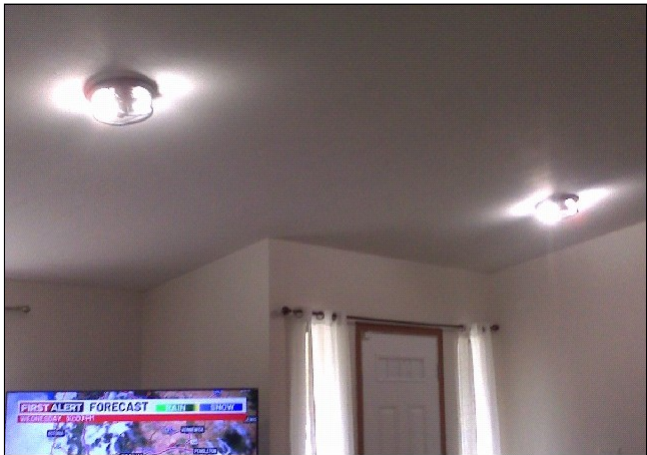
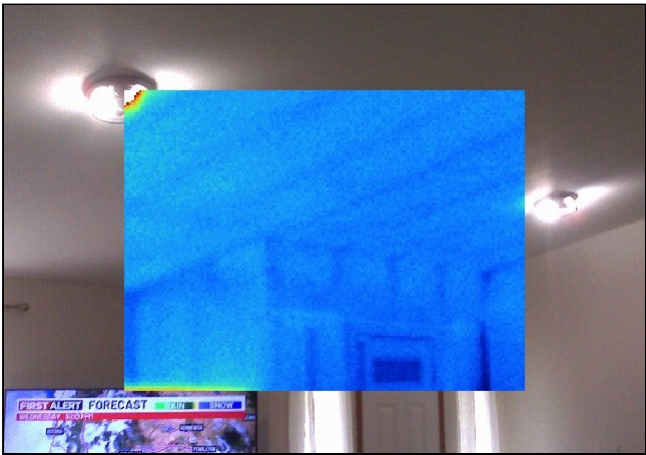
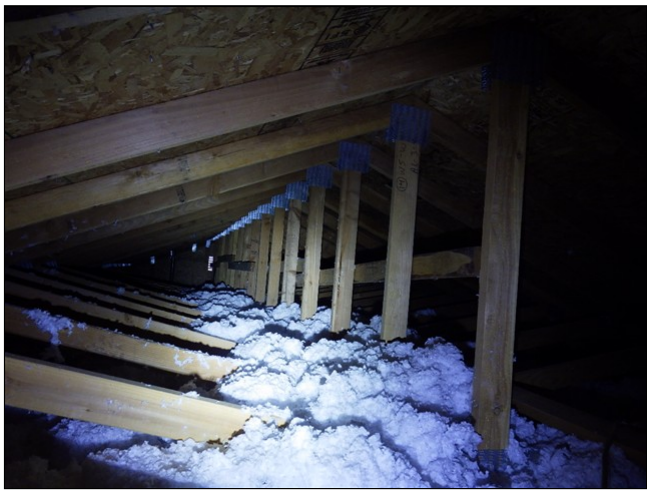
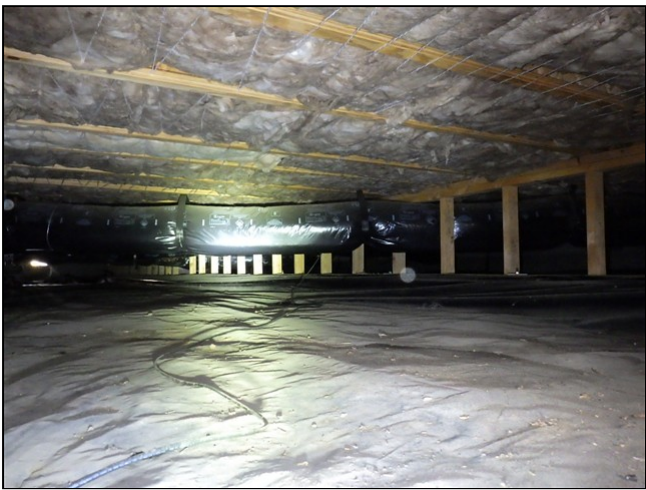
Normal structure

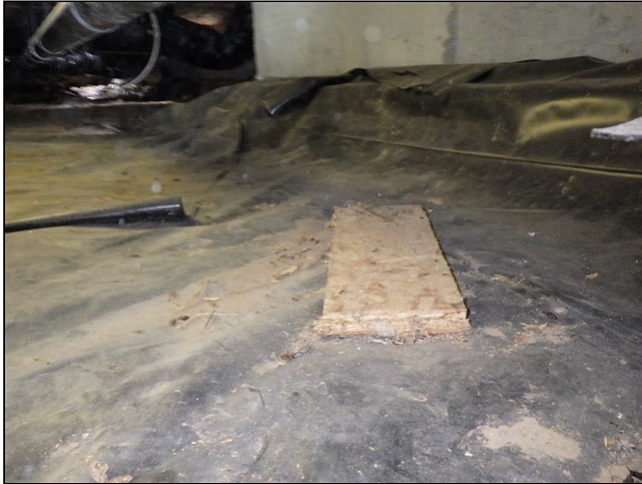
5.0 Item 1(Picture)

- ✎ The wood/cellulose construction debris should be removed from the crawlspace. The excess wood that is under the building can be an excellent home base for wood destroying organisms, allowing them to multiply. When the wood runs out or the wood destroying organisms start looking for more they may look to your building. In general all pieces large enough to be caught in a garden rake should be removed.

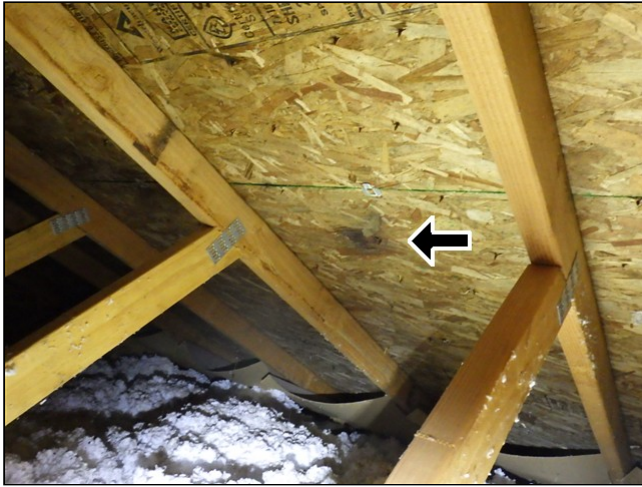
5.6 Item 1(Picture)

necessary and monitor after a heavy rain and repair if needed.

Water stains were on the roofing structure above the rear bedroom. Due to lack of recent rains I was unable to determine if leak has been corrected. It is recommend to further investigate, repair if necessary and monitor after a heavy rain and repair if needed.

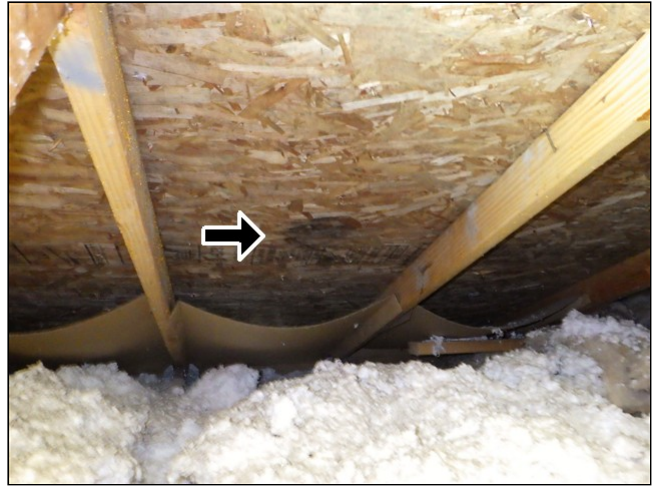
5.6 Item 2(Picture)

🔍 Water stains were on the roofing structure above the rear bedroom. Due to lack of recent rains I was unable to determine if leak has been corrected. It is recommend to further investigate, repair if

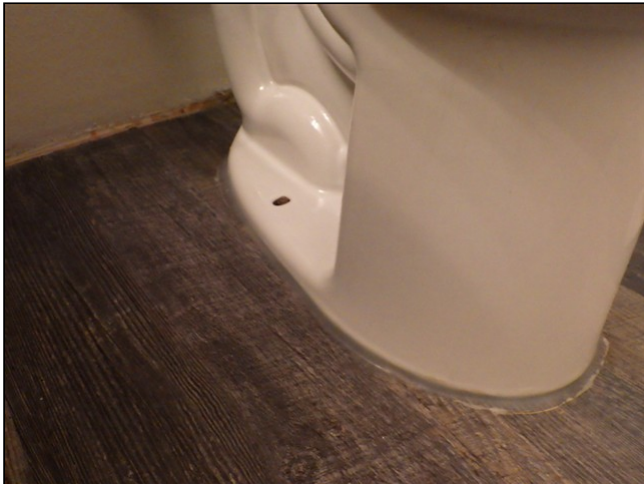
6.0 Item 1(Picture)

🔧 (1) The toilet was loose and leaked at floor at the hall bath. Repairs should involve re-setting the toilet on a new wax seal. I recommend a qualified licensed plumber repair or correct as needed.

(1) The toilet was loose and leaked at floor at the hall bath. Repairs should involve re-setting the toilet on a new wax seal. I recommend a qualified licensed plumber repair or correct as needed.
-

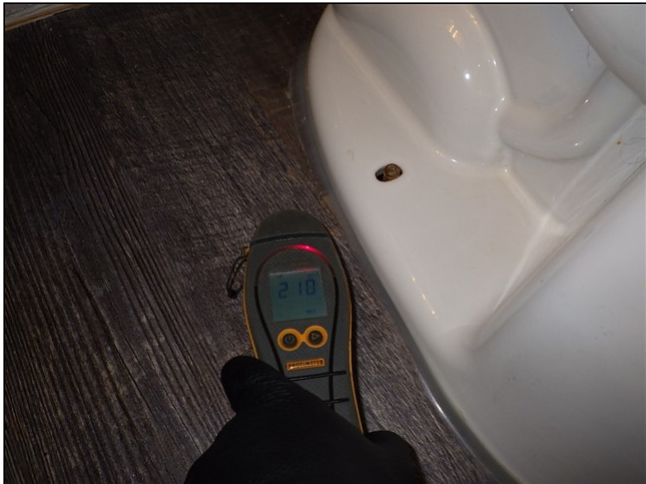
6.0 Item 2(Picture) Moisture meter confirming current leakage.

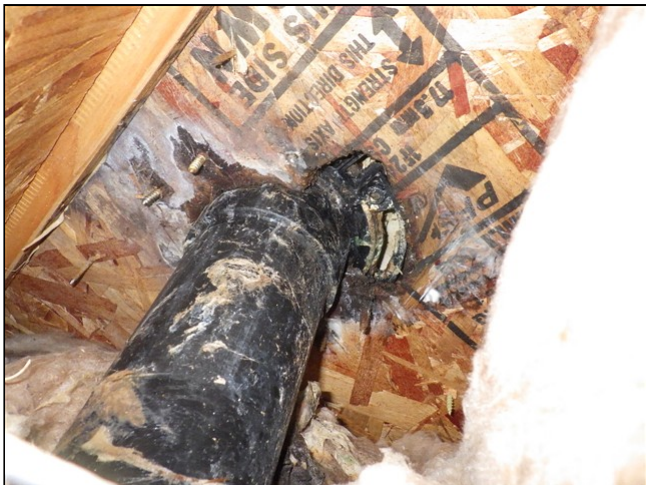
6.0 Item 4(Picture)

- 🔧 (2) The shower drains leaked in the crawlspace under the master bath and under the hall bath. Repairs are needed. I recommend a licensed plumber inspect further and repair as necessary.

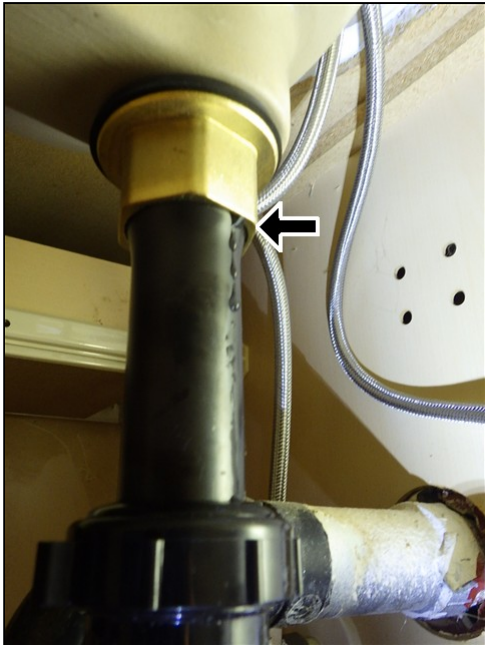
6.0 Item 7(Picture)

- 🔧 (3) The plumbing waste line leaked at the hall bath sink. Repairs are needed. I recommend a licensed plumber inspect further and repair as necessary.

(3) The plumbing waste line leaked at the hall bath sink. Repairs are needed. I recommend a licensed plumber inspect further and repair as necessary.
-

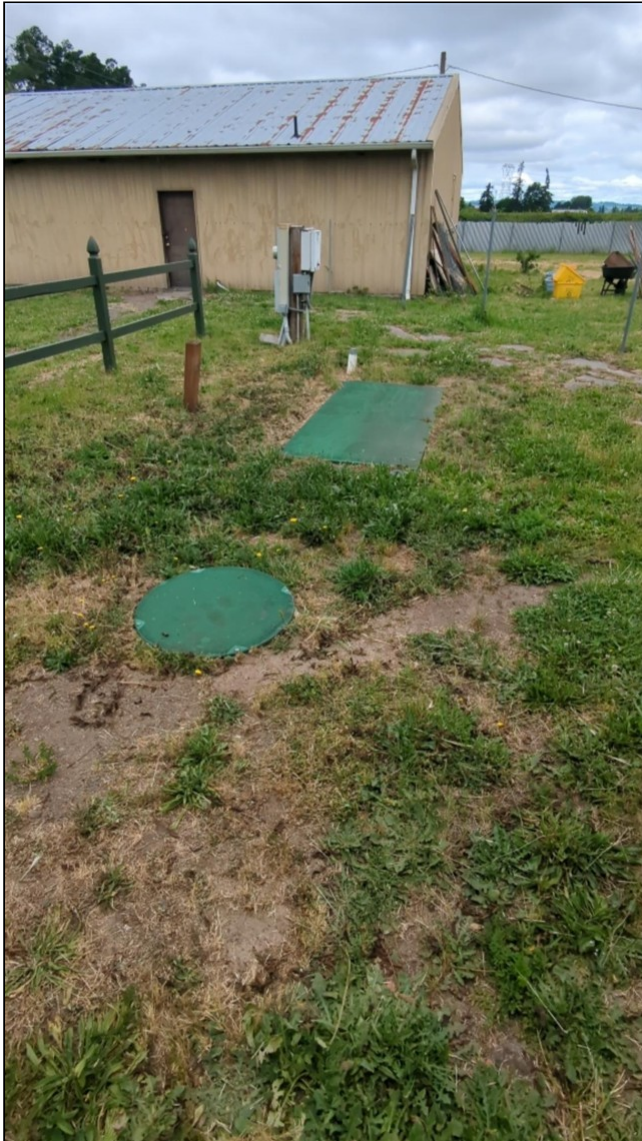
6.0 Item 10(Picture)

- 🔍 (5) This inspection did not access the septic tank or determine its location. For a more detailed inspection, I recommend you contact a septic pumping company and have them empty the tank. At that time the tank could be inspected for proper functioning. **Then the leach field should be scoped or camera inspected to determine its functionality and exact position.**

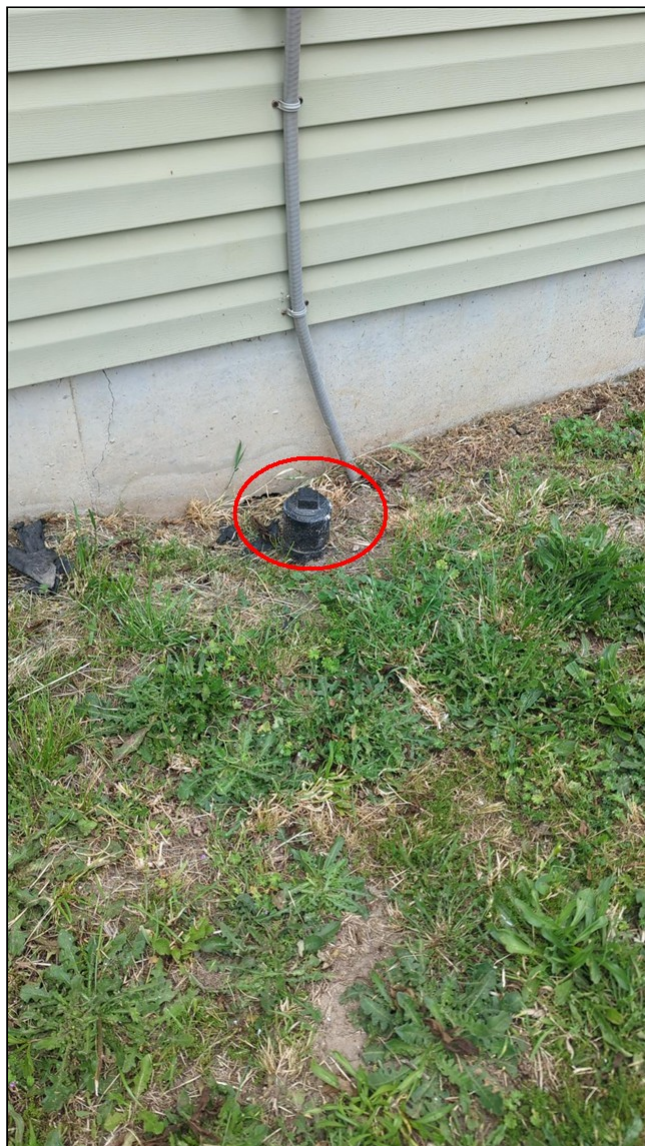
6.0 Item 11(Picture)

- 🔍 (6) You should strongly consider having the sewer line scoped. Issues with the main underground waste line can be common and the repairs can be costly. The main under ground soil pipe could not be viewed and was not inspected.

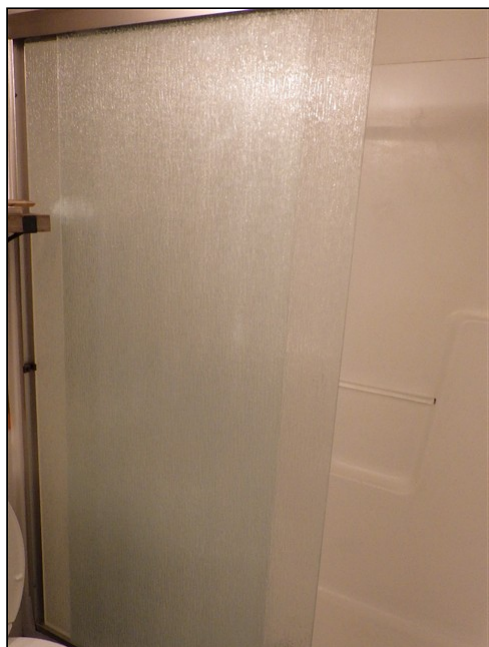
6.1 Item 1(Picture)

- 🔧 (1) The shower door was missing handles and was difficult to operate at the hall bath. Repairs are needed A qualified, licensed professional contractor should repair as necessary.

(1) The shower door was missing handles and was difficult to operate at the hall bath. Repairs are needed A qualified, licensed professional contractor should repair as necessary.
-

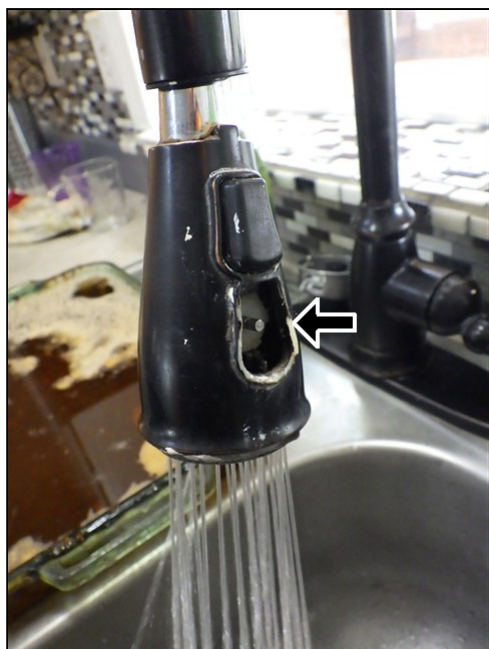
6.1 Item 2(Picture)

- 🔧 (2) The spray nozzle button was damaged at the kitchen sink. Repairs are needed. I recommend a licensed plumber inspect further and repair as necessary.

(2) The spray nozzle button was damaged at the kitchen sink. Repairs are needed. I recommend a licensed plumber inspect further and repair as necessary.
-

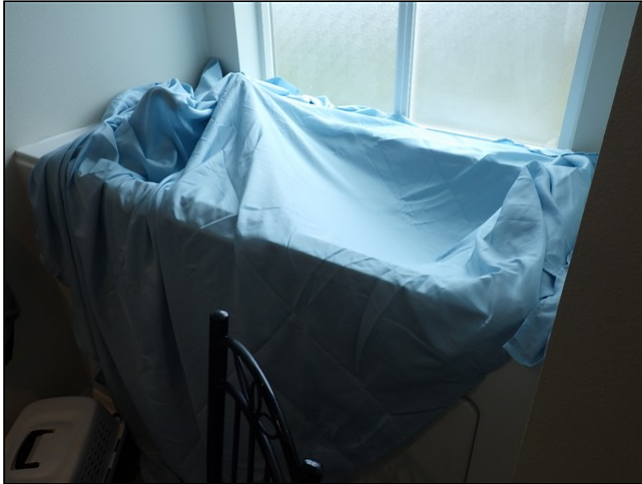
6.1 Item 3(Picture)

- 🔧 (3) The bathtub in the master bathroom was not tested due to storage. This unit should be tested as necessary.

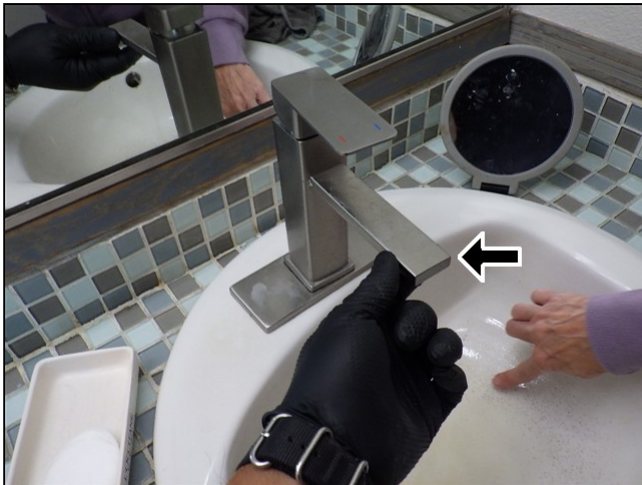
6.1 Item 4(Picture)

- 🔧 (4) The sink faucets were loose at the master bath. Repairs are needed. I recommend a licensed plumber inspect further and repair as necessary.

(4) The sink faucets were loose at the master bath. Repairs are needed. I recommend a licensed plumber inspect further and repair as necessary.

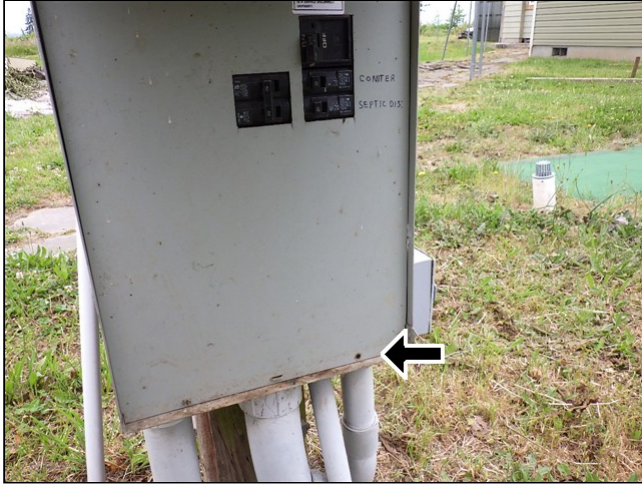
7.1 Item 1(Picture)

- 🔧 (1) Screw(s) missing from the main panel cover. All of the screws should be installed for the cover to function properly in an emergency over-current situation. The screw(s) should be replaced with a proper screw designed for this panel.

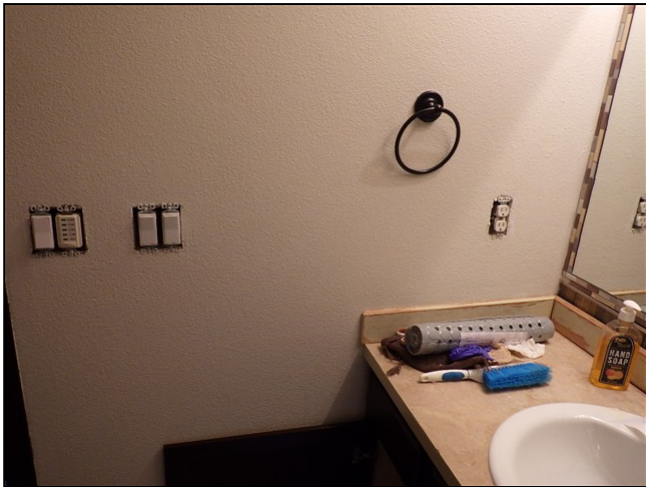
7.3 Item 1(Picture)

(1) Outlets and wall switches were missing cover plates due to painting/repairs. These should be replaced when the painting/repairs are complete.

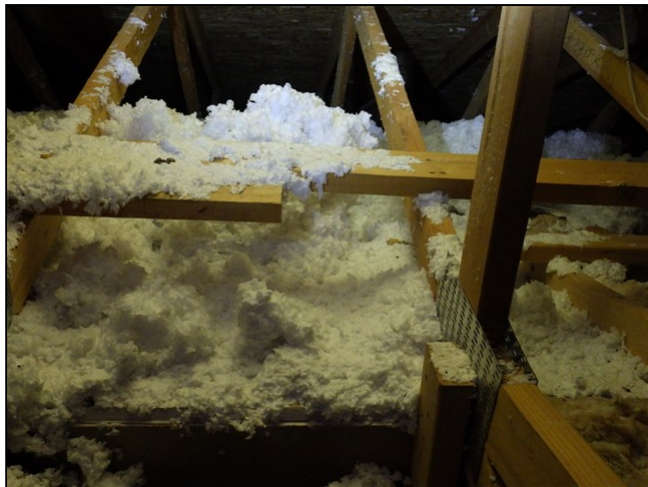
9.0 Item 1(Picture)

Insulation was compressed in sections of the attic. Heat loss can occur more on this building than one that is properly insulated. A qualified contractor should inspect and repair as needed.

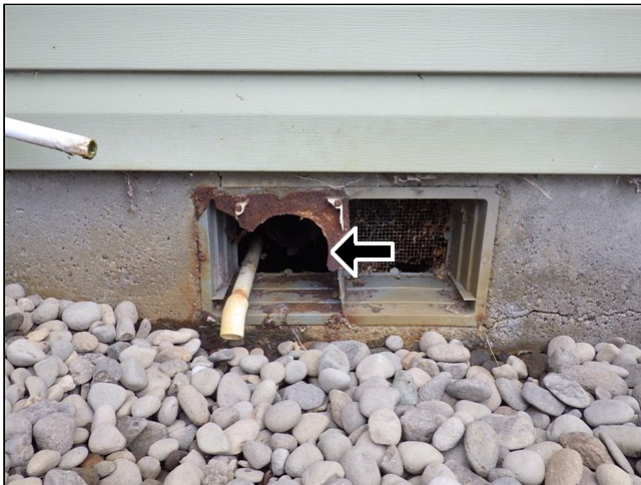
9.3 Item 1(Picture)

- 🔧 The foundation has a hole large enough for pests at the front and side of the building. Exclusion of pests is the best way to prevent issues. A qualified contractor should inspect and repair as needed.

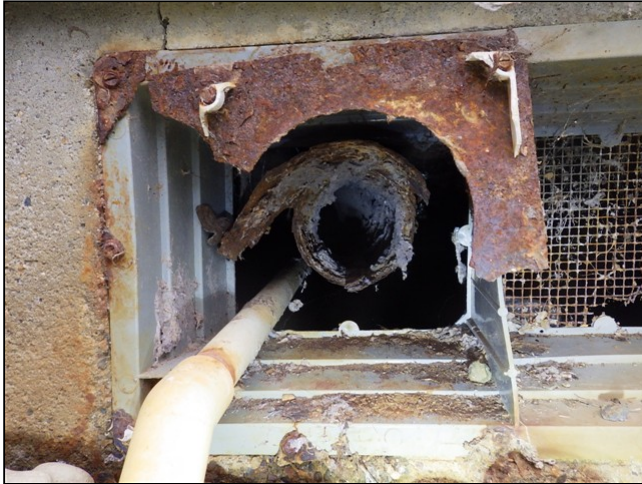
9.4 Item 1(Picture)

- 🔧 The dryer vent piping had a damaged vent hood outside. Damaged piping can cause an obstruction of lint that has a possibility to create a fire hazard. I recommend repair as needed.

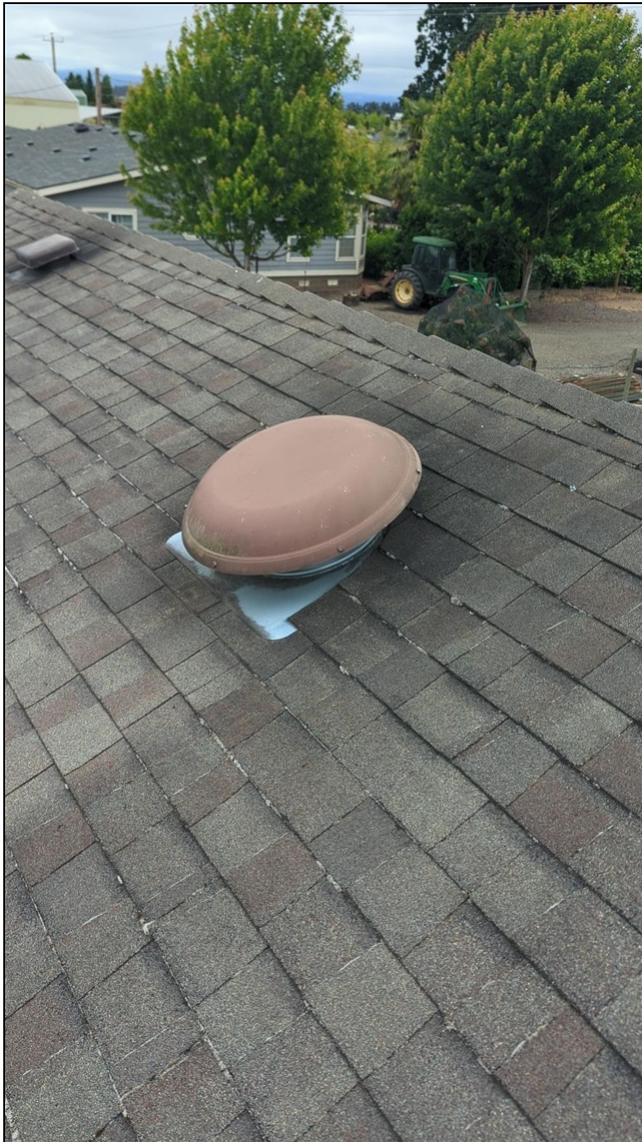
9.5 Item 1(Picture)

- ✎ The attic fan should be disabled as the energy it uses and the significant pressure differences it creates are not worth the few degrees of temperature difference in the attic. Thorough air sealing between the building and attic should be done instead of power attic ventilation.
