# Perfection<sup>✓</sup> Inspection, Inc

**Property Address:**  
1030 21st St NE  
Salem OR 97301

**11/7/2025**

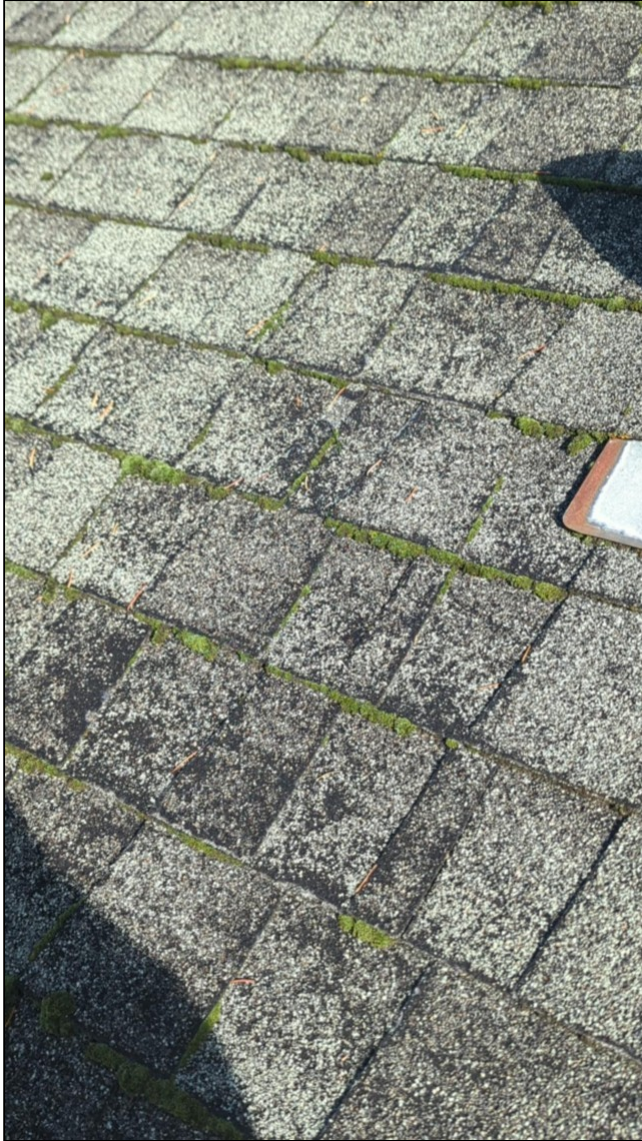
1.0 Item 1(Picture)

- 🔧 (1) **The roof coverings on the house and garage were old, and the life of covering has expired. The covering does need to be replaced. A licensed professional roofing contractor should replace the roofing system.**

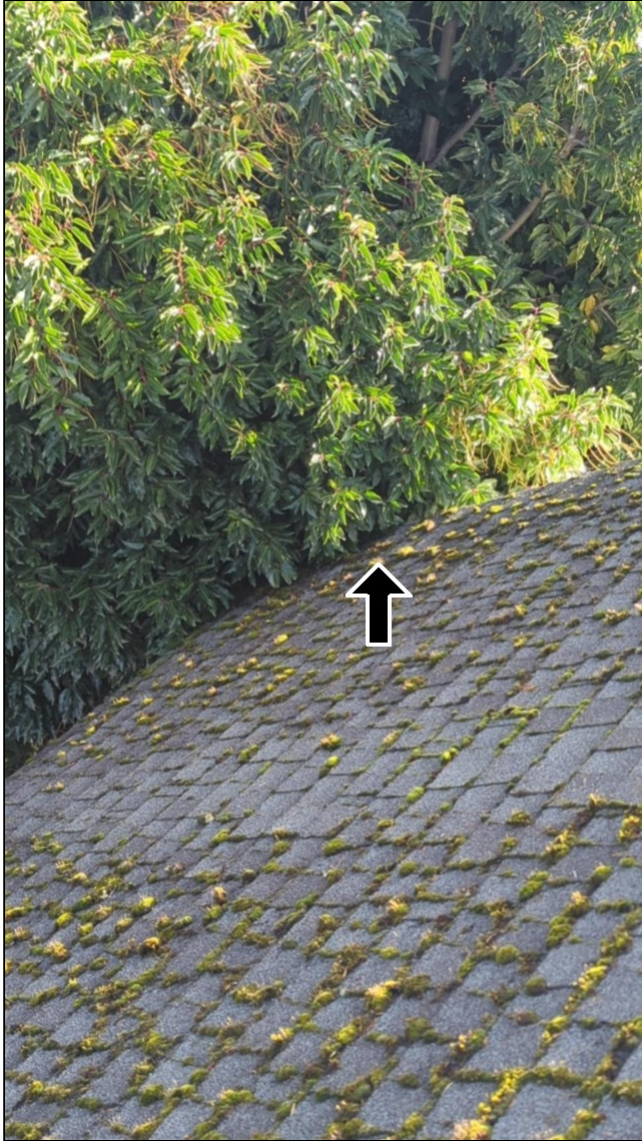
1.0 Item 8(Picture)

(3) The tree limbs that were in contact with roof or hanging near roof should be trimmed. The surface of the roofing may be damaged under the branches. This issue should be repaired by a licensed professional contractor.

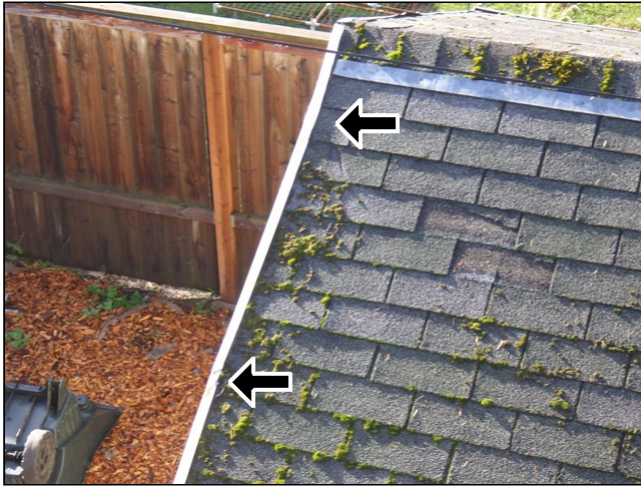
1.1 Item 1(Picture)

- 🔧 The edge metal is installed incorrectly and should be repaired and any damaged sheathing uncovered during repair should be repaired or replaced. The edge metal in this installation will allow water that is on the shingles to wick under the edge metal and access the wood sheathing. More information here: [Edge metal installation](#)

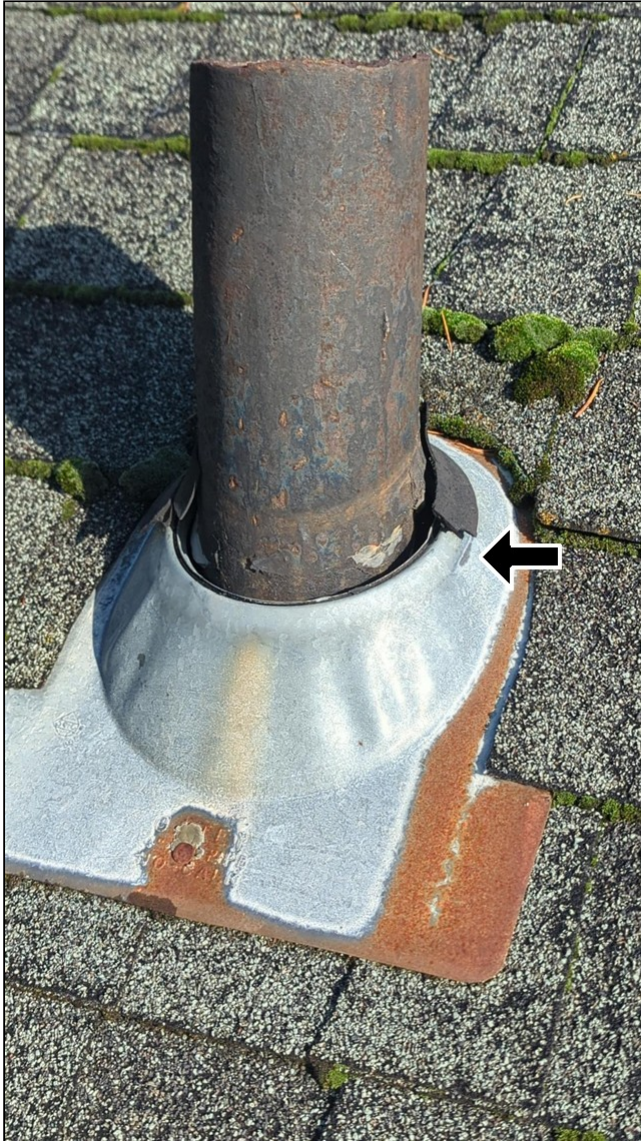
1.2 Item 1(Picture)

- 🔧 (1) The plumbing vent pipe flashing(s) need repair/replacement around the perimeter of pipe where boot flanges have failed. A qualified, licensed professional should examine and correct as necessary

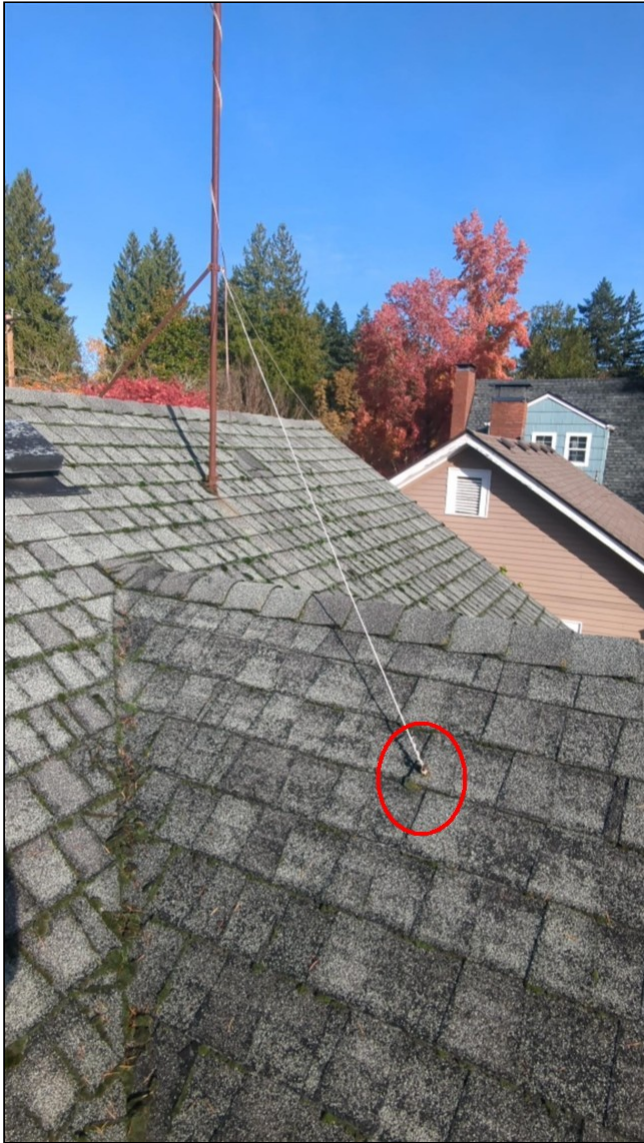
1.2 Item 3(Picture)

🔍 (2) The roof had penetrations with the installation of the dish/antennae. No current leakage could be noted however it is recommended that you monitor these penetrations and repair if damage or leakage is observed.

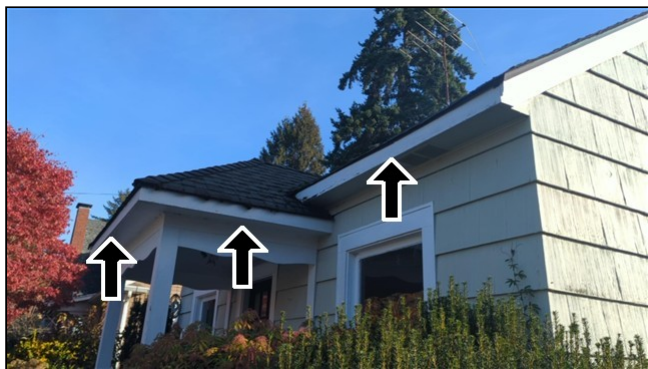
1.3 Item 1(Picture)

🔍 (1) The gutter were missing at the front and rear of the building. Missing gutters that allow storm water to splash near the foundation can cause moisture issues around the building and can lead to foundation

issues. A qualified contractor should inspect and repair as needed.

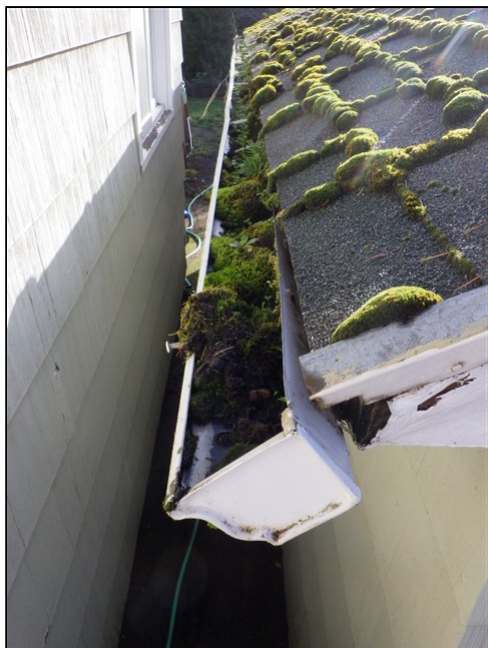
1.3 Item 2(Picture)

(2) The gutter were damaged at the garage. Loose or leaking gutters can cause deterioration of fascia, soffit or roof edge. It can also cause gutters to pull loose and lead to possible water intrusion. A qualified contractor should inspect and repair as needed.

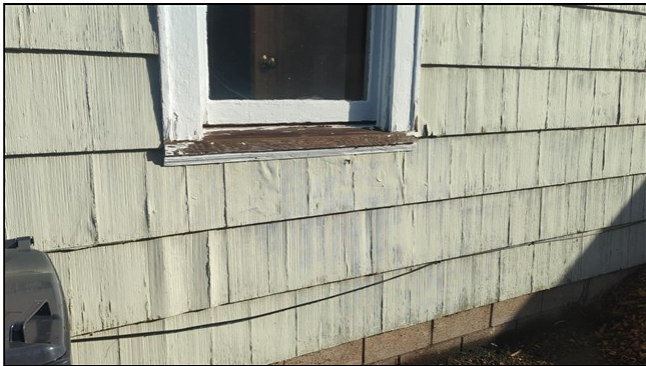
2.0 Item 1(Picture)

(1) The wood siding at the south side of of the building (refer to picture(s)) was deteriorated. Further deterioration can occur if not corrected. A qualified contractor should inspect and repair as needed.

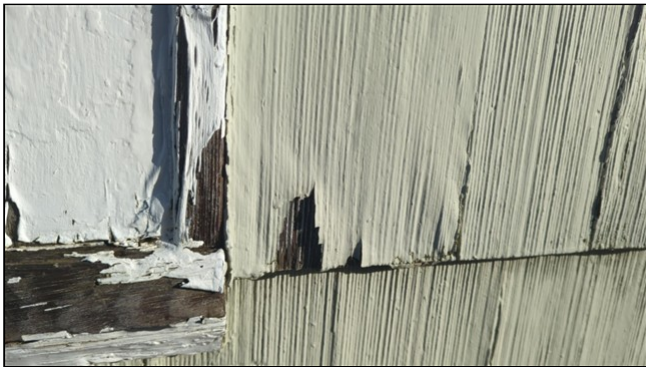
2.0 Item 3(Picture)

(2) Paint was worn on siding. The building should be properly prepped and painted to preserve the building envelope.

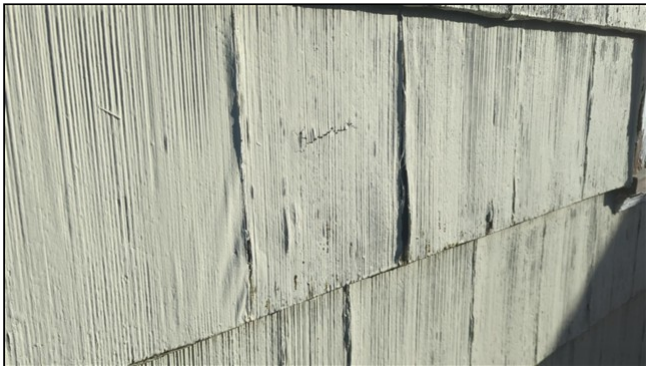
2.0 Item 4(Picture)

(3) The paint was peeling in areas. The building was built prior to 1978 and there is a chance of lead paint. If you are painting or planning on repairing areas and disturbing the paint you should consider having the building tested for lead or assuming the building has lead if you elect to not test. If the building has lead paint careful control of the dust and paint chips must be strictly attended. If the

building is to be rented, additional rules will apply for who can paint or conduct repairs.

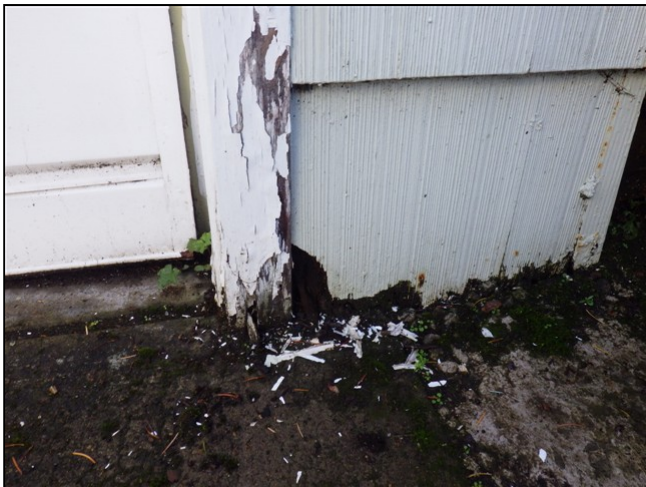
2.0 Item 5(Picture)

(4) The siding is deteriorated on bottom edge along the garage. Further deterioration can occur if not corrected. A qualified contractor should inspect and repair as needed.

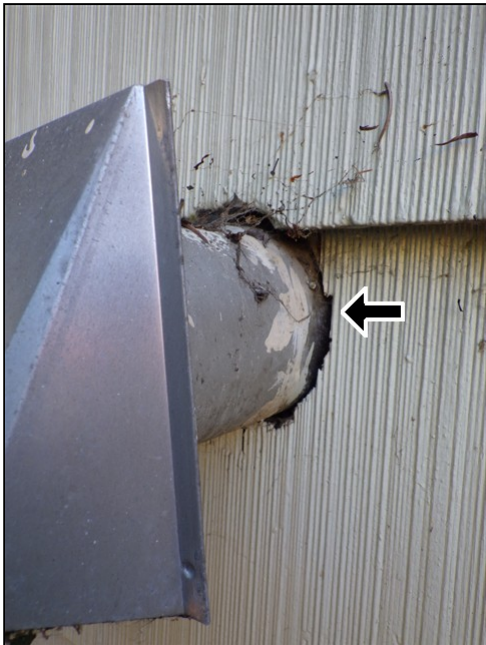
2.0 Item 10(Picture)

- (6) The hole(s) in siding need to be properly filled/caulked/painted at the north side of the building where the dryer duct penetrates the building envelope.

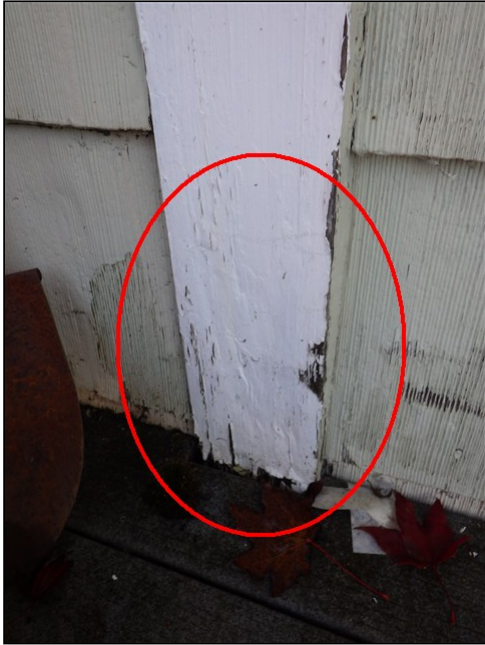
2.0 Item 11(Picture)

- 🔧 (7) The wood trim at the front of the building (refer to picture(s)) was deteriorated. Further deterioration can occur if not corrected. A qualified contractor should inspect and repair as needed.

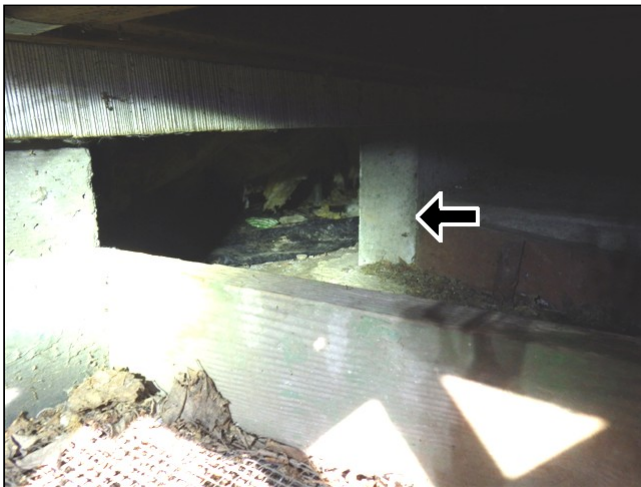
2.1 Item 1(Picture)

- 🔧 The access door to the crawlspace did not completely seal the opening, allowing pest entry. I recommend a licensed professional contractor repair as needed.

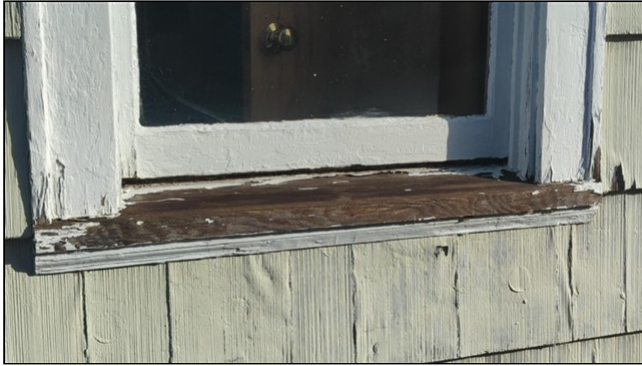
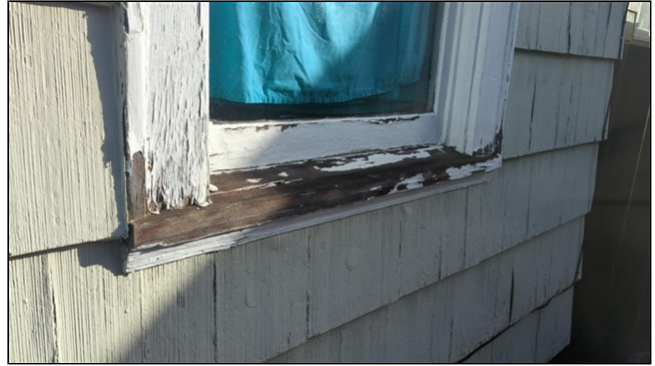
- 🔧 (1) The wood trim is peeling paint at most windows. Further deterioration may occur if not repaired. I recommend a qualified contractor inspect and repair as needed.

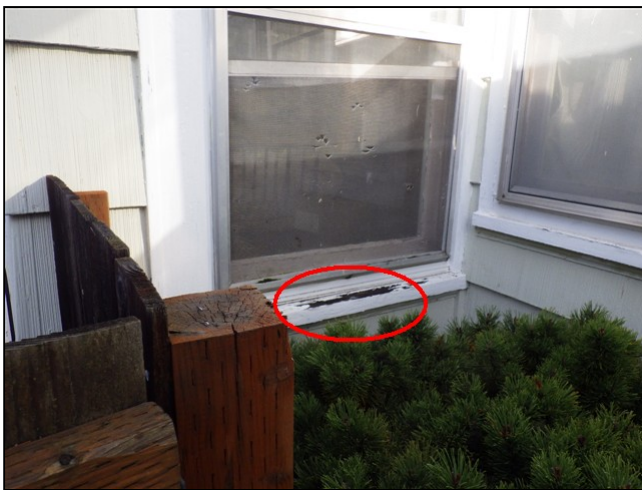
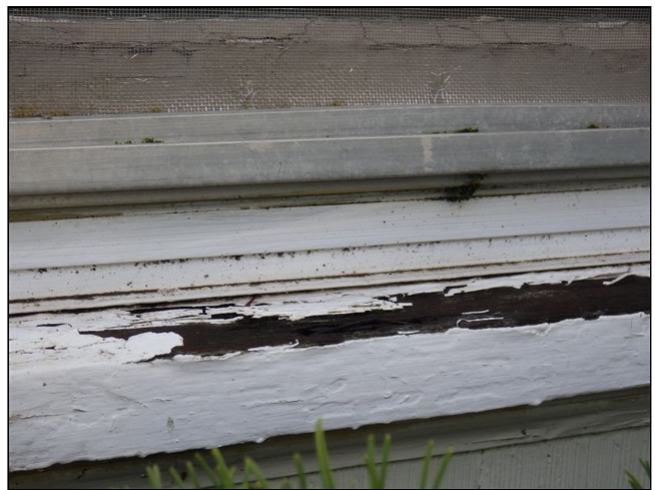
- 🔧 (2) The window sill was deteriorated at south side of the building. Further deterioration may occur if not repaired. A qualified contractor should inspect and repair as needed.

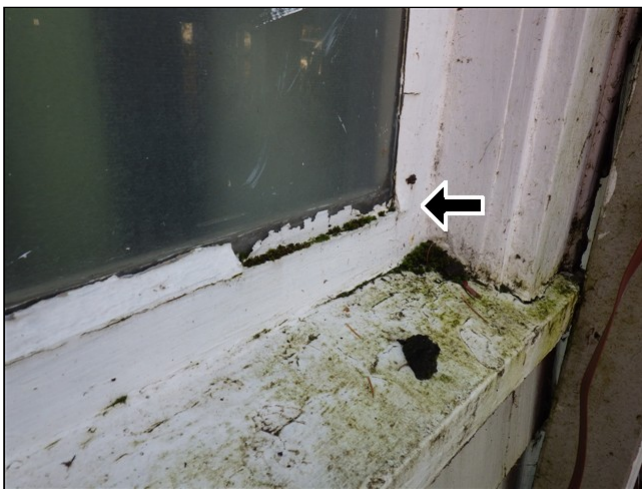
2.2 Item 5(Picture)

- 🔧 (3) The glazing putty that holds the glass in the sash is failing at some windows. A qualified person should repair and re-putty as necessary. This is a normal maintenance item.

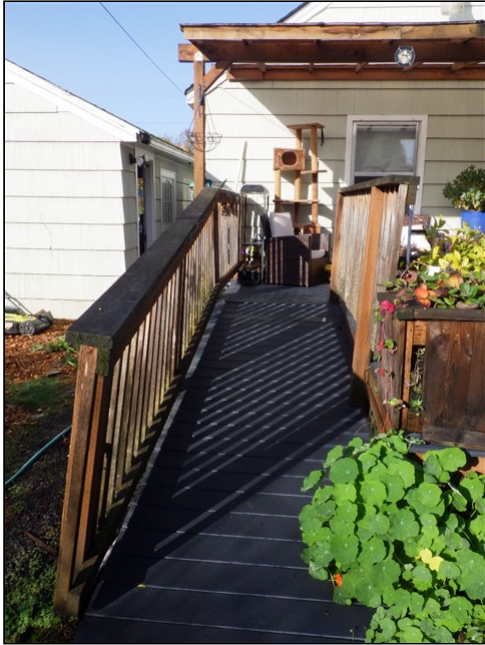
2.3 Item 1(Picture)

of lateral force and not deflect more than 1/4". A fall or injury could occur if not corrected. A qualified contractor should repair or replace as needed.

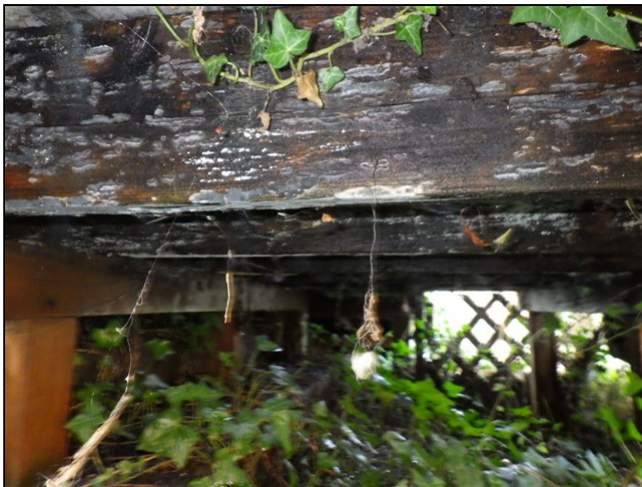
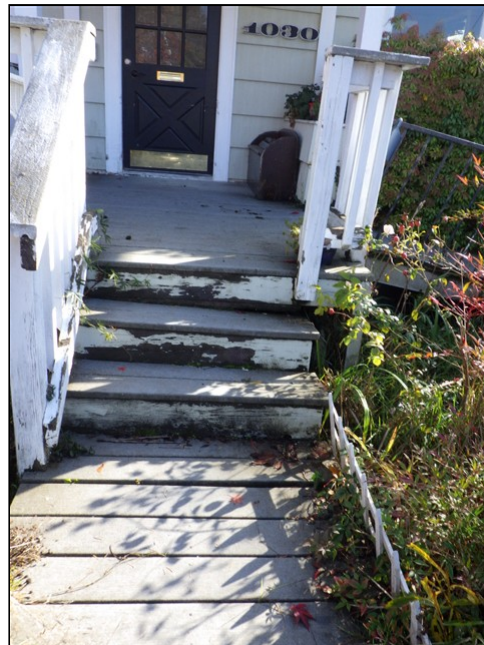
(2) The wood structure on the deck at the front of the building had some boards that were deteriorated. Further deterioration can occur if not repaired. A qualified contractor should repair or replace as needed.

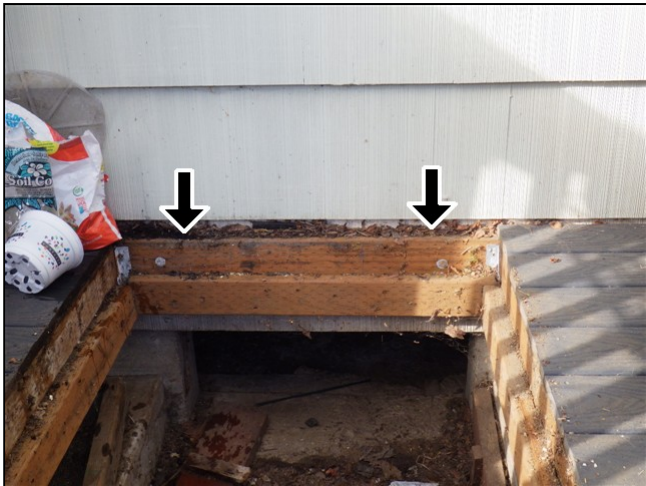
(3) The deck's ledger board at the rear of the building did not appear to have the proper flashing installed to prevent water from getting in between the home and the deck. This could lead to moisture issues against the home. I recommend monitor and repair if needed.

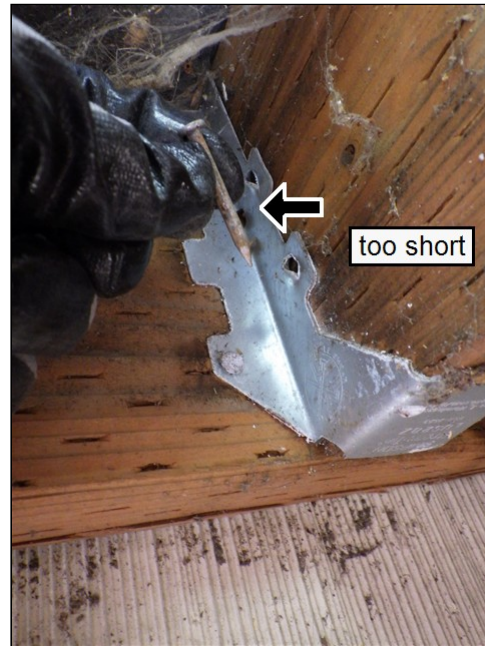
- 🔧 (4) The deck structure on the rear of the building were not installed properly. The joist hangers were missing fasteners and were using the wrong fasteners. A qualified contractor should repair or replace as needed.

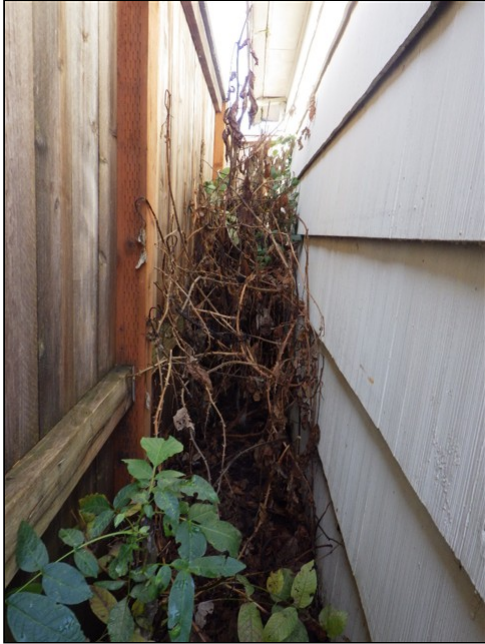
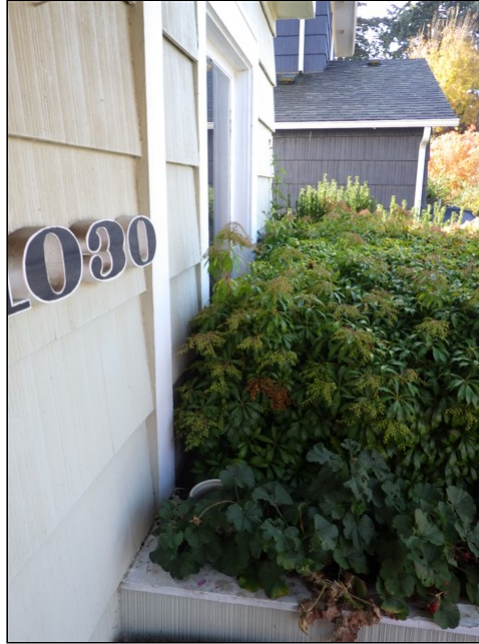
The plants should be trimmed or removed from contact with the buildings. Vegetation in contact with the home can mechanically open the paint, decrease ventilation and may lead to pest/insect issues. 18" of space should be actively maintained.

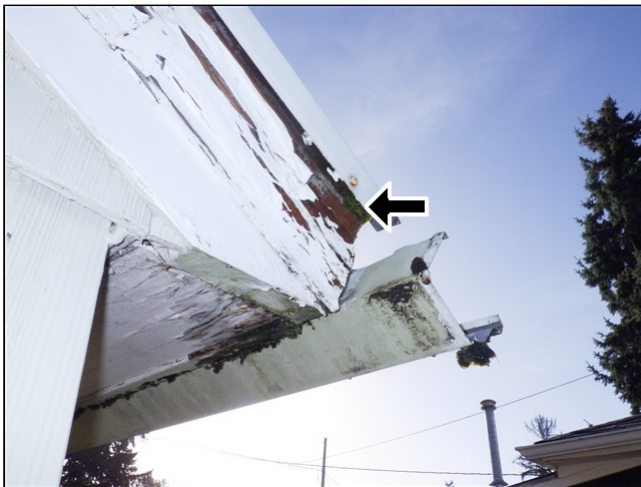
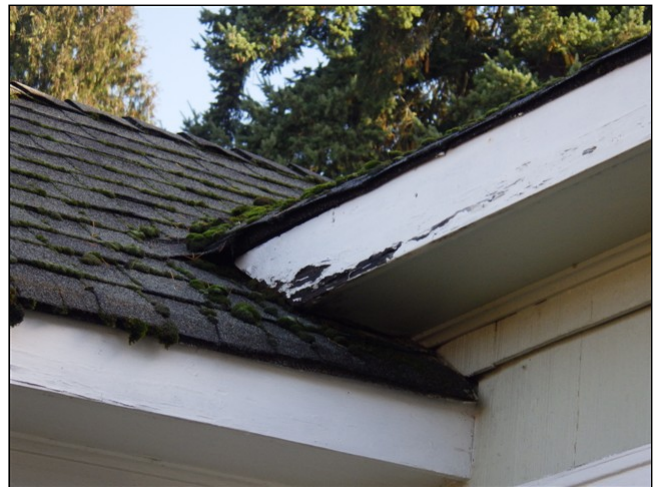
The paint on eave was failing. I recommend prep and paint at the exterior in areas.

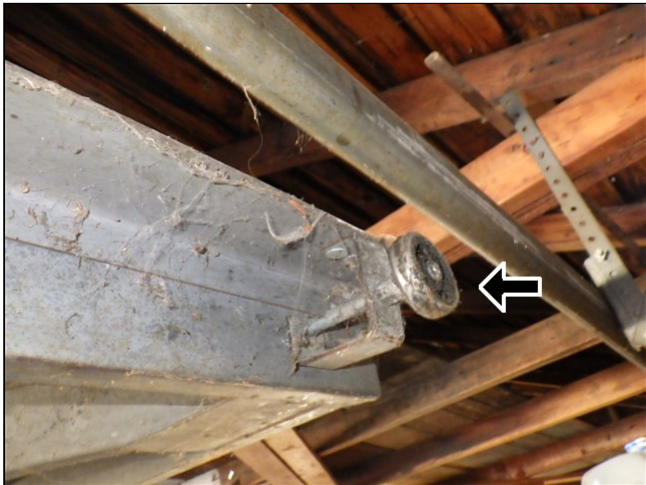
3.3 Item 1(Picture)

🔧 (1) The garage door does not operate properly and falls out of the track. This should be repaired/ replaced. A qualified contractor should inspect and repair as needed.

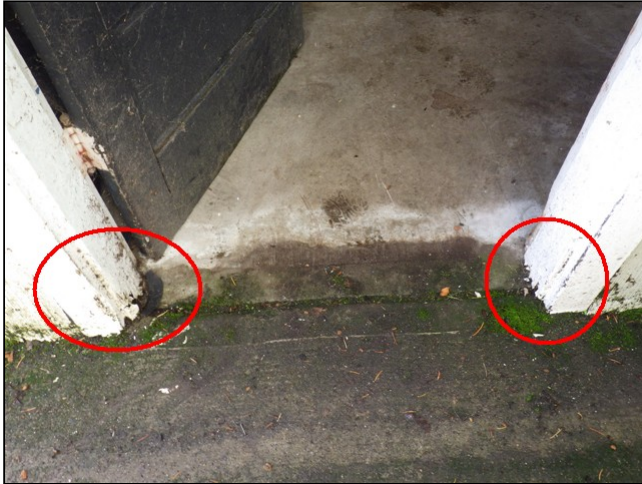
3.3 Item 2(Picture)

- 🔧 (2) The garage door at the side of the building shows deterioration on bottom of side jambs. This should be repaired. A qualified contractor should inspect and repair as needed.

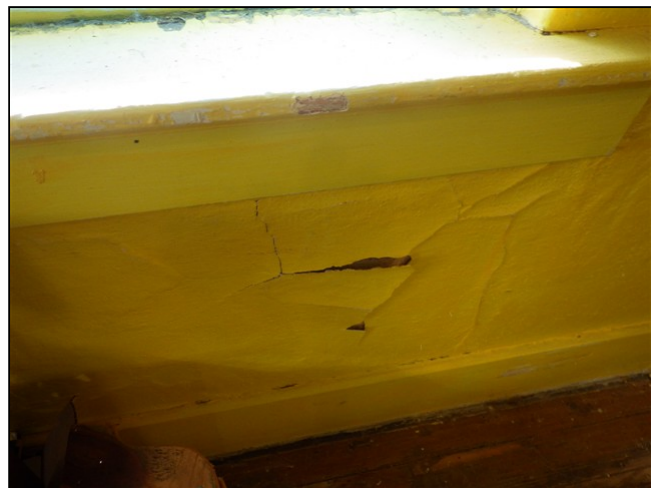
4.1 Item 1(Picture)

The plaster on the wall was damaged at the bedroom. While this damage is cosmetic, it needs to be repaired. A qualified contractor should inspect and repair as needed.

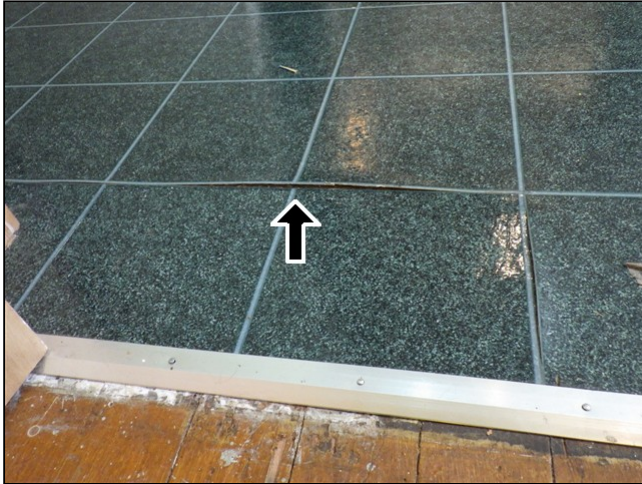
4.2 Item 1(Picture)

- 🔧 The vinyl reveals seam at the hall bath. Repairs are needed. A qualified contractor should inspect and repair as needed.

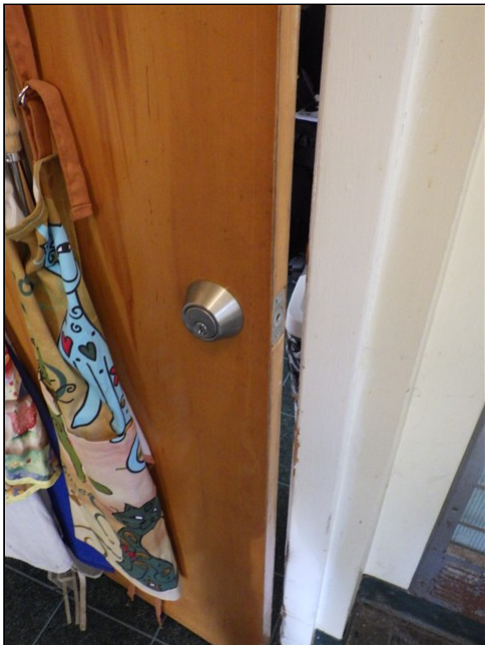
4.5 Item 1(Picture)

- 🔧 The entry door was missing knob hardware at the washer/dryer room. This should be repaired/replaced. A qualified contractor should inspect and repair as needed.

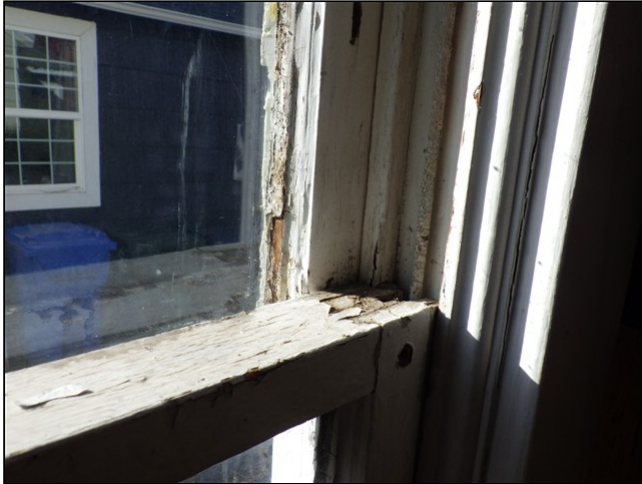
4.6 Item 1(Picture)

- 🔧 (1) The wood windows were stuck or painted shut throughout the building. This is a maintenance issue and is for your information. A qualified contractor should inspect and repair as needed.

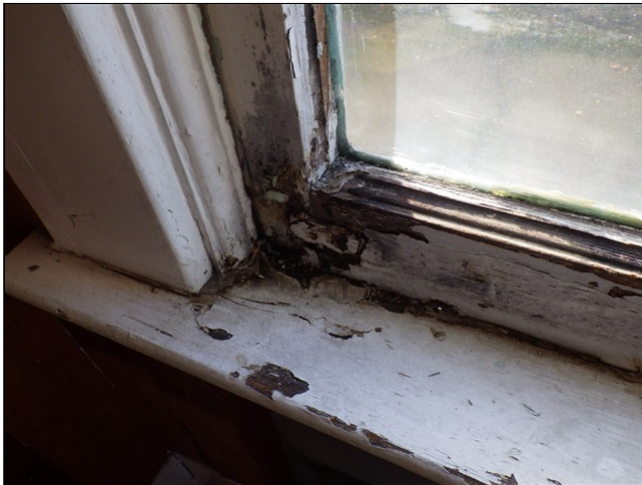
4.6 Item 2(Picture)

- 🏠 (2) The windows show evidence of high moisture levels and condensation issues. This is a common occurrence with tightly sealed window coverings in sleeping rooms and windows that are facing the weather. I recommend cleaning the windows periodically and opening the shades in the mornings to allow the moist areas to ventilate.

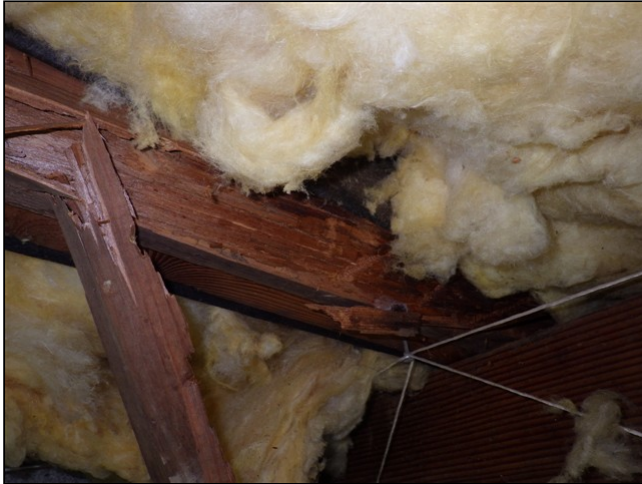
5.4 Item 1(Picture)

- 🔍 Floor joist(s) had some fungal deterioration under the living room. The damaged joist has been sistered  
🔧 and no additional repairs appear to be needed at this time.

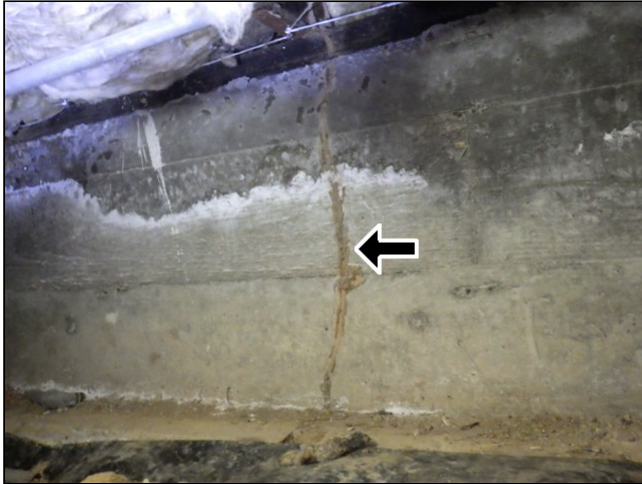
5.7 Item 1(Picture)

(2) Old historic signs of subterranean termites noted in the crawlspace. No significant, current, ongoing

🔧 indications of issues within the building however the building should be inspected every year as a matter a maintenance.

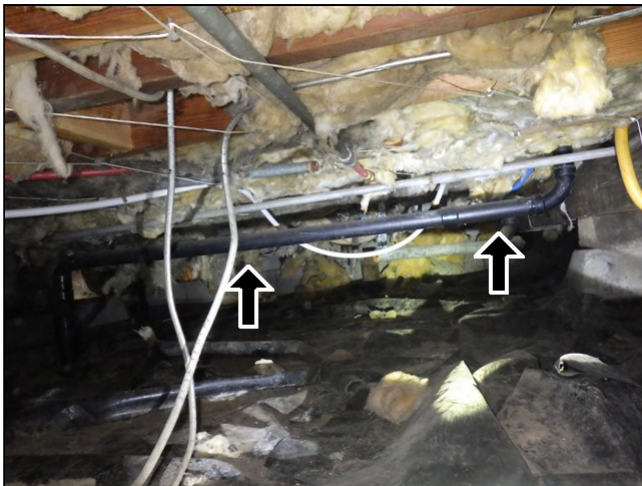
6.0 Item 2(Picture)

(3) The plumbing waste line was not properly supported in the crawlspace under the hall bath. Repairs are needed. I recommend a licensed plumber inspect further and repair as necessary.

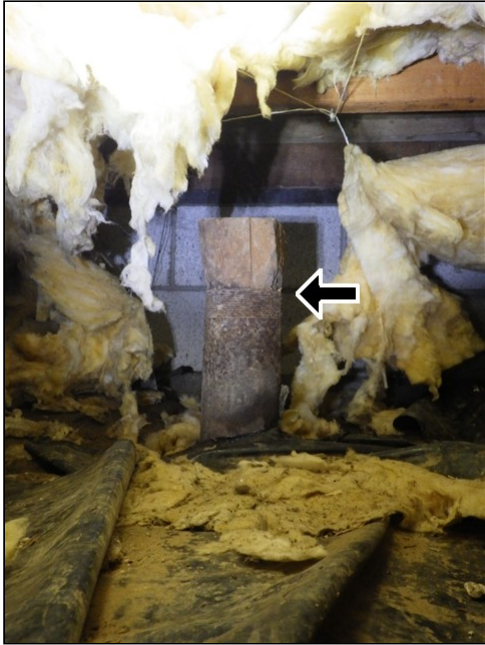
6.0 Item 3(Picture)

- 🔧 (4) The plumbing waste line appears to be an open pipe that has a wood plug in the crawlspace. Repairs are needed. I recommend a licensed plumber inspect further and repair as necessary.

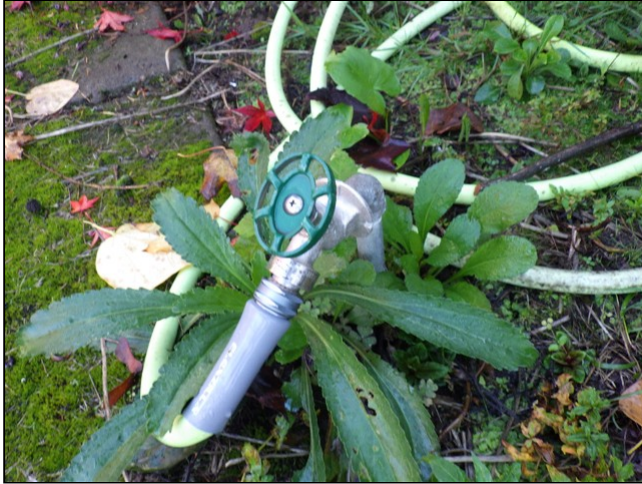
6.1 Item 2(Picture)

- 🔧 (2) The outside water faucets do not have vacuum-breakers (anti-siphon valves) installed at the front and rear. The valves prevent harmful liquids from entering your water system and should be installed to improve the safety of the building. A qualified licensed plumber should repair or correct as needed.

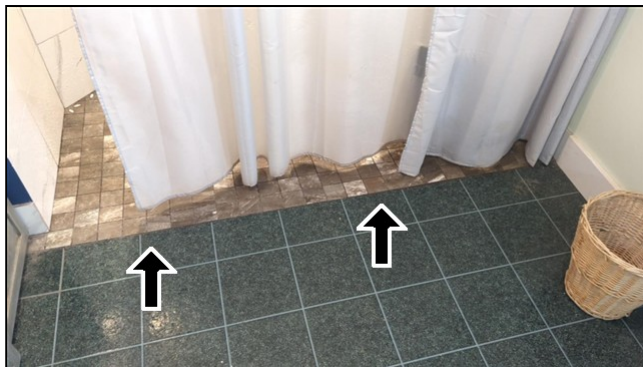
6.1 Item 5(Picture)

- 🔍 (5) The shower pan was a "curbless shower." This type of pan offers great access without a curb to potentially trip over however you should be aware that the waterproof membrane, under the tiles usually comes to the edge of the pan. You should be careful to avoid excess water outside to shower threshold to avoid damage to the wood frame in the flooring system.

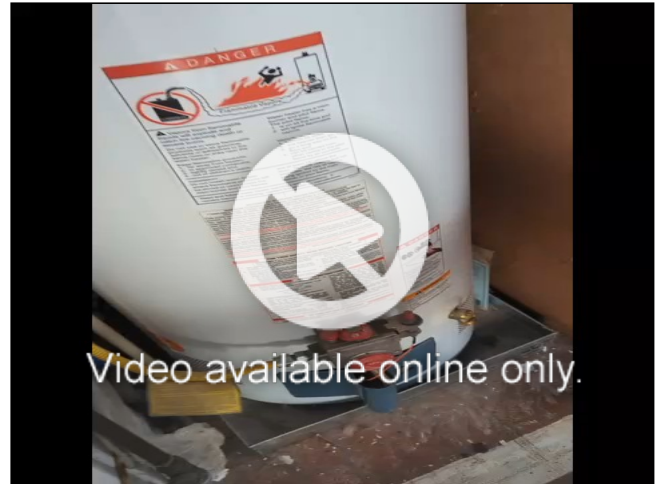
- 🔧 (1) The water heater bubbled and popped while heating. This suggests a sediment build-up at the bottom. I recommend a licensed plumber inspect further and repair as necessary.

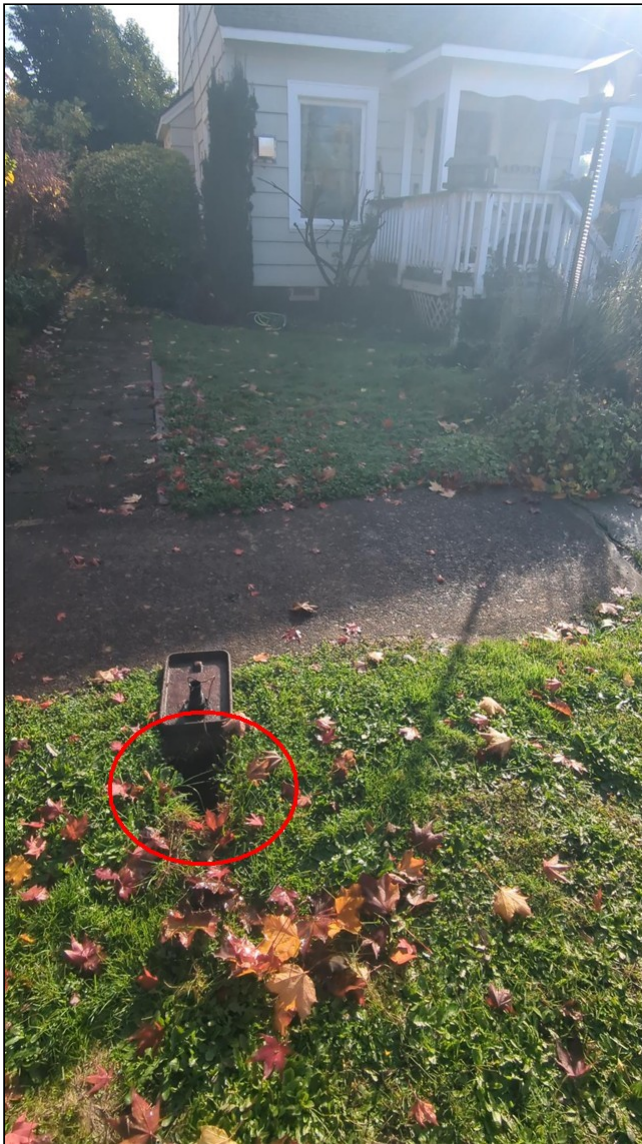
6.3 Item 1(Picture)

The main shut off was located outside in the ground.

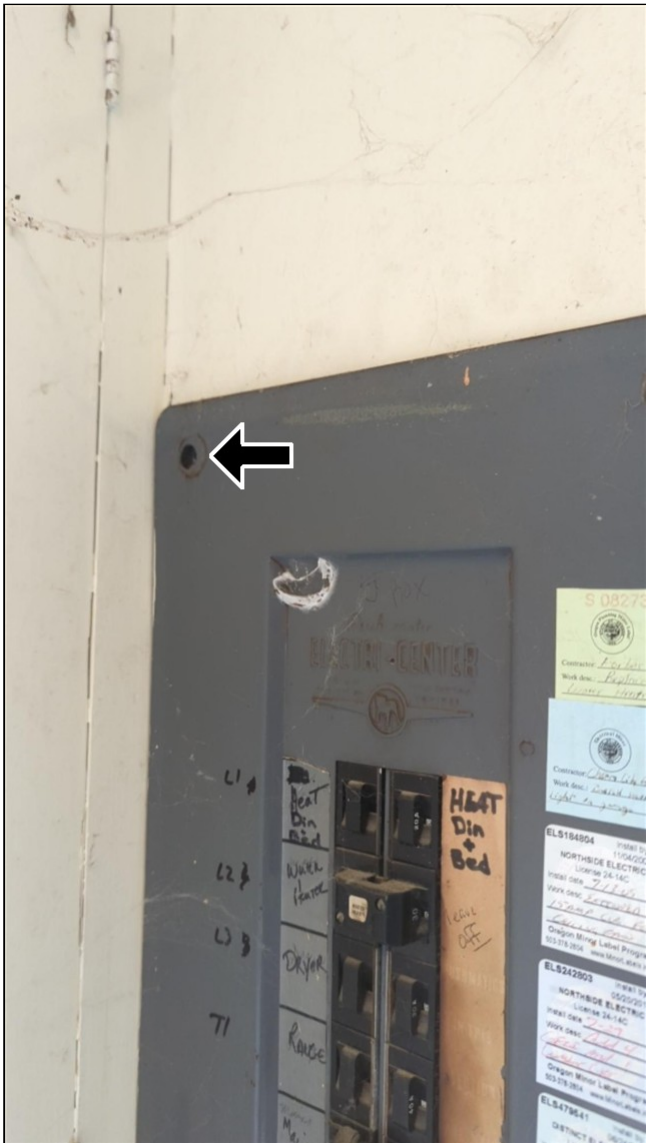
7.1 Item 1(Picture)

(1) Screw(s) missing from the sub panel/splice box cover. All of the screws should be installed for the cover to function properly in an emergency over-current situation. The screw(s) should be replaced with a proper screw designed for this panel.

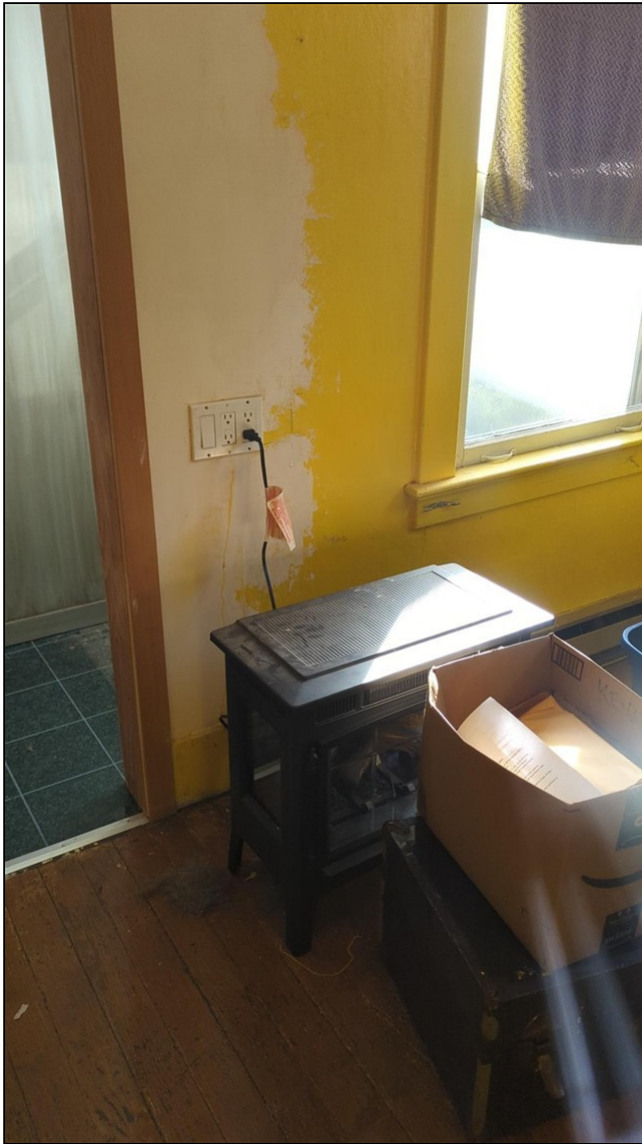
7.3 Item 1(Picture)

- 🔧 (1) The "three-prong" outlets were not grounded throughout the building and garage. Electrical issues are considered a hazard until repaired. A qualified licensed electrician should correct as needed.

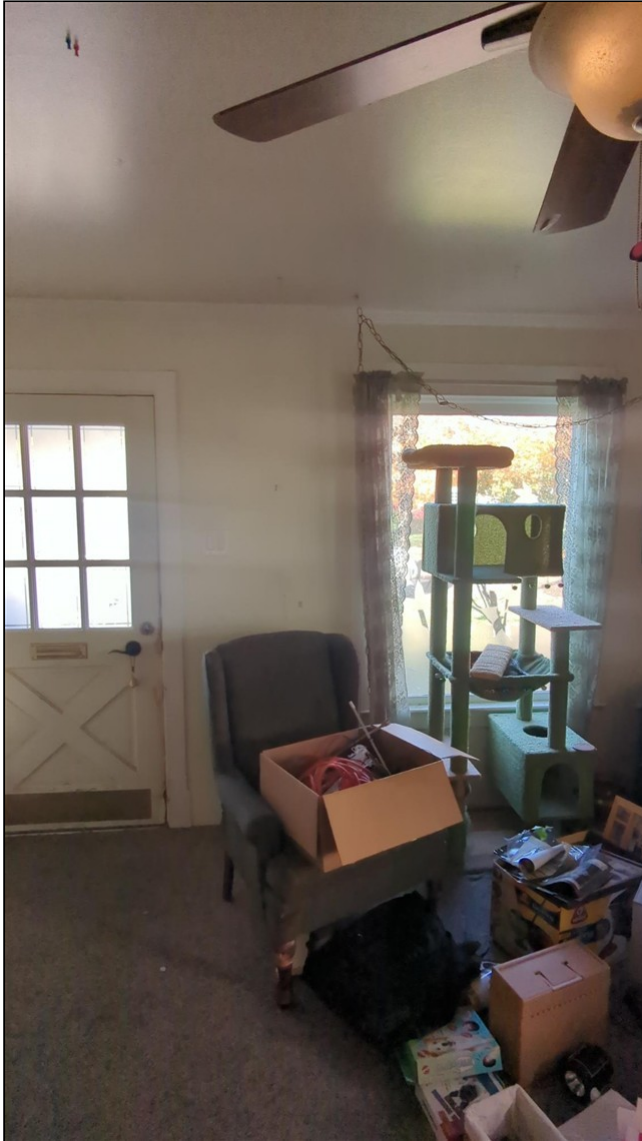
7.3 Item 3(Picture)

- 🔧 (2) The wall switch was missing at the living room. A light source should be able to be controlled when entering a room. A qualified licensed electrician should perform repairs that involve wiring.

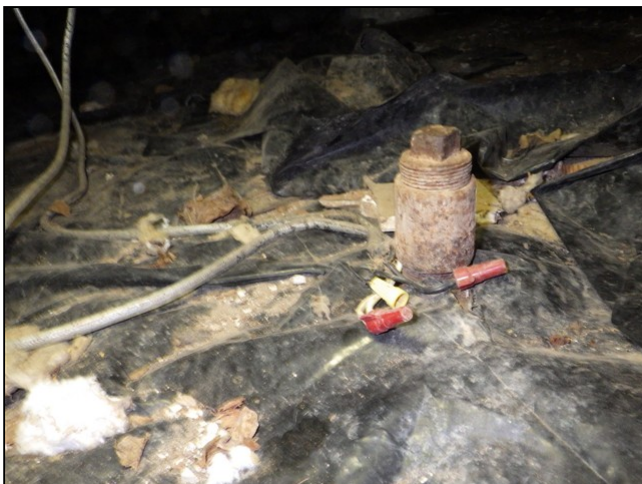
7.3 Item 4(Picture)

- 🔧 (3) Improperly secured wiring splice in the crawlspace. This is for your information. I recommend repair as needed.

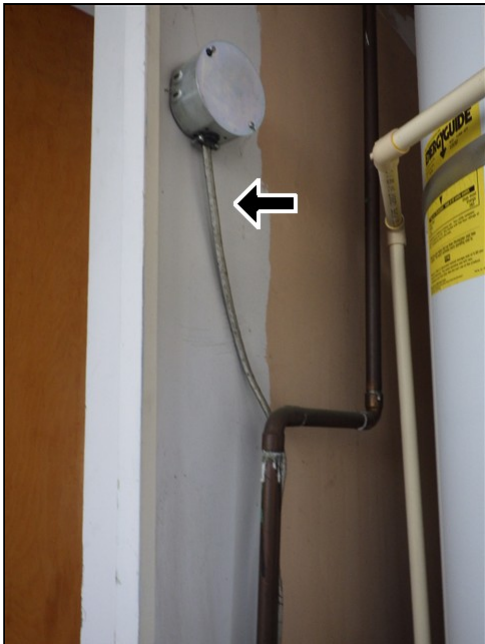
7.3 Item 6(Picture)

- 🔧 (5) Exposed wiring on wall near the water heater. This is a safety issue that needs to be corrected. A qualified licensed electrician should perform repairs that involve wiring.

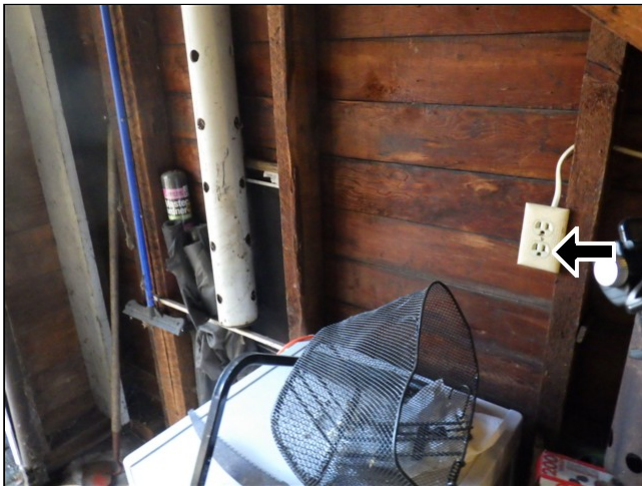
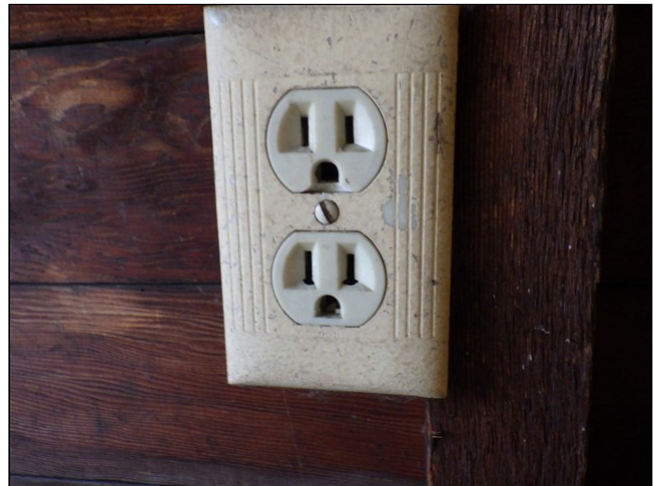
- 🔧 (1) The outlet at the garage was clogged. Electrical issues are considered a hazard until repaired. A qualified licensed electrician should perform repairs that involve wiring.

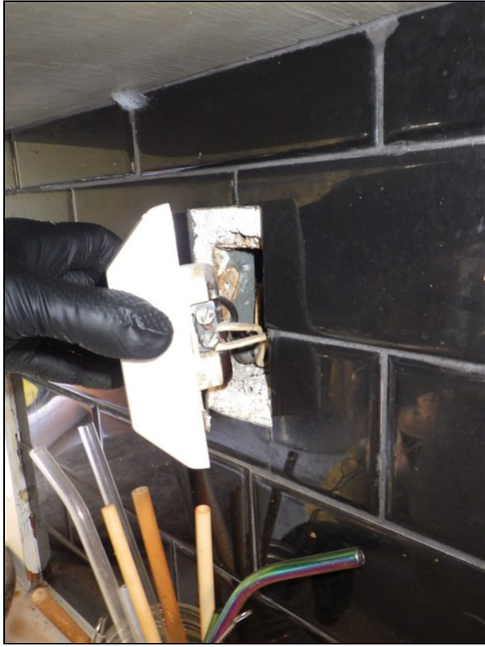
7.4 Item 3(Picture)

- 🔧 (2) The outlet at the kitchen (right of sink) was loose in the wall. Electrical issues are considered a hazard until repaired. A qualified licensed electrician should perform repairs that involve wiring.

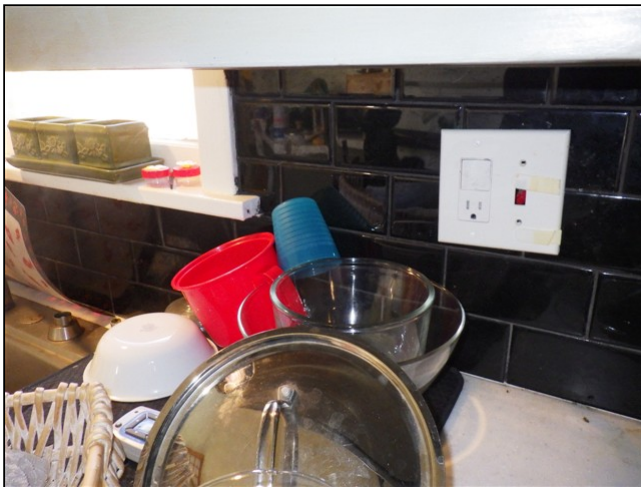
7.5 Item 1(Picture)

- 🔧 The addition of GFCI's to the building in the exterior, garage and kitchen would be a wise modern safety update.

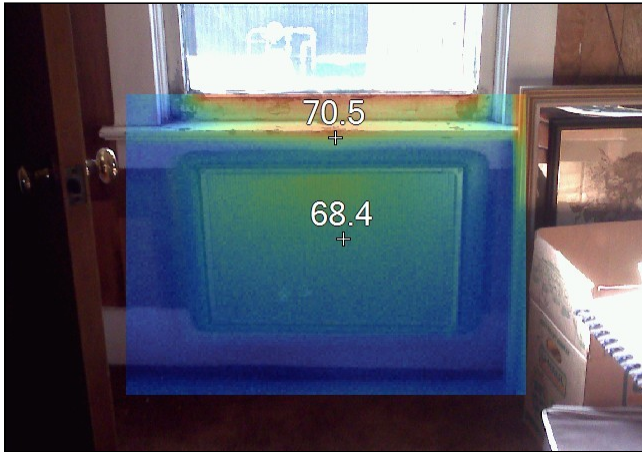
8.0 Item 2(Picture)

- 🔧 (4) The wall mounted heater did not operate when tested in the front corner bedroom. I recommend repair as needed.

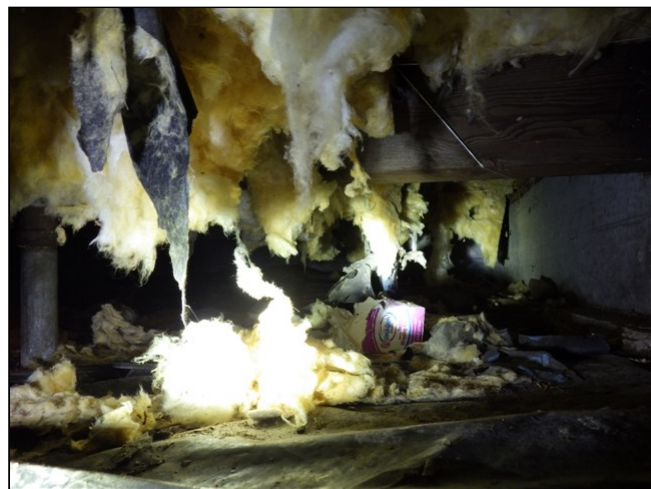
9.1 Item 1(Picture)

The insulation was deteriorated in areas in the crawlspace. Heat loss can occur more on this building than one that is properly insulated. A qualified contractor should inspect and repair as needed.

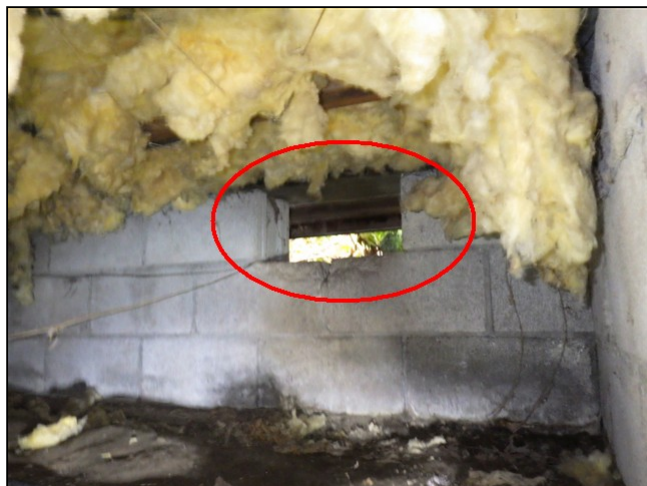
9.3 Item 4(Picture)

- (2) The foundation has a hole large enough for pests at the right side (facing front from the inside). Exclusion of pests is the best way to prevent issues. A qualified contractor should inspect and repair as needed.
