# Perfection<sup>✓</sup> Inspection, Inc

**Property Address:**  
1030 21st St NE  
Salem OR 97301

**11/7/2025**

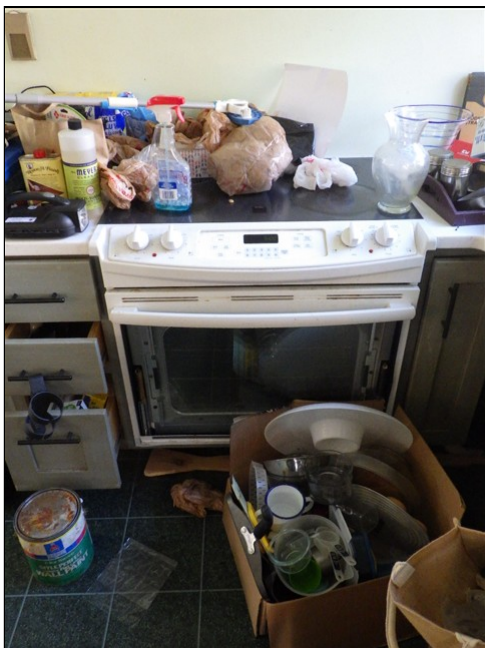
10.2 Item 1(Picture)

The oven door for oven was missing the front trim and glass. I recommend repair as needed.

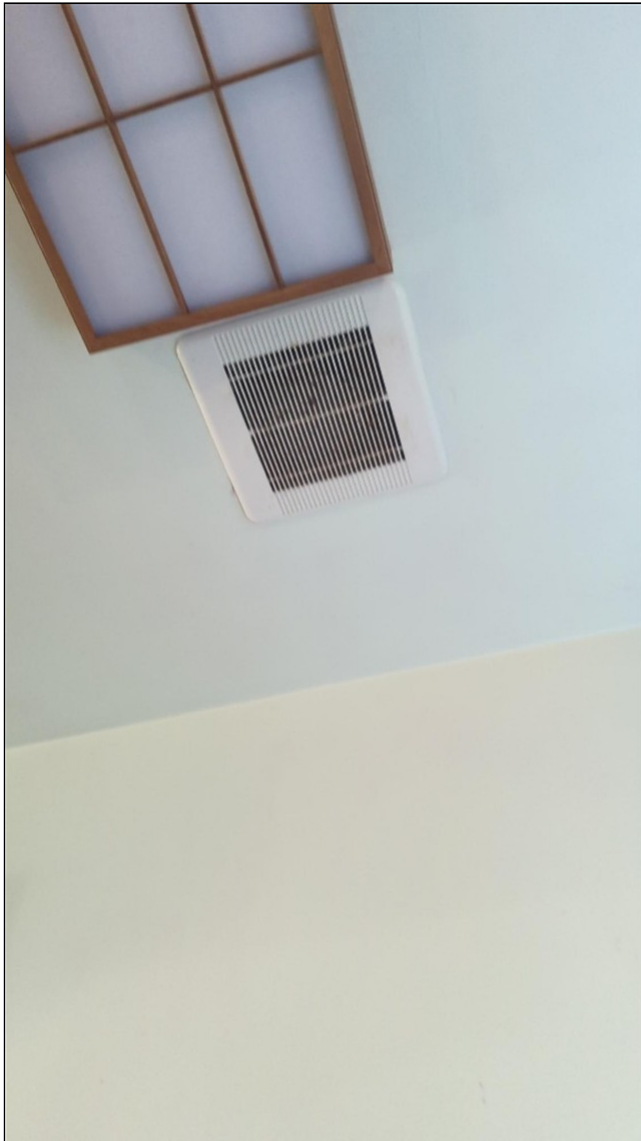
10.3 Item 1(Picture)

The ceiling mounted fan was an exhaust fan designed for bathrooms and moist air not necessarily designed to handle grease. I recommend repair or replace as needed.
