# Perfection Inspection, Inc

**Property Address:  
4504 Century Dr S  
Salem OR 97302**

**1/28/2026**

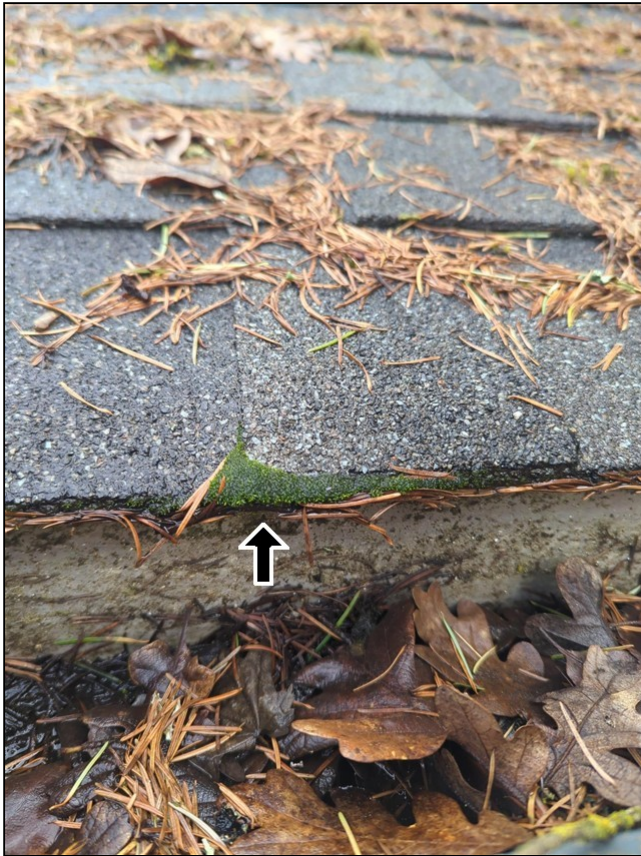
1.0 Item 1(Picture)

(1) Moss noted on the shaded sections of the roof. Moss is best treated chemically annually with as little disturbance to the shingles as possible.

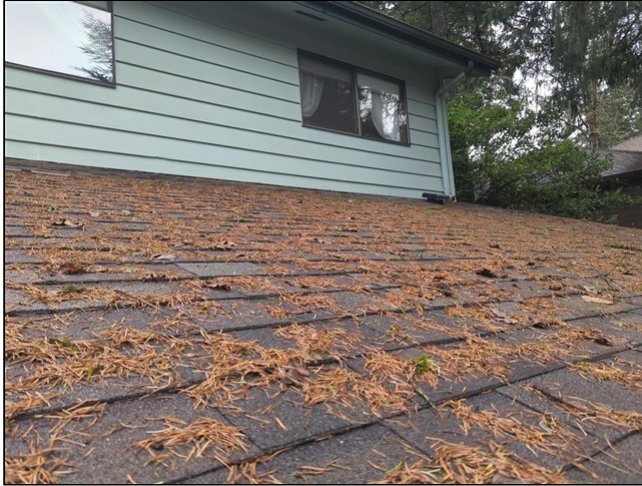
1.0 Item 3(Picture)

(2) The debris that was on the roof should be removed. The debris can cause damage if left in place and shorten the roof's life. No comment can be offered on the condition of the roofing under the debris. A qualified, person should carefully remove debris as necessary.

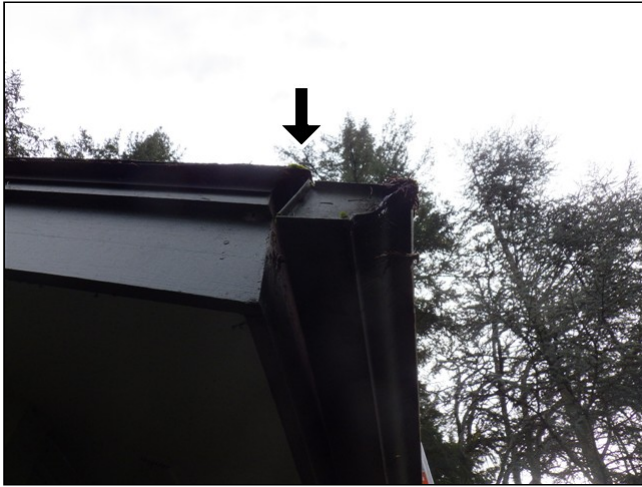
1.3 Item 1(Picture)

- 🔧 (1) The gutters were loose at the front right corners (facing forward from the inside) of the building and garage. Loose or leaking gutters can cause deterioration of fascia, soffit or roof edge. It can also cause gutters to pull loose and lead to possible water intrusion. A qualified contractor should inspect and repair as needed.

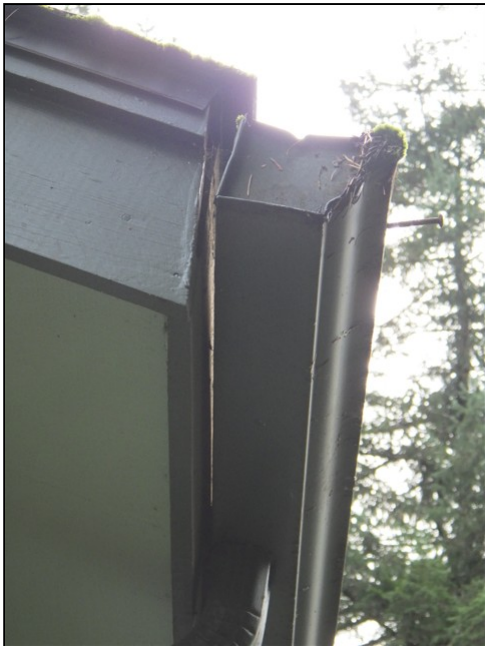
1.3 Item 3(Picture)

(2) The gutters had debris in areas and need to be cleaned. This is a maintenance issue and is important to prevent storm water issues around the building.

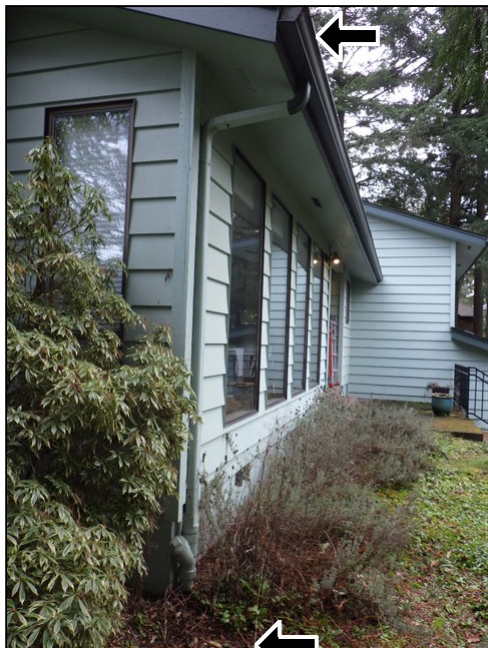
1.3 Item 6(Picture)

- (4) The gutter appeared to overflow at the front right corner (facing forward from the inside) of the building. Gutters that dump storm water near the foundation can cause moisture issues around the building and can lead to foundation issues. A qualified contractor should inspect and repair as needed.

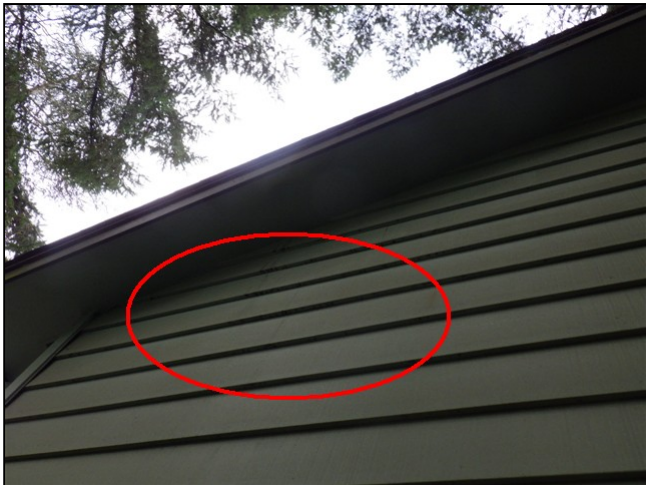
2.0 Item 3(Picture)

(2) Stains could be observed on the south wall of the building. These stains may be related to a previous issue as current leakage could not be observed. This area should be further investigated or at least closely monitored and repaired if continued leakage can be observed.

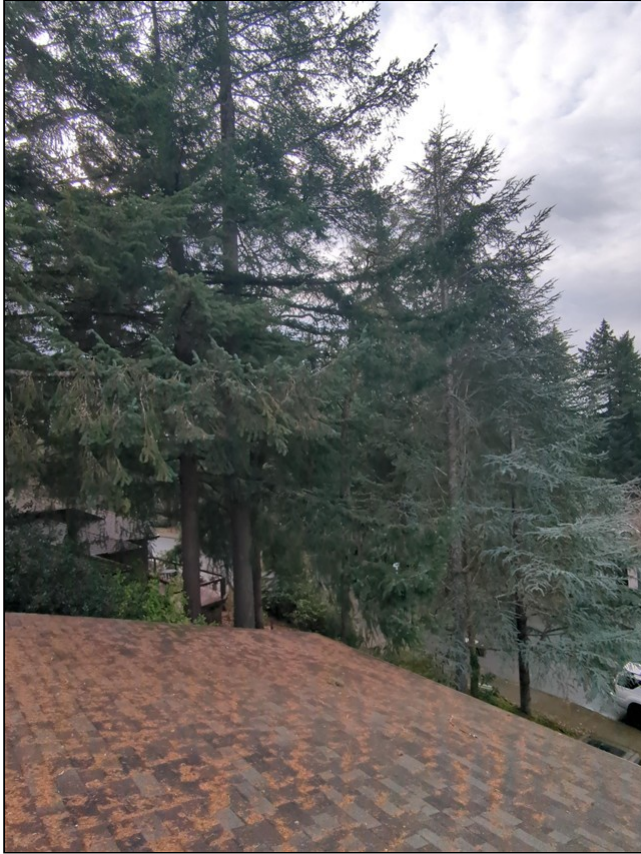
2.4 Item 1(Picture)

(1) Large trees were close to the building. Most home owners insurance companies expect you to employ a licensed tree service at least every three years. You should strongly consider routine trimming/removal by a licensed professional arborist.

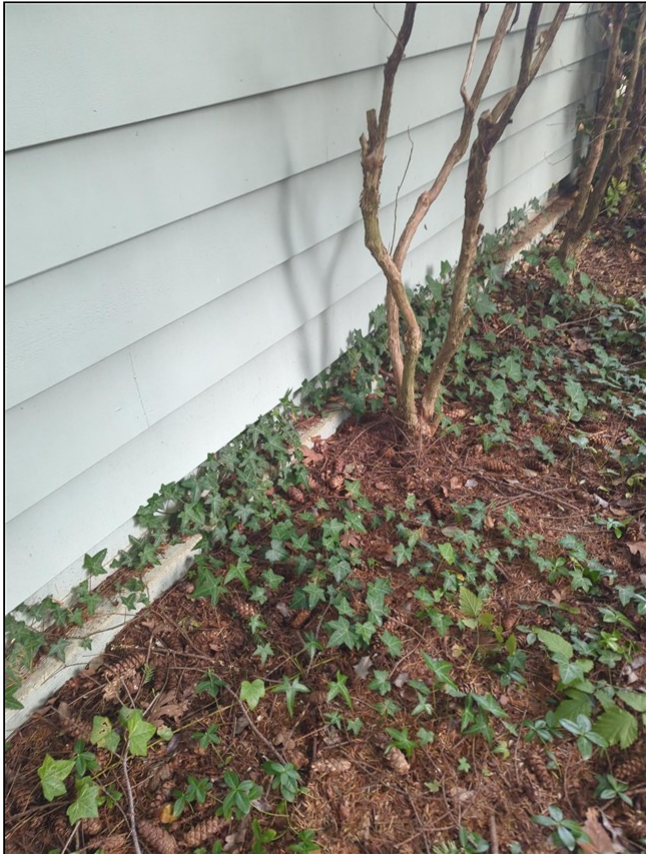
2.4 Item 3(Picture)

(2) The plants should be trimmed or removed from contact with the building. Vegetation in contact with the home can mechanically open the paint, decrease ventilation and may lead to pest/insect issues. 18" of space should be actively maintained.

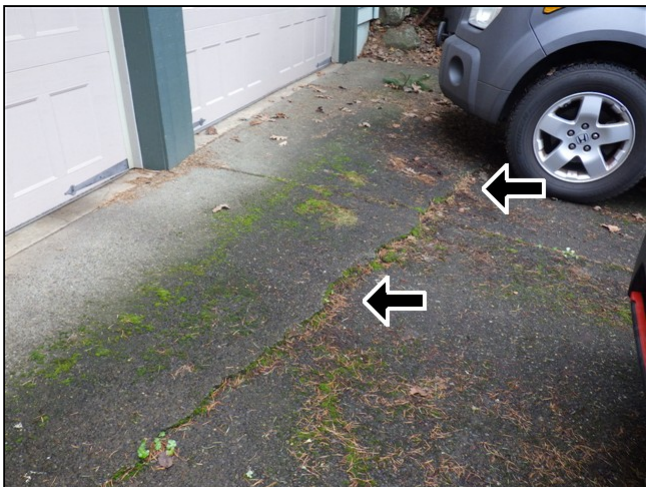
2.4 Item 5(Picture)

(3) The concrete drive at the front of the building was uneven, and could be a tripping hazard. A fall or injury can occur if not corrected. A qualified contractor should inspect and repair as needed.

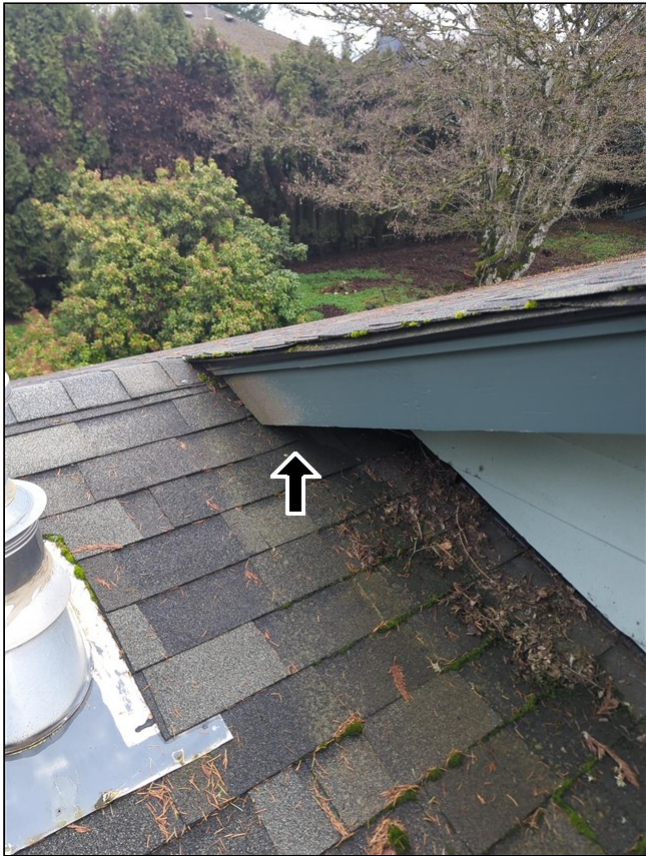
2.5 Item 1(Picture)

(1) A gap between the fascia and roof sheathing exists which may allow vermin to nest in the eave and possibly enter the attic. A licensed professional contractor should seal these openings as necessary.

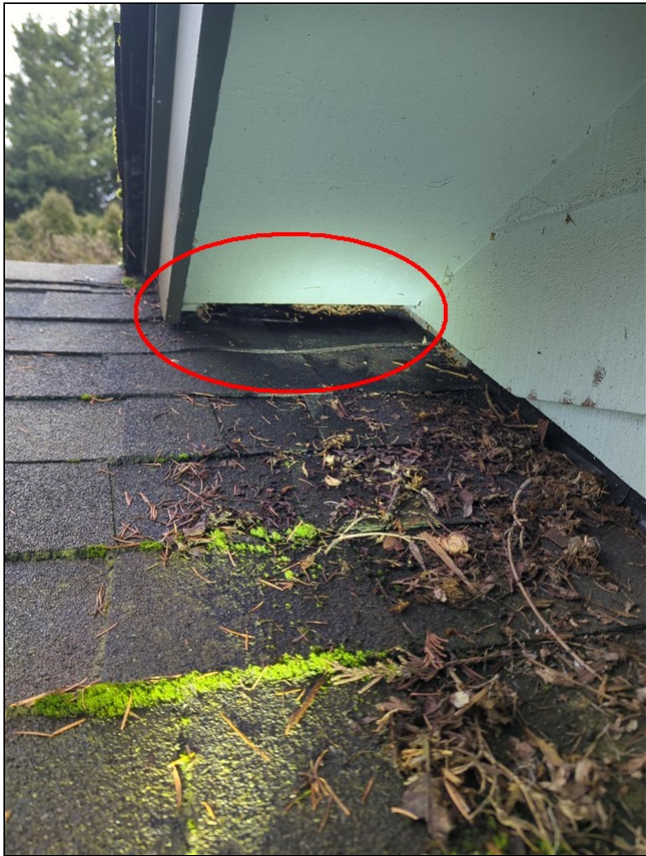
2.5 Item 2(Picture)

(2) The fascia (behind gutter) at eave on the front and rear shows moisture leakage. This indicates storm water is getting behind the gutter and should be repaired as necessary. A qualified contractor should inspect and repair as needed.

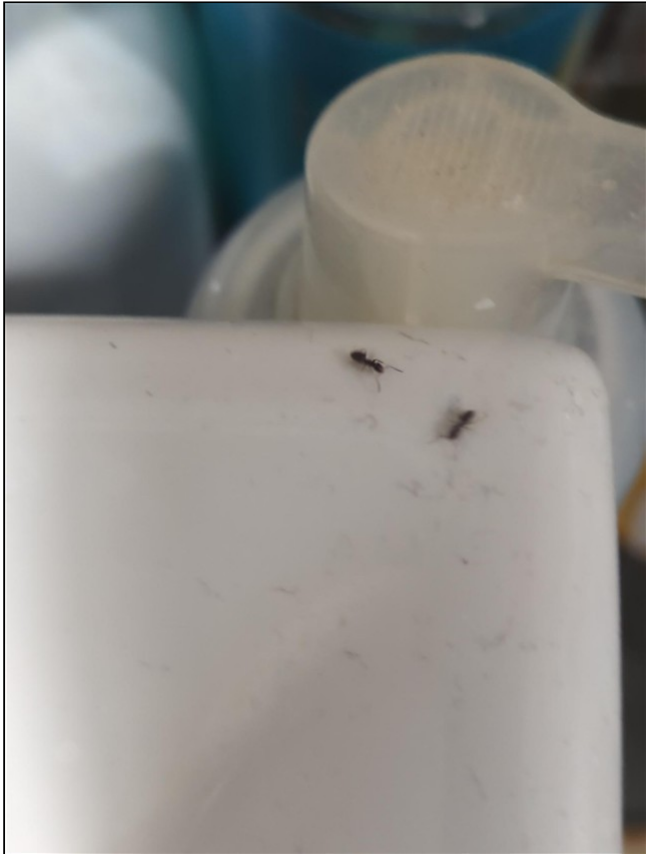
2.6 Item 1(Picture)

- (1) Odiferous house ants noted in various areas. These ants are common household pests and are not structurally significant. However they should be controlled. A licensed professional pest control operator should treat the building as necessary.

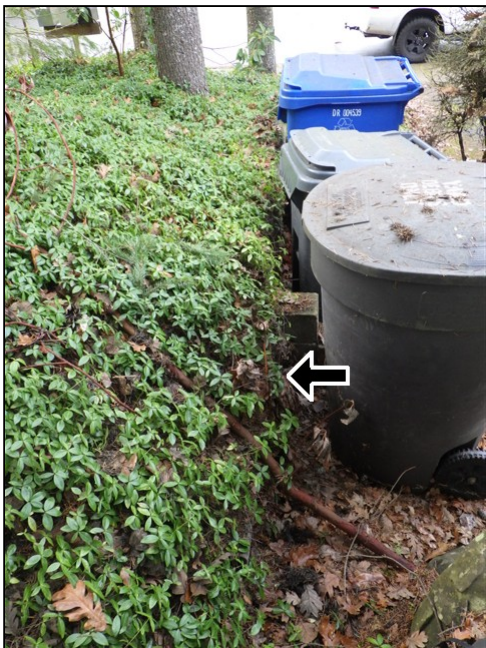
2.6 Item 2(Picture)

- (2) The wood ties at the front of the building may provide a conducive environment for wood destroying organisms as the treatment leaches in to the soil. You should consider removing the ties.

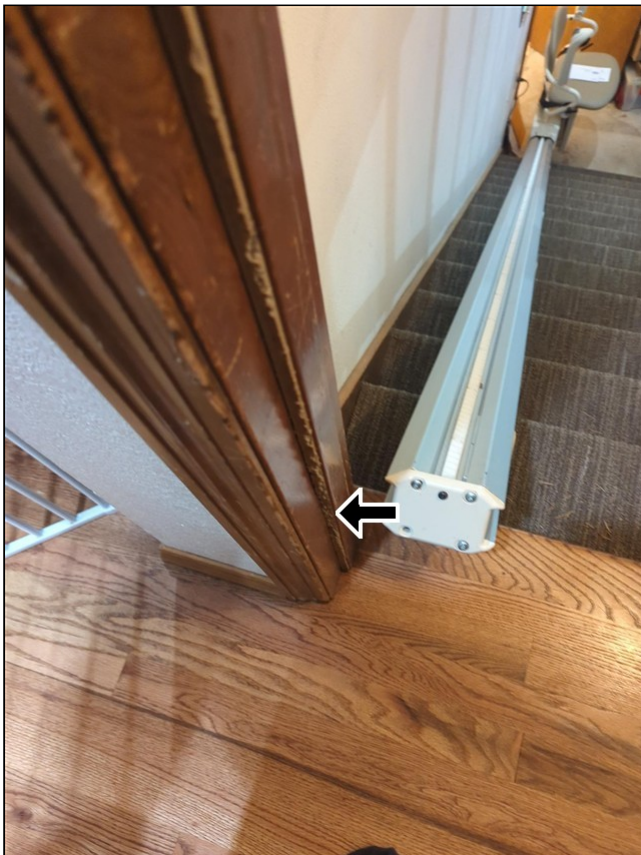
3.4 Item 1(Picture)

- 🔧 (1) The door between the home and the garage should have new weather stripping installed.

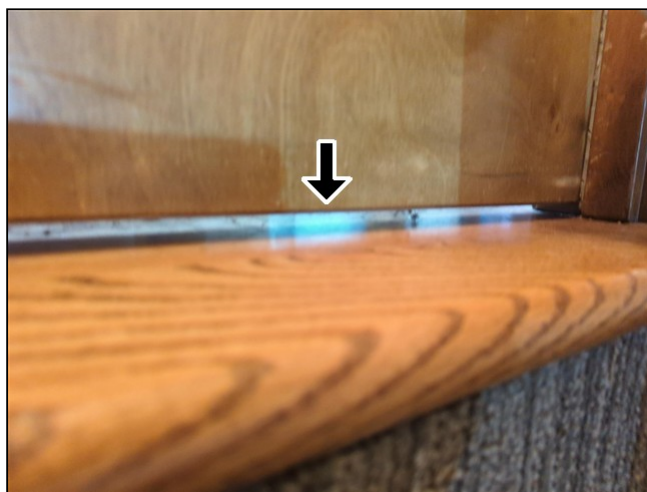
3.4 Item 2(Picture)

- 🔧 (2) The door between the home and the garage should have an air tight threshold/door sweep installed.

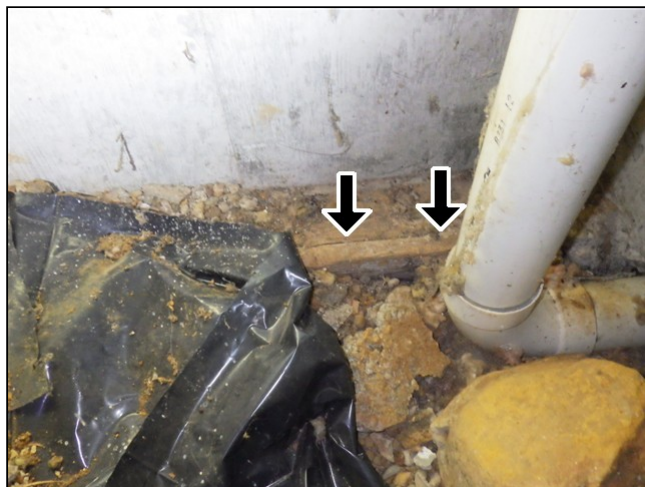
5.0 Item 1(Picture)

- 🔧 The wood/cellulose construction debris should be removed from the crawlspace. The excess wood that is under the building can be an excellent home base for wood destroying organisms, allowing them to multiply. When the wood runs out or the wood destroying organisms start looking for more they may look to your building. In general all pieces large enough to be caught in a garden rake should be removed.

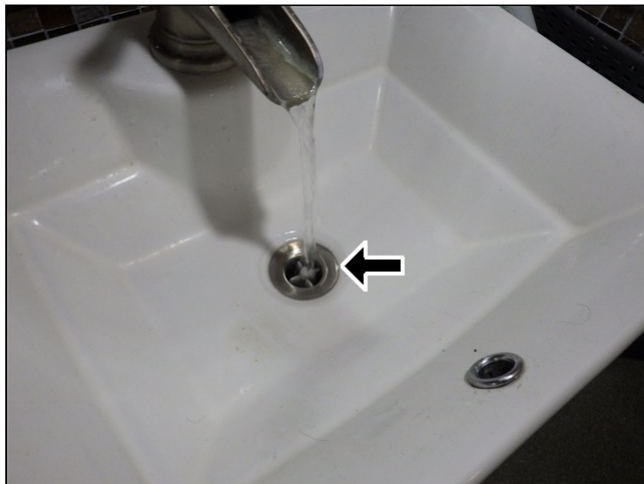
6.0 Item 1(Picture)

- 🔧 (1) You should strongly consider having the sewer line scoped. Issues with the main underground waste line can be common and the repairs can be costly. The main under ground soil pipe could not be viewed and was not inspected.
- 🔧 (2) The stop-valve does not work properly at the master bath sink (right sink). Repairs are needed. A qualified licensed plumber should repair or correct as needed.

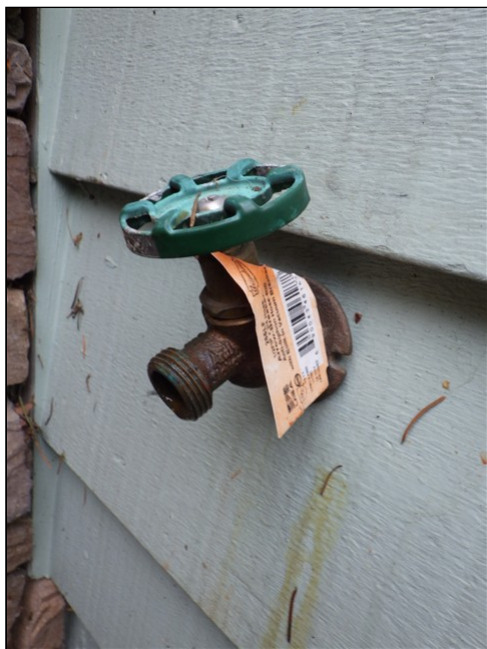
6.1 Item 1(Picture)

- 🔧 (1) The outside water faucet threads were stripped at the front of the building. Repairs are needed. I recommend a licensed plumber inspect further and repair as necessary.

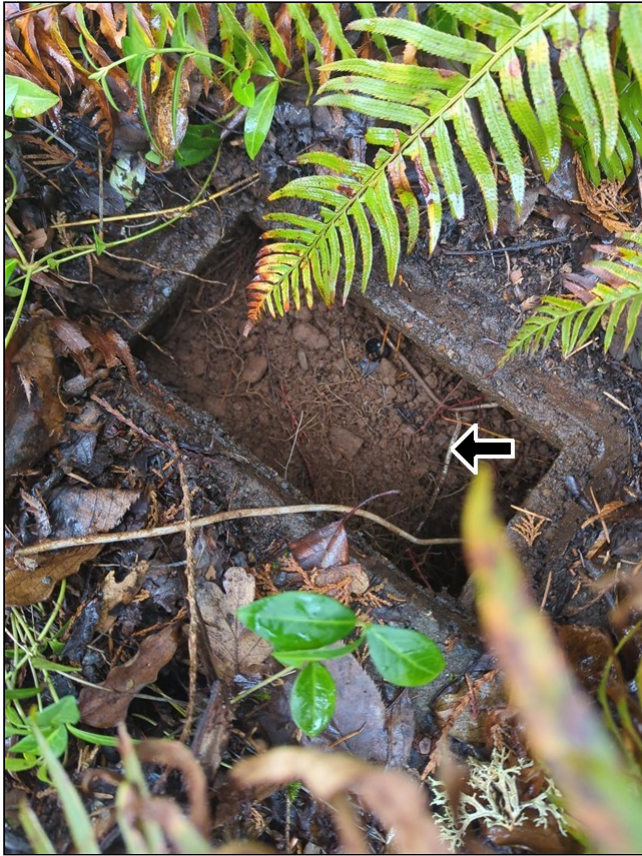
6.3 Item 1(Picture)

- 🔧 (1) The main shut off was located outside in the ground was buried. The dirt should be removed to

provide proper access.

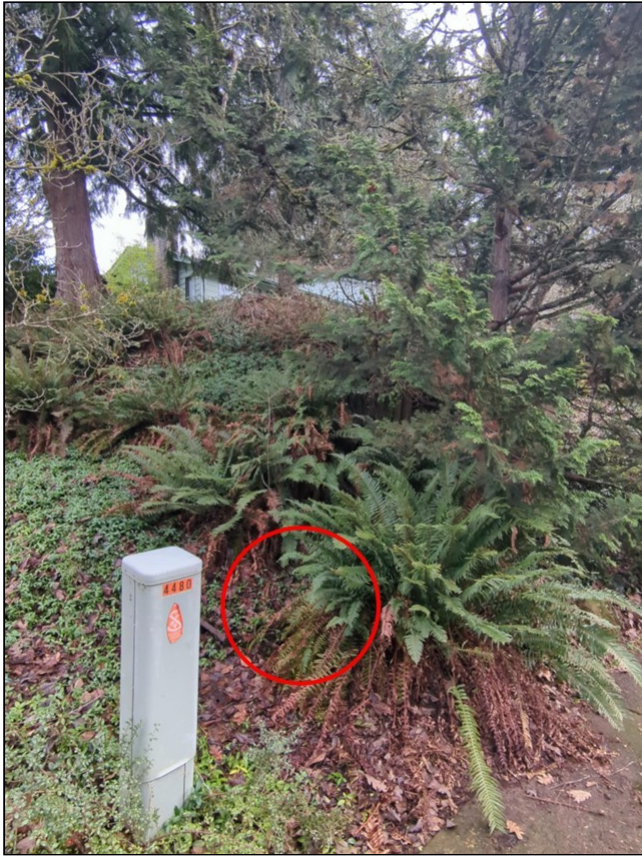
6.3 Item 2(Picture)

(2) The main shut offs were located outside in the ground and crawlspace.

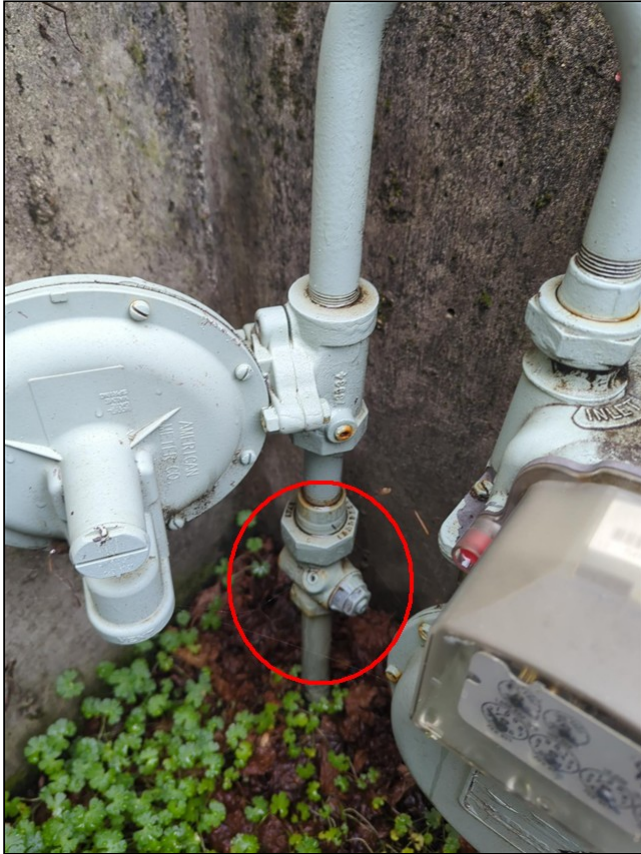
6.4 Item 1(Picture)

- 🔧 The gas line had a leak near the gas meter. This leakage should be repaired promptly by a licensed professional contractor.

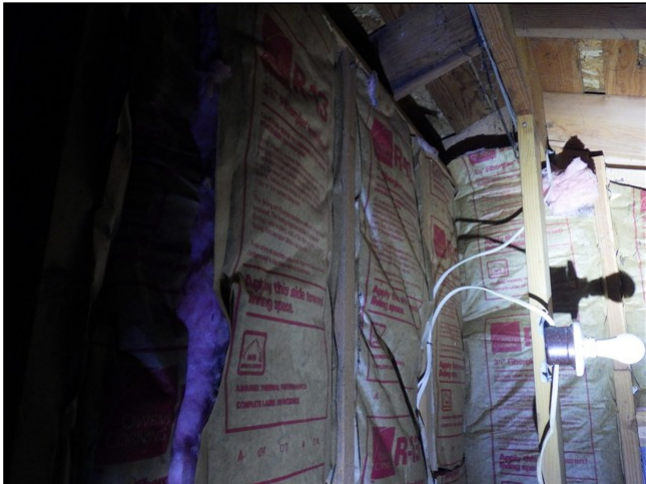
9.0 Item 1(Picture)

(1) Fiberglass (Batts) insulation is installed with "paper or kraft" face out. The paper side should always face the "conditioned space" or condensation could occur in attic. Condensation can cause mold or wood deterioration. A qualified contractor should inspect and repair as needed.

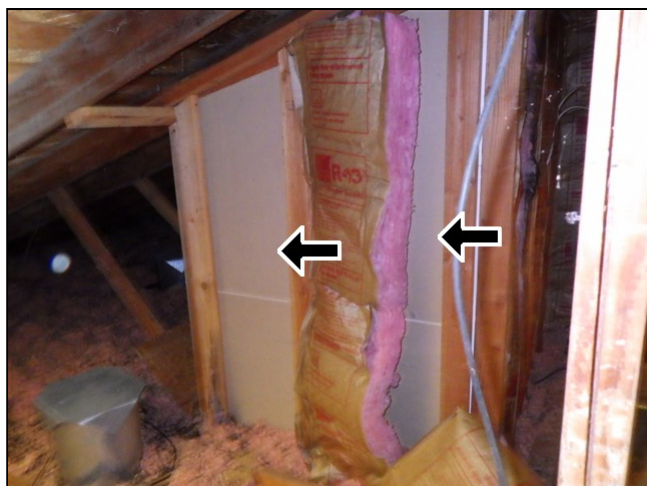
9.0 Item 4(Picture)

🔧 (2) Fiberglass (Batts) insulation was fallen in areas of the vault in attic. Heat loss can occur more on this home than one that is properly insulated. A qualified contractor should inspect and repair as needed.

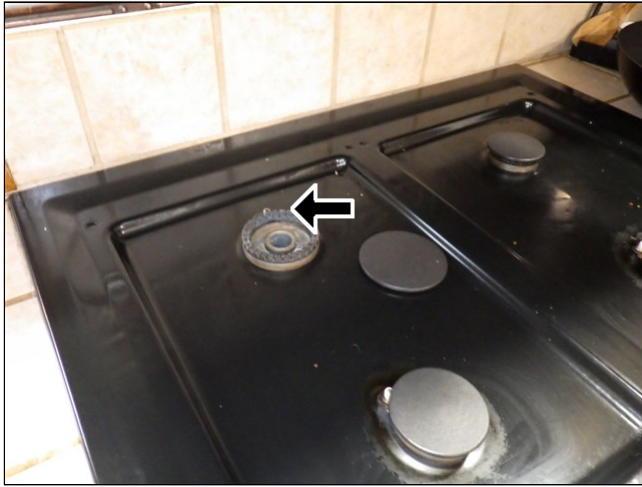
10.2 Item 1(Picture)

🔧 The left rear burner for range would not ignite properly. I recommend repair as needed.
