# Perfection Inspection, Inc

**Property Address:  
4260 Barrett St S  
Salem OR 97302**

**1/30/2026**

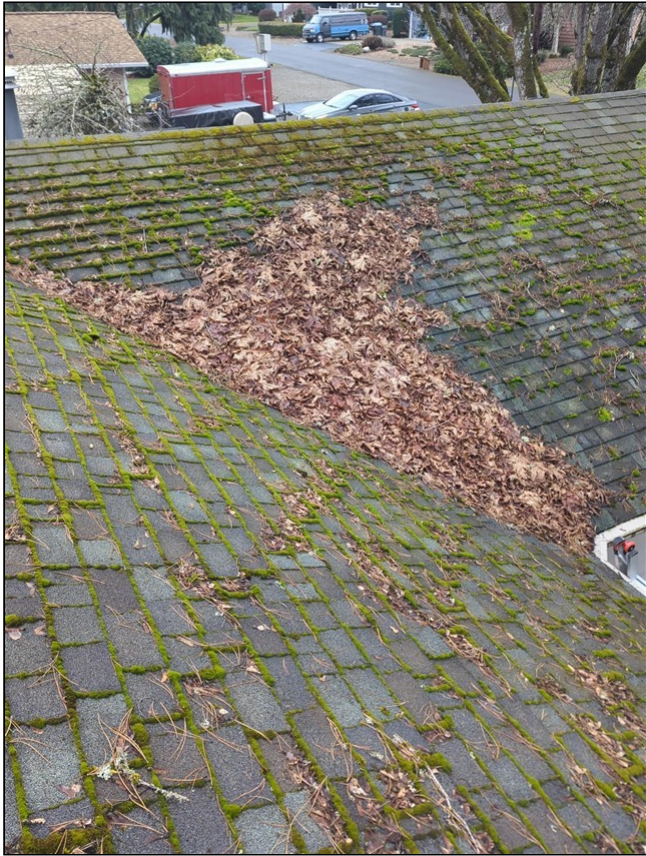
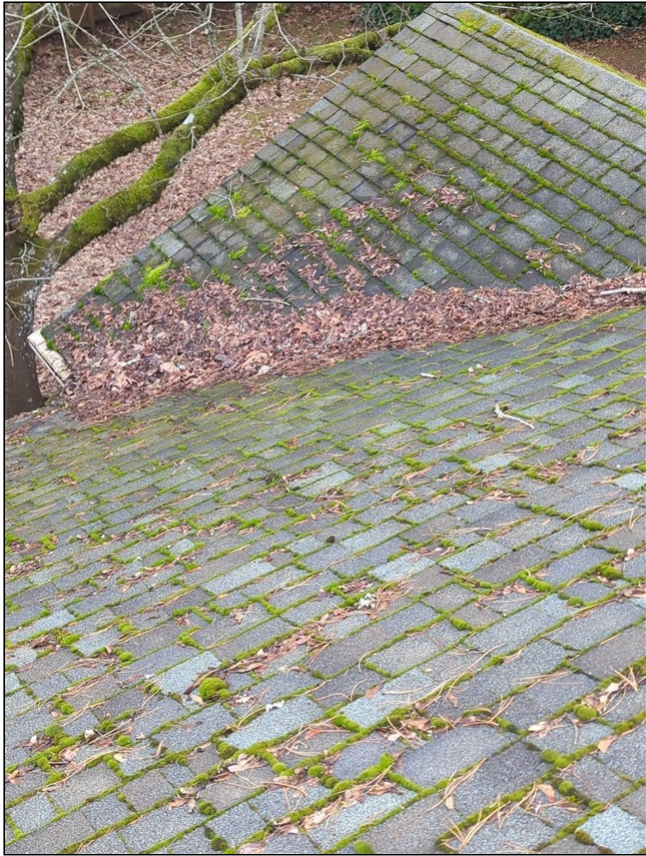
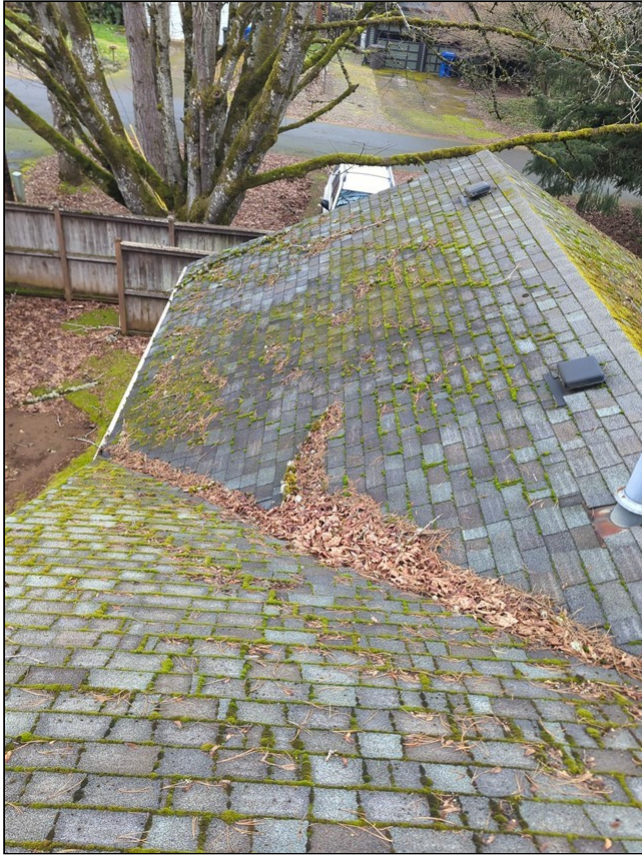
(2) The debris that was on the roof should be removed. The debris can cause damage if left in place and shorten the roof's life. No comment can be offered on the condition of the roofing under the debris. A qualified, person should carefully remove debris as necessary.

(2) The debris that was on the roof should be removed. The debris can cause damage if left in place and shorten the roof's life. No comment can be offered on the condition of the roofing under the debris. A qualified, person should carefully remove debris as necessary.

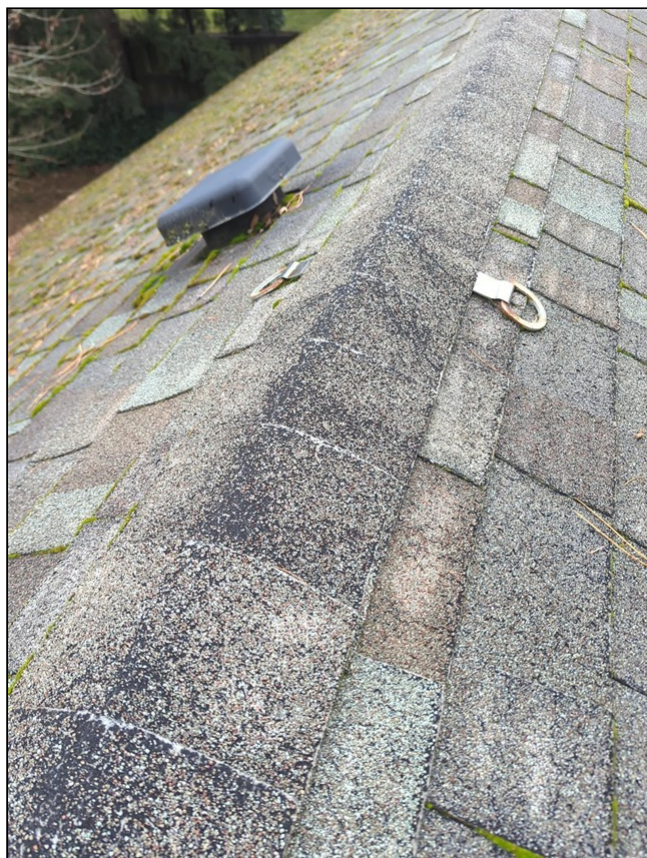
1.0 Item 5(Picture)

- 🔧 (3) The ridge shingles were damaged. The damaged shingles should be replaced as soon as possible. A qualified contractor should inspect and repair as needed.

(3) The ridge shingles were damaged. The damaged shingles should be replaced as soon as possible. A qualified contractor should inspect and repair as needed.

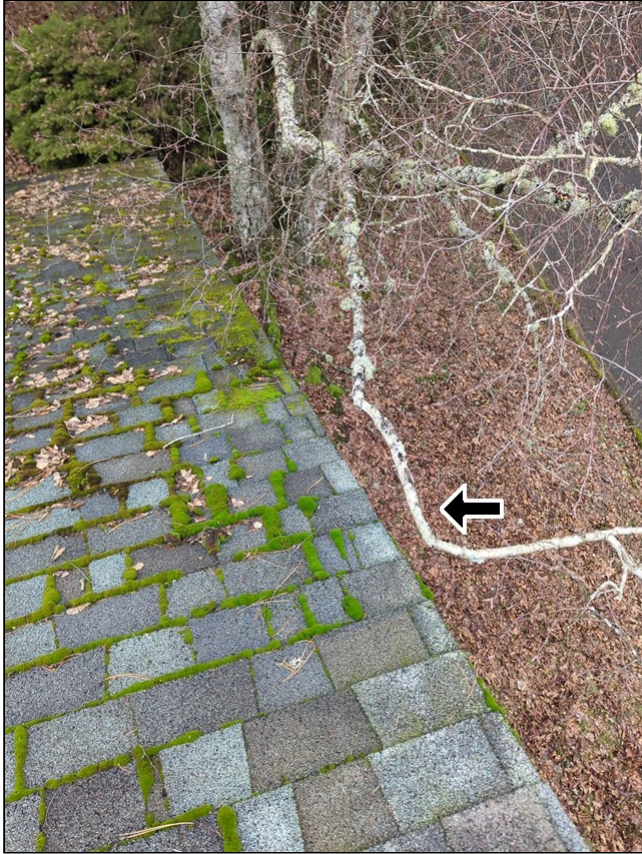
1.0 Item 6(Picture)

- 🔧 (4) The tree limbs that were in contact with roof or hanging near roof should be trimmed. The surface of the roofing may be damaged under the branches. This issue should be repaired by a licensed professional contractor.

(4) The tree limbs that were in contact with roof or hanging near roof should be trimmed. The surface of the roofing may be damaged under the branches. This issue should be repaired by a licensed professional contractor.

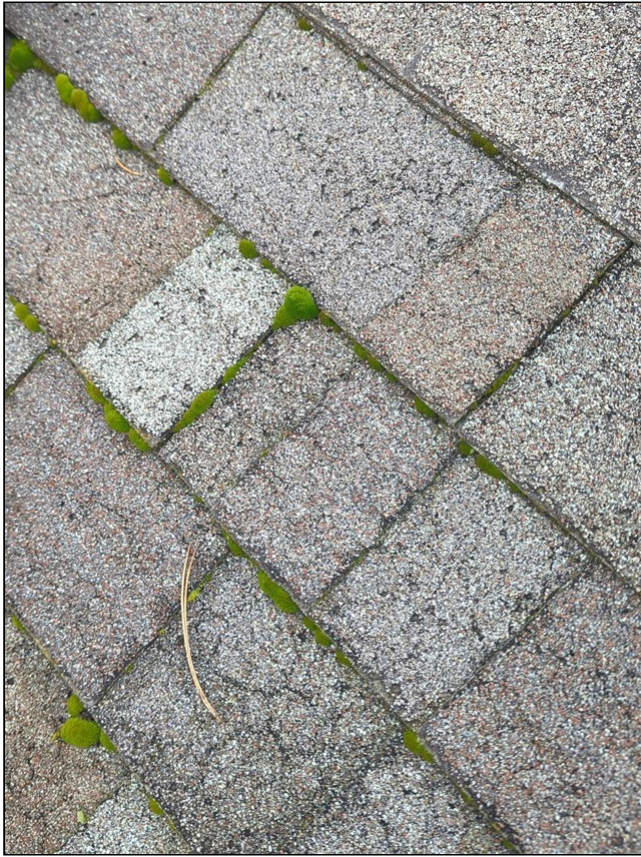
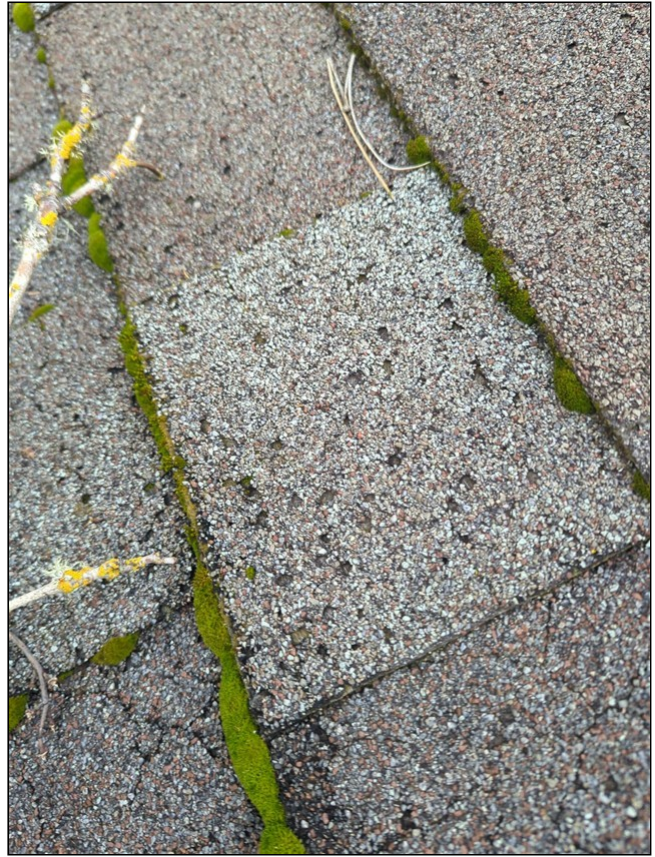
- 🔍 (5) The sloped roofing was showing signs of wear and may require an active maintenance schedule to ensure performance. Issues such as missing granuals, exposed fiberglass, cracked, or damaged shingles and exposed fasteners can be individually repaired as needed. You should consider replacement of the roof within the next 5-10 years.

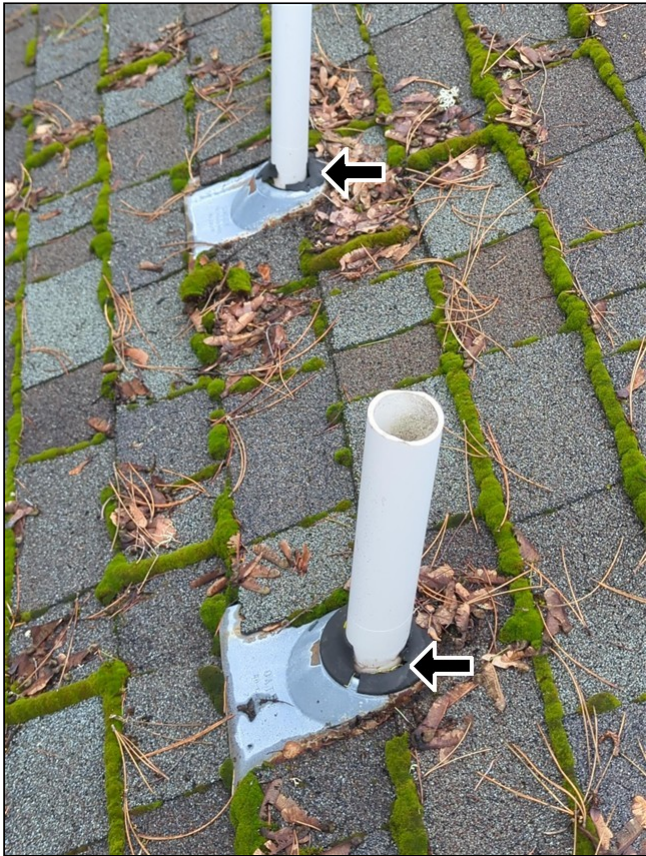
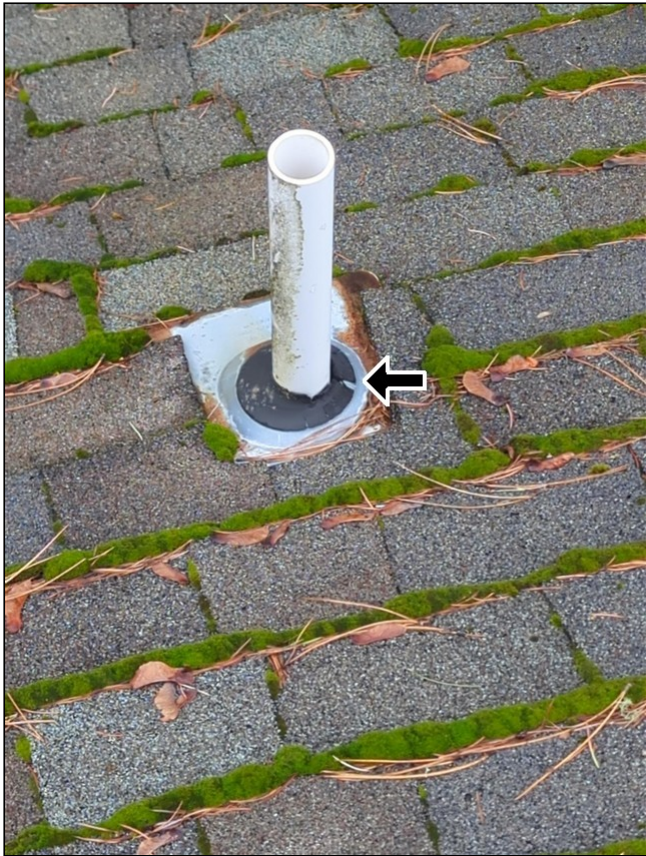
🔧 The plumbing vent pipe flashing(s) need repair/replacement around the perimeter of pipe where boot flanges have failed. A qualified, licensed professional should examine and correct as necessary

The plumbing vent pipe flashing(s) need repair/replacement around the perimeter of pipe where boot flanges have failed. A qualified, licensed professional should examine and correct as necessary

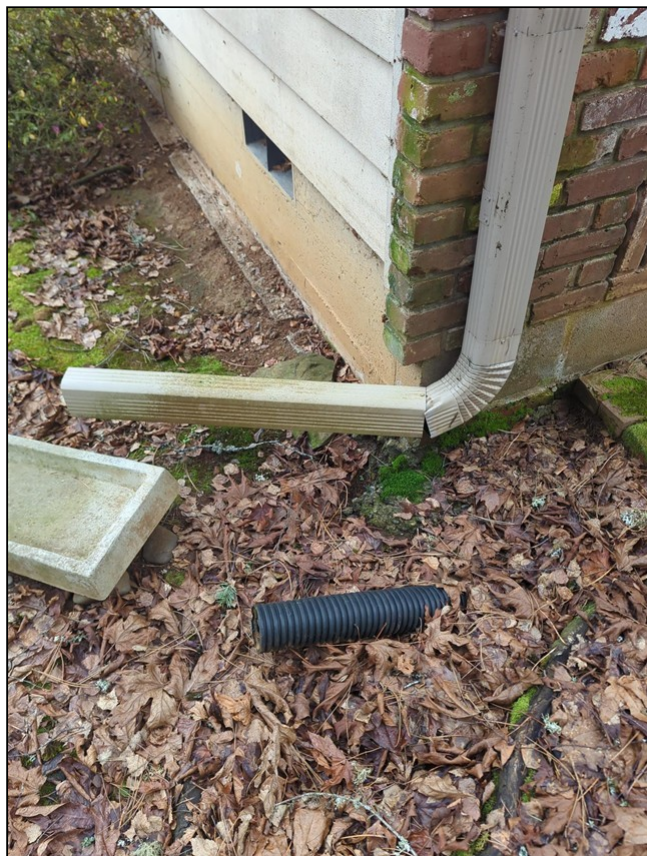
🔧 (1) The downspouts need to carry water at least 10 feet away from the building at the front, rear and sides of the building. A licensed professional contractor should repair this issue. Allowing excess storm water to dump near the building can contribute to water in the crawlspace, structure/siding deterioration and structural movement.

(1) The downspouts need to carry water at least 10 feet away from the building at the front, rear and sides of the building. A licensed professional contractor should repair this issue. Allowing excess storm water to dump near the building can contribute to water in the crawlspace, structure/siding deterioration and structural movement.
-

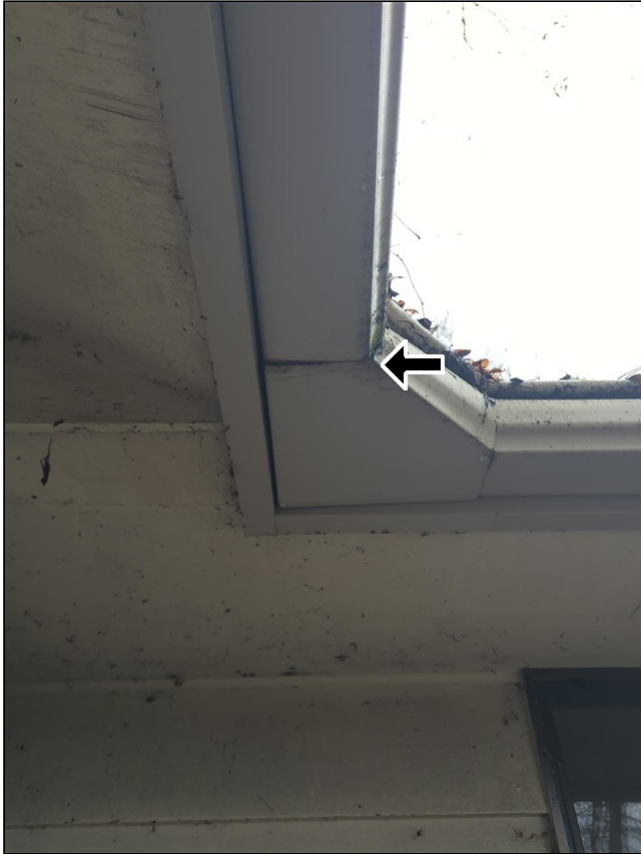
1.3 Item 3(Picture)

- 🔧 (2) The gutters appear to leak at the seams on the front and rear. I recommend cleaning and apply gutter sealant or epoxy.

(2) The gutters appear to leak at the seams on the front and rear. I recommend cleaning and apply gutter sealant or epoxy.

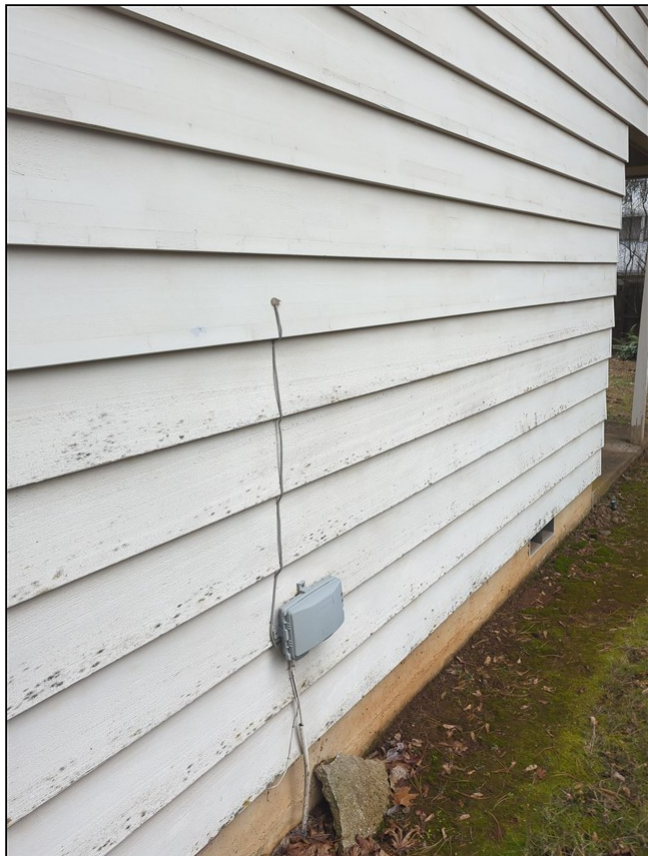
2.0 Item 1(Picture)

Paint was worn on siding. The building should be properly prepped and painted to preserve the building envelope.

Paint was worn on siding. The building should be properly prepped and painted to preserve the building envelope.

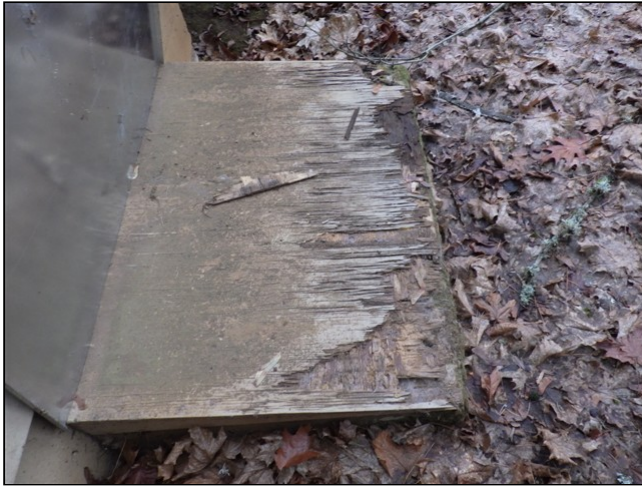
2.1 Item 1(Picture)

🔧 The access door to the crawlspace was deteriorated. I recommend repair as needed.

The access door to the crawlspace was deteriorated. I recommend repair as needed.

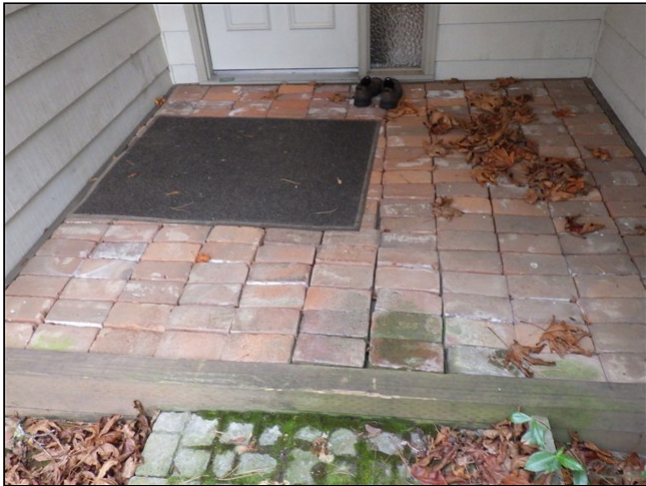
2.4 Item 6(Picture)

(3) The walkway at the front of the building was loose, uneven, and can be a tripping hazard. A fall or injury can occur if not corrected. A qualified contractor should inspect and repair as needed.

(3) The walkway at the front of the building was loose, uneven, and can be a tripping hazard. A fall or injury can occur if not corrected. A qualified contractor should inspect and repair as needed.

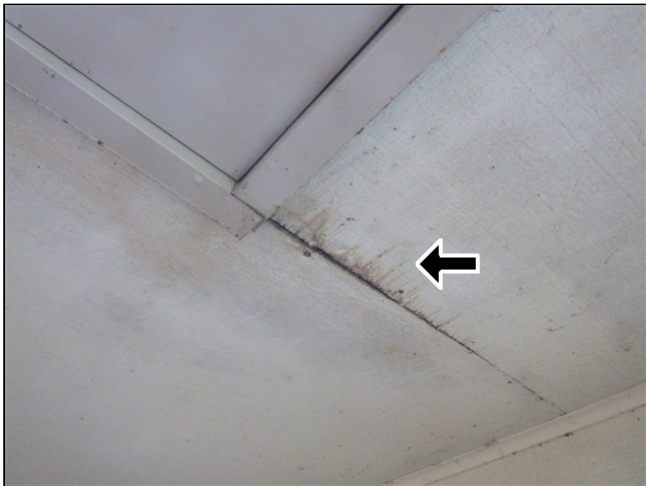
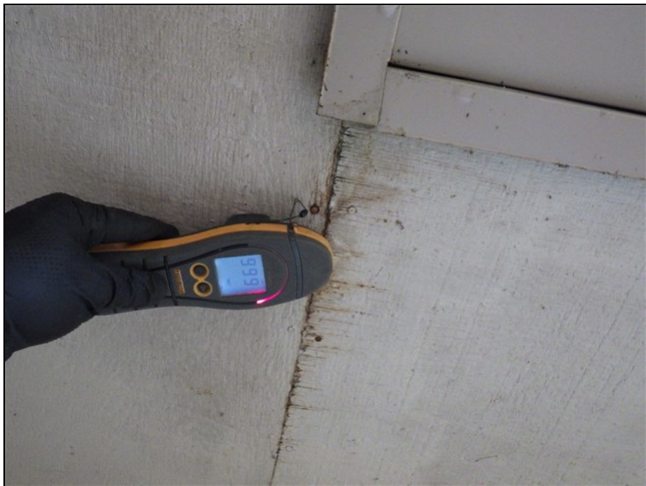
The soffit panel at eave on the front main entrance of the building (refer to picture(s)) shows evidence of moisture absorption. Further deterioration may occur if not repaired. A qualified contractor should inspect and repair as needed.

2.5 Item 2(Picture) Moisture meter confirming current leakage.

The soffit panel at eave on the front main entrance of the building (refer to picture(s)) shows evidence of moisture absorption. Further deterioration may occur if not repaired. A qualified contractor should inspect and repair as needed.

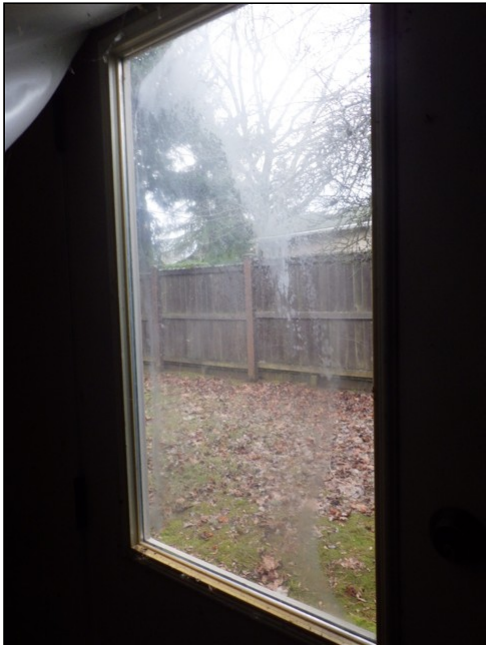
3.3 Item 1(Picture)

🔧 The human door at the left side (facing front from the inside) was "cloudy," moisture trapped between the panes. This should be repaired/replaced. A qualified contractor should inspect and repair as needed.

The human door at the left side (facing front from the inside) was "cloudy," moisture trapped between the panes. This should be repaired/replaced. A qualified contractor should inspect and repair as needed.

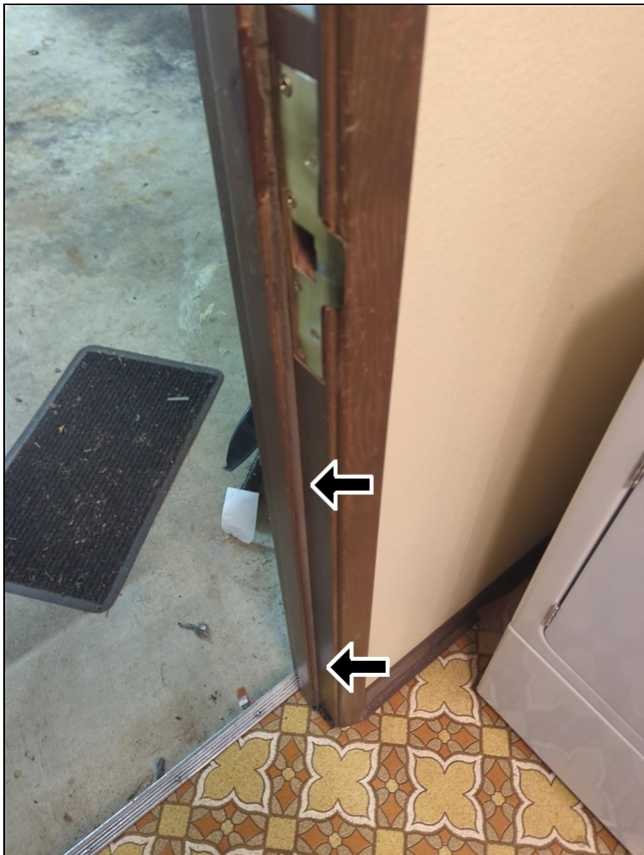
3.4 Item 1(Picture)

🔧 The door between the home and the garage should have new weather stripping installed.

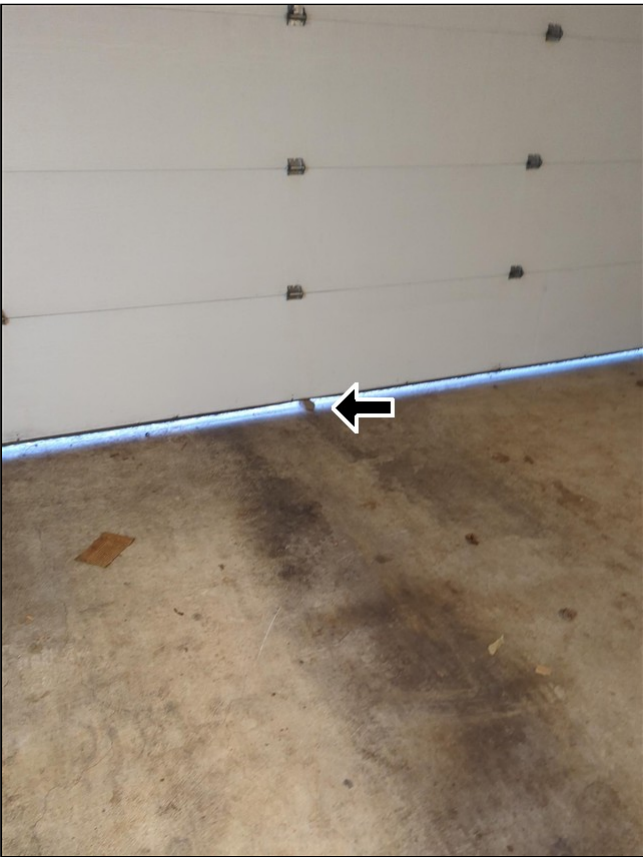
3.5 Item 2(Picture)

The automatic opener for garage door at the front of the building will not reverse when met with resistance. This is considered unsafe and needs correcting. A qualified contractor should inspect and repair as needed.

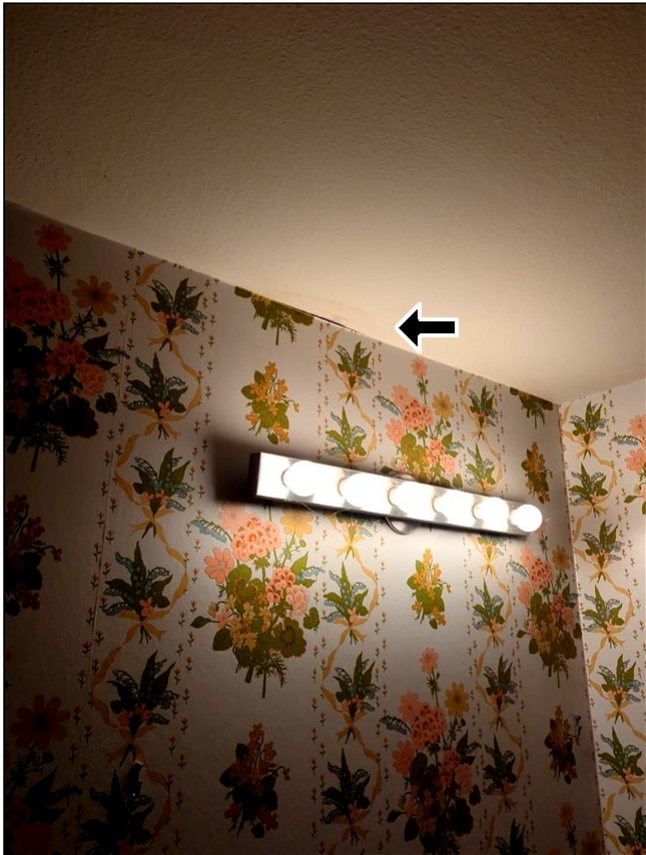
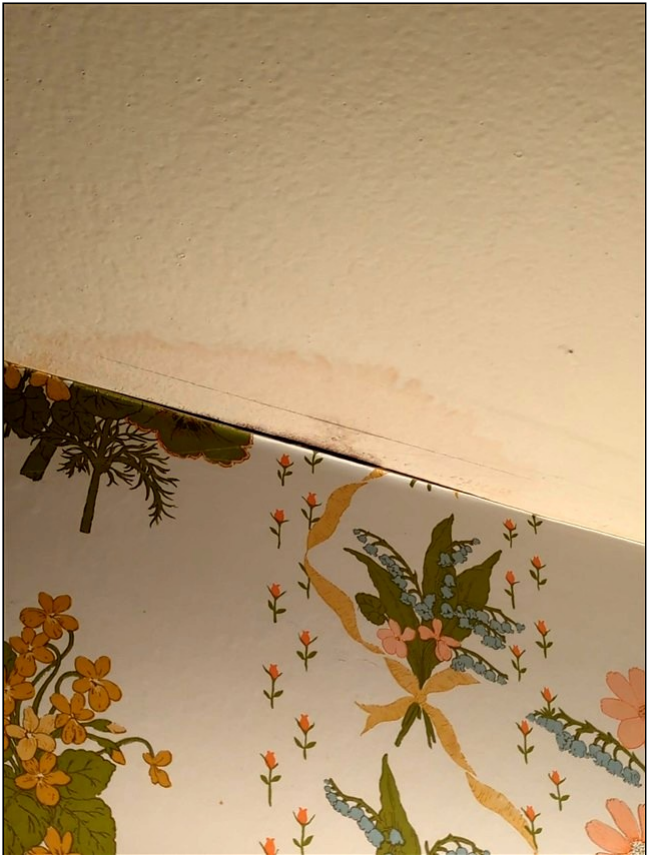
The drywall on the ceiling reveals water stains which appears to be from water leaks at the hall bath. The thermal camera and moisture meter were used and they did not indicate a current leak at the time of the inspection. I recommend monitoring this issue to determine if repairs are necessary.

4.0 Item 4(Picture) No current moisture

The drywall on the ceiling reveals water stains which appears to be from water leaks at the hall bath. The thermal camera and moisture meter were used and they did not indicate a current leak at the time of the inspection. I recommend monitoring this issue to determine if repairs are necessary.

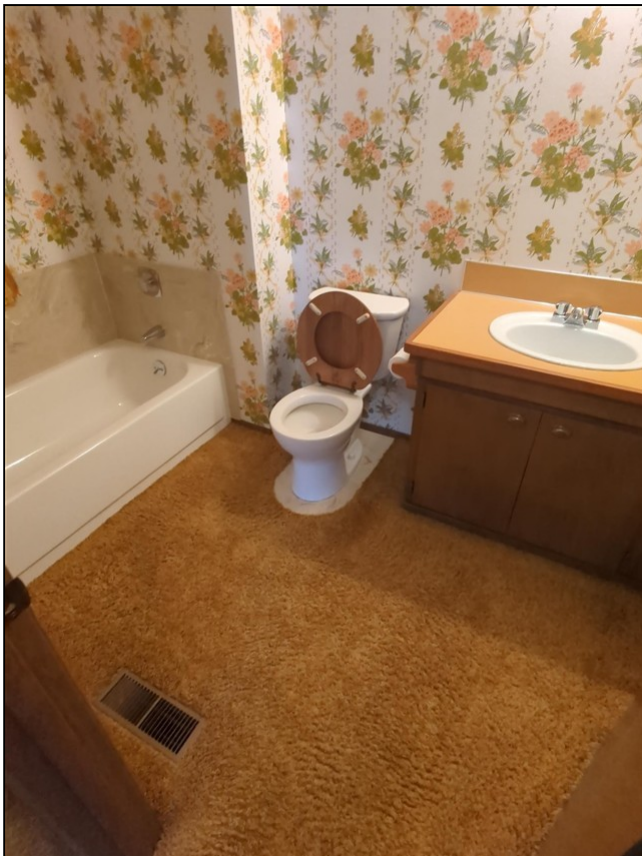
- 🔍 The carpet in the bathroom may conceal damage to the flooring. The inspection of the floor structure under the carpet was very limited and there is a chance that there is damage to the flooring under the surface that could not be observed at the time of the inspection. This area should be monitored and repaired if necessary.

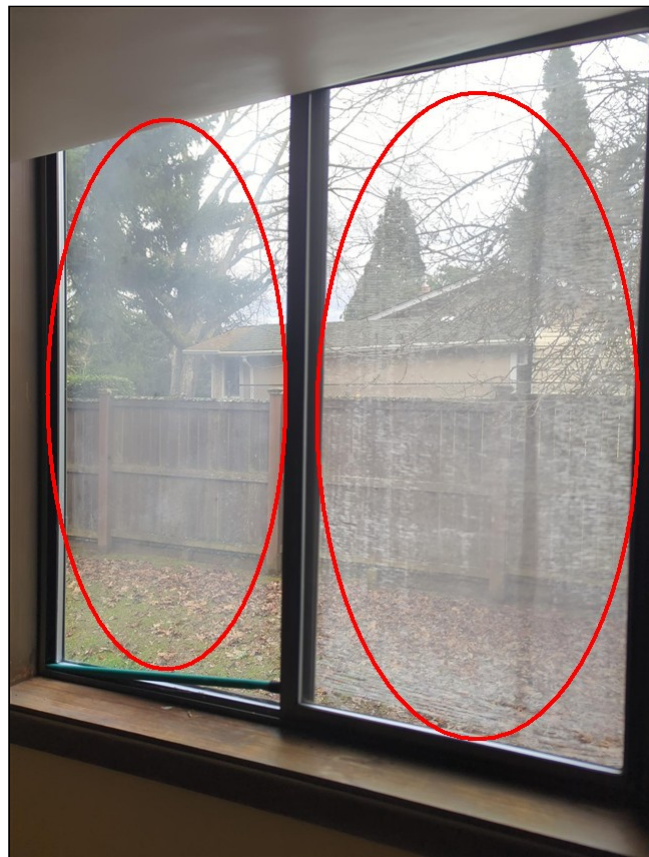
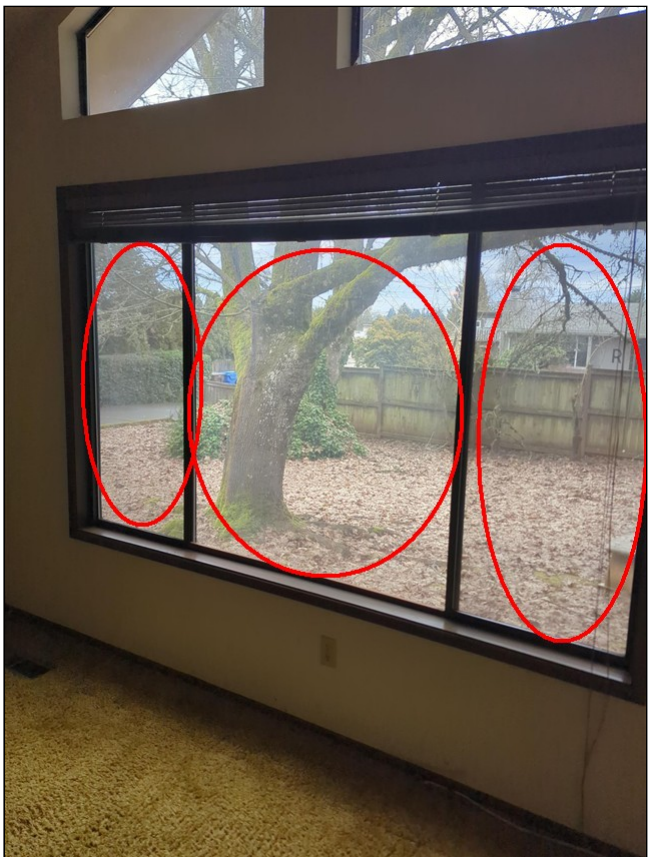
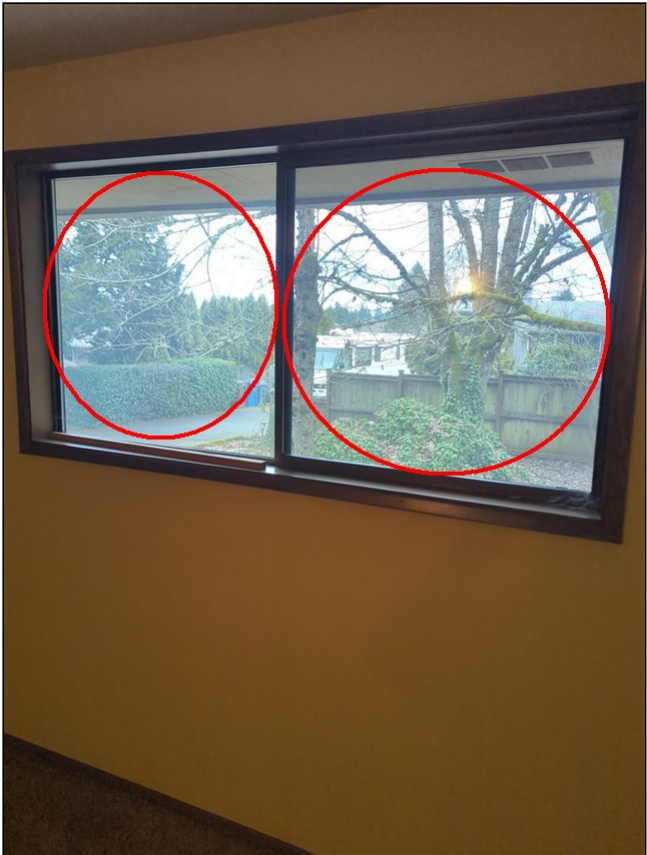
(1) Windows were cloudy (moisture trapped between the panes) . In order to correct the cloudy appearance of glass, a replacement of glass pane or the unit will be necessary. A qualified contractor should inspect and repair as needed.

(1) Windows were cloudy (moisture trapped between the panes) . In order to correct the cloudy appearance of glass, a replacement of glass pane or the unit will be necessary. A qualified contractor should inspect and repair as needed.
-

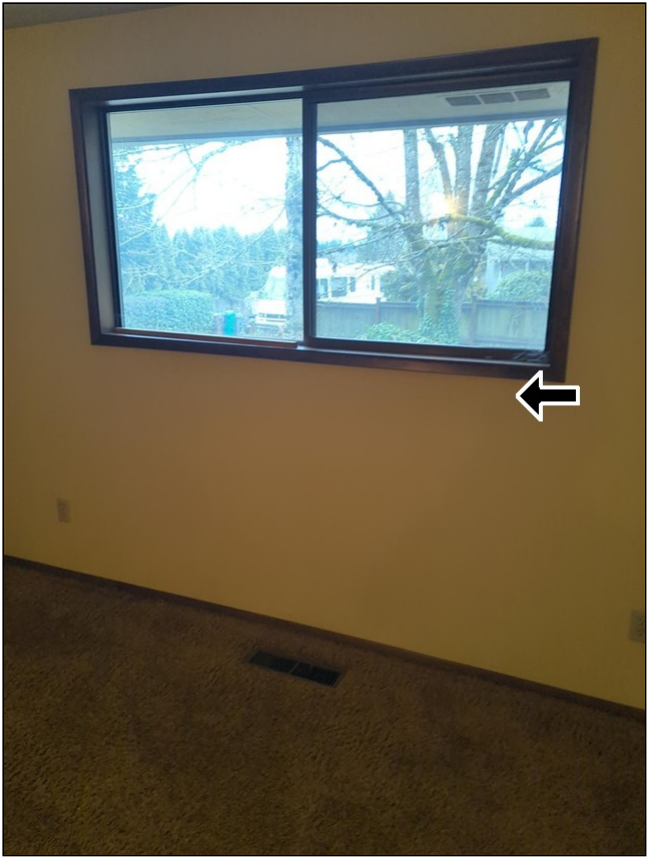
(2) The windows were not low enough to be considered egress windows at the bedrooms. This may be a safety concern if a window is needed to escape fire. A qualified contractor should inspect and repair as needed.

(2) The windows were not low enough to be considered egress windows at the bedrooms. This may be a safety concern if a window is needed to escape fire. A qualified contractor should inspect and repair as needed.

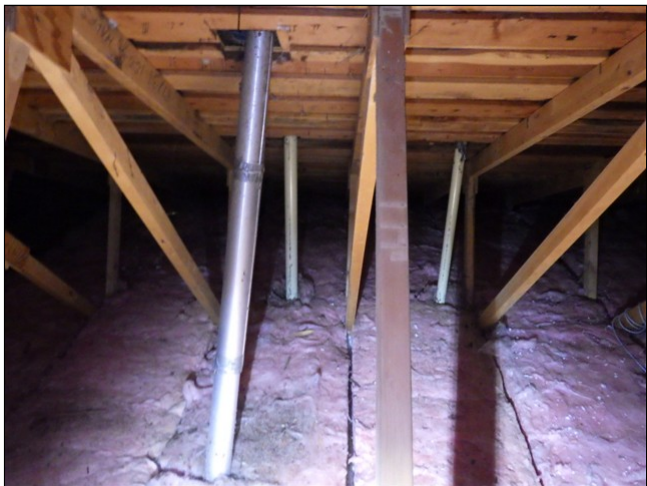
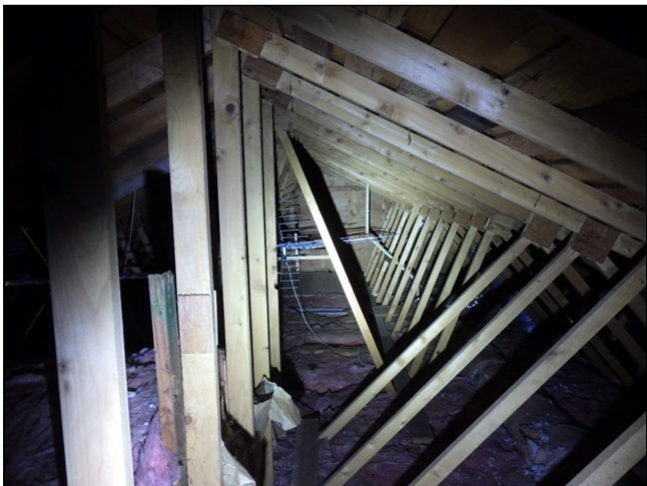
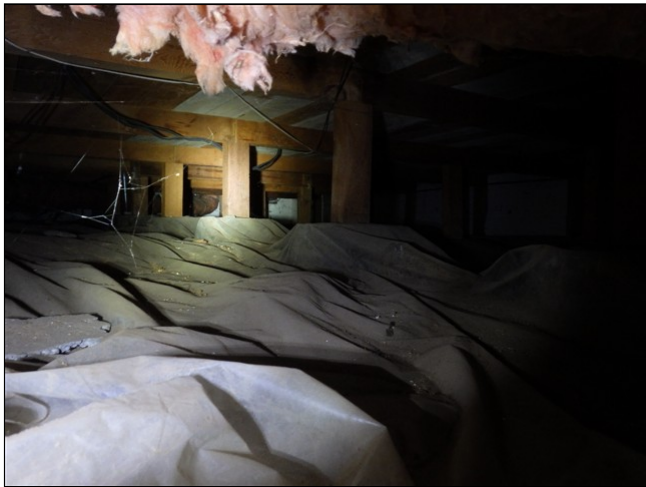
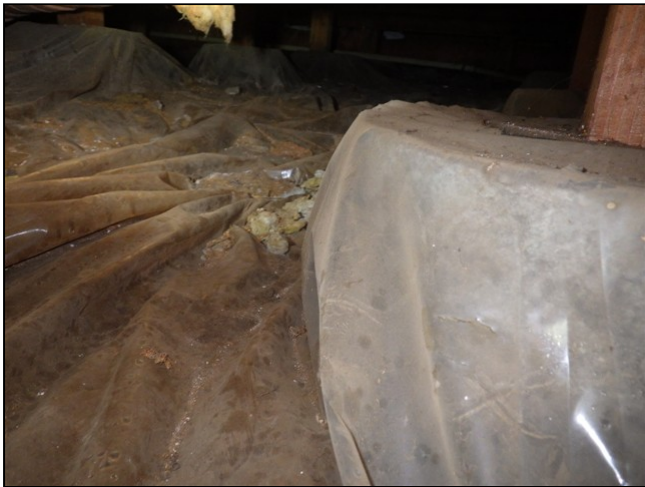
Normal structure

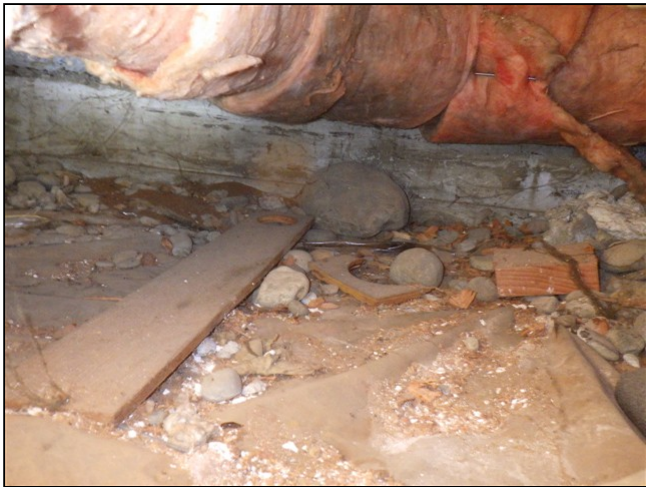
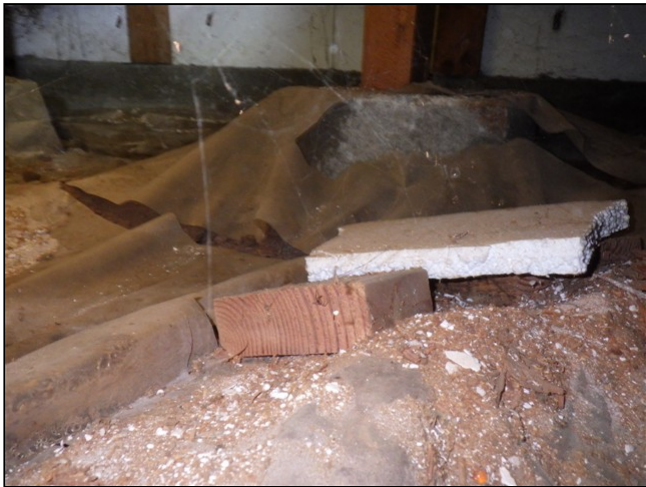
The wood/cellulose construction debris should be removed from the crawlspace. The excess wood that is under the building can be an excellent home base for wood destroying organisms, allowing them to multiply. When the wood runs out or the wood destroying organisms start looking for more they may look to your building. In general all pieces large enough to be caught in a garden rake should be removed.

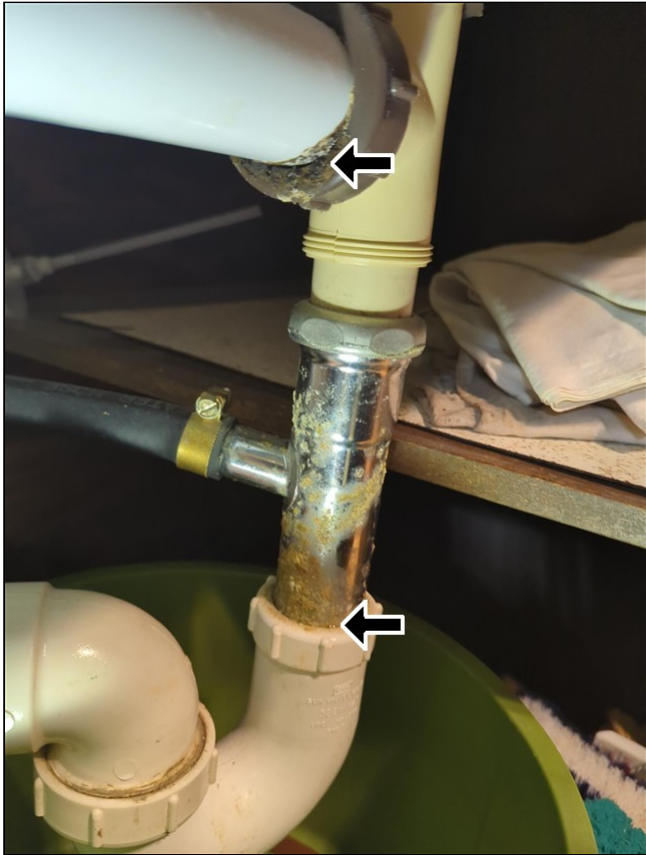
**Comments:** Inspected, Repair or Replace  
(1) The waste line was leaking at the kitchen sink. Repairs are needed. I recommend a licensed plumber inspect further and repair as necessary.

(1) The waste line was leaking at the kitchen sink. Repairs are needed. I recommend a licensed plumber inspect further and repair as necessary.
-

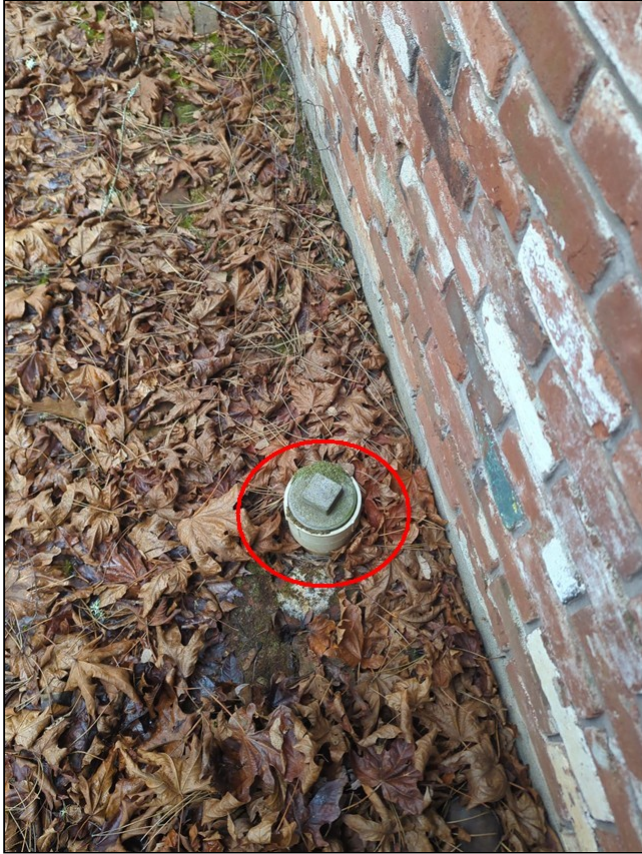
6.0 Item 4(Picture)

- 🔧 (3) You should strongly consider having the sewer line scoped. Issues with the main underground waste line can be common and the repairs can be costly. The main under ground soil pipe could not be viewed and was not inspected.

(3) You should strongly consider having the sewer line scoped. Issues with the main underground waste line can be common and the repairs can be costly. The main under ground soil pipe could not be viewed and was not inspected.

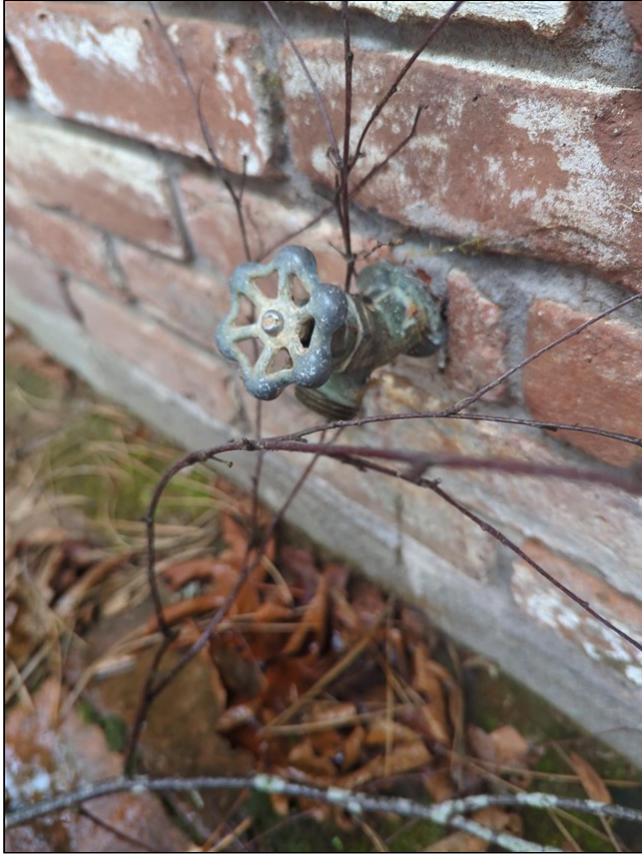
6.1 Item 1(Picture)

- 🔧 (1) The outside water faucets do not have vacuum-breakers (anti-siphon valves) installed at the front and rear. The valves prevent harmful liquids from entering your water system and should be installed to improve the safety of the building. A qualified licensed plumber should repair or correct as needed.

(1) The outside water faucets do not have vacuum-breakers (anti-siphon valves) installed at the front and rear. The valves prevent harmful liquids from entering your water system and should be installed to improve the safety of the building. A qualified licensed plumber should repair or correct as needed.
-

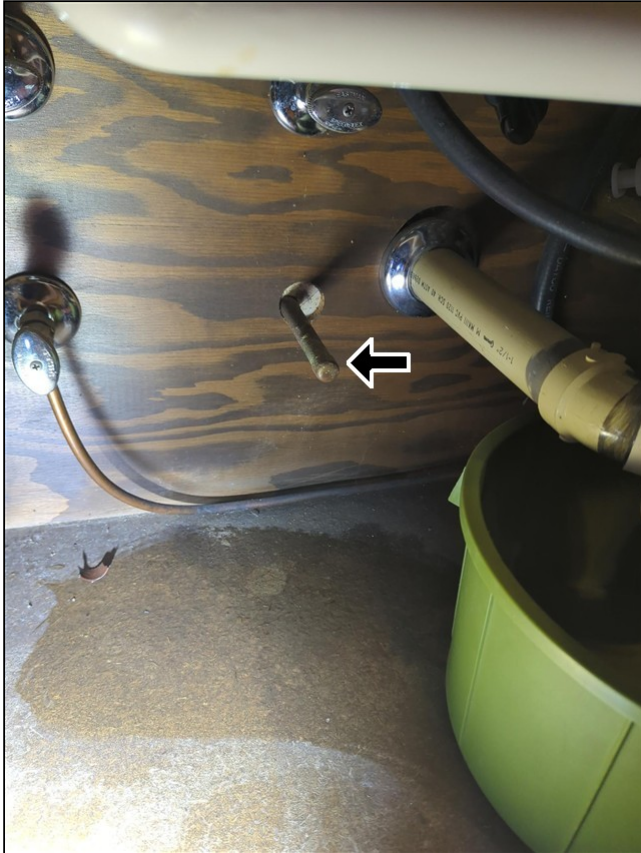
6.1 Item 2(Picture)

- 🔧 (2) The supply line had a "dead leg," present under the kitchen sink. Dead legs are short sections of piping that do not allow water to circulate and may collect harmful bacteria <http://www.buellinspections.com/dead-legs-might-not-kill-you-but-they-can-make-you-sick/>. A qualified licensed plumber should repair or correct as needed.

Oregon building codes also advises against dead legs: <https://www.oregon.gov/bcd/codes-stand/Documents/interp-22-01-dead-legs.pdf>

(2) The supply line had a "dead leg," present under the kitchen sink. Dead legs are short sections of piping that do not allow water to circulate and may collect harmful bacteria <http://www.buellinspections.com/dead-legs-might-not-kill-you-but-they-can-make-you-sick/>. A qualified licensed plumber should repair or correct as needed.

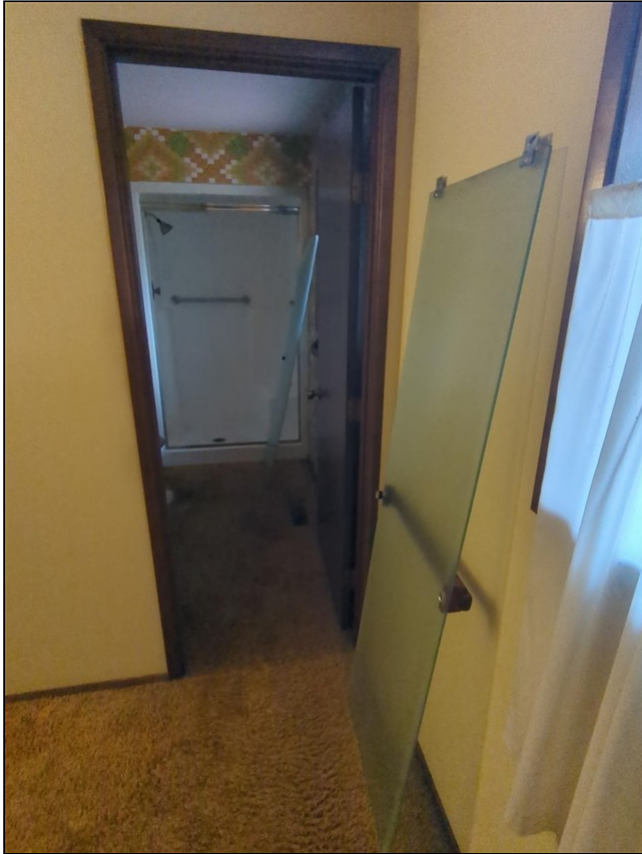
6.1 Item 3(Picture)

- 🔧 (3) The shower doors were missing at the master bath. Repairs are needed A qualified, licensed professional contractor should repair as necessary.

(3) The shower doors were missing at the master bath. Repairs are needed A qualified, licensed professional contractor should repair as necessary.

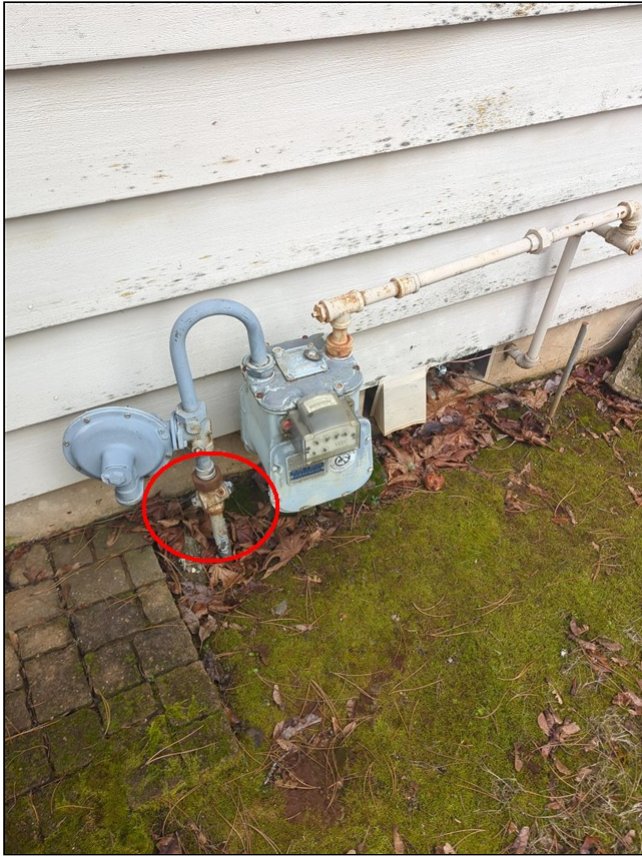
6.5 Item 1(Picture)

The main fuel shut off was at gas meter outside

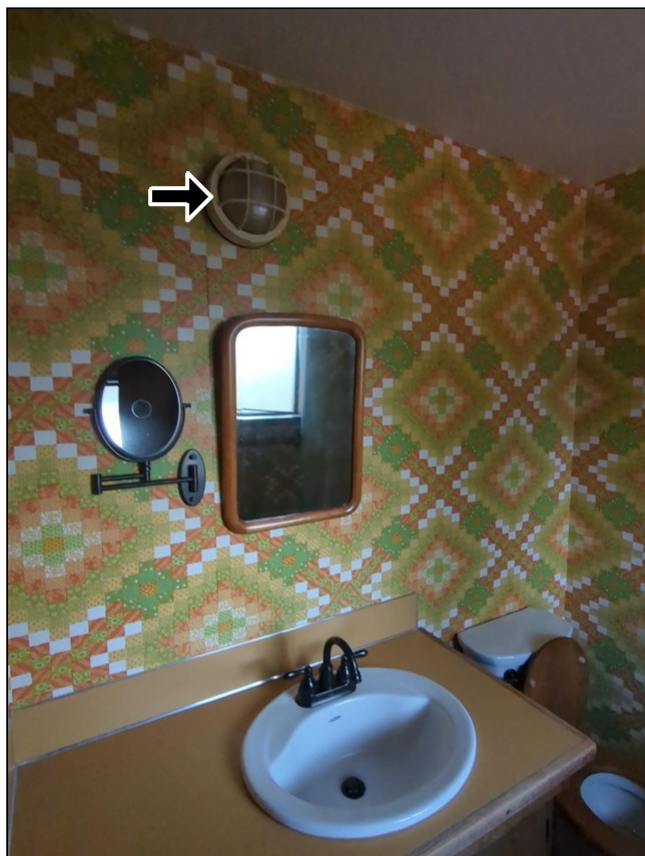
7.3 Item 1(Picture)

- 🔧 (1) The light fixtures did not work in various locations. This is for your information. Check the bulbs first and if the bulbs are not the issue an electrician should be consulted.

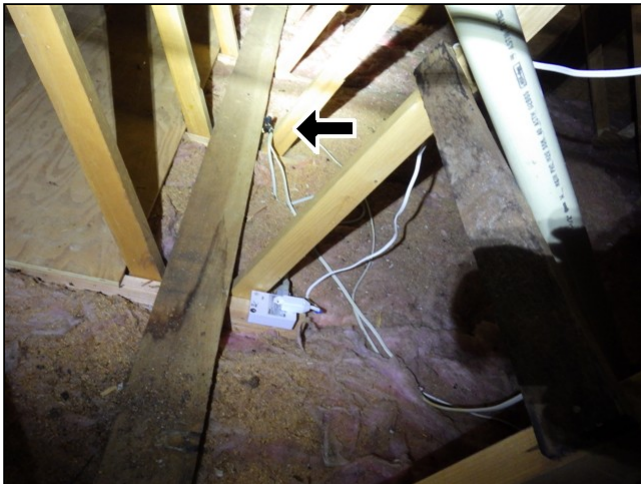
- 🔧 (3) One loose wire splice needs placing inside a box with a cover-plate above the Kitchen in attic. Electrical issues are considered a hazard until repaired. I recommend a qualified licensed electrician correct.

(3) One loose wire splice needs placing inside a box with a cover-plate above the Kitchen in attic. Electrical issues are considered a hazard until repaired. I recommend a qualified licensed electrician correct.

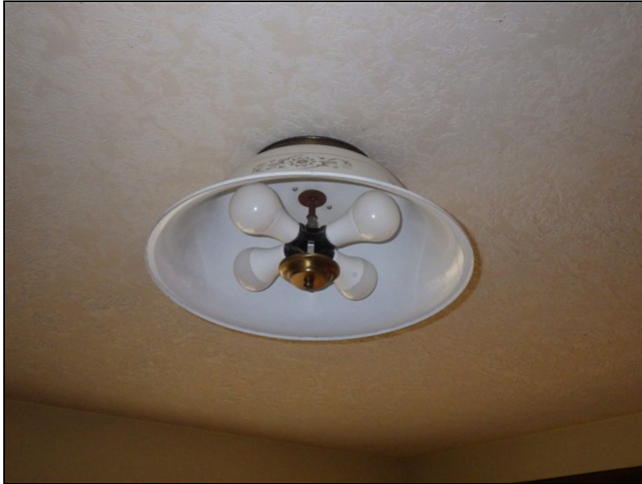
7.3 Item 6(Picture)

- 🔧 (4) The light fixture was missing glass at the dining room. This is for your information. I recommend repair as needed.
