# Perfection Inspection, Inc

**Property Address:  
4260 Barrett St S  
Salem OR 97302**

**1/30/2026**

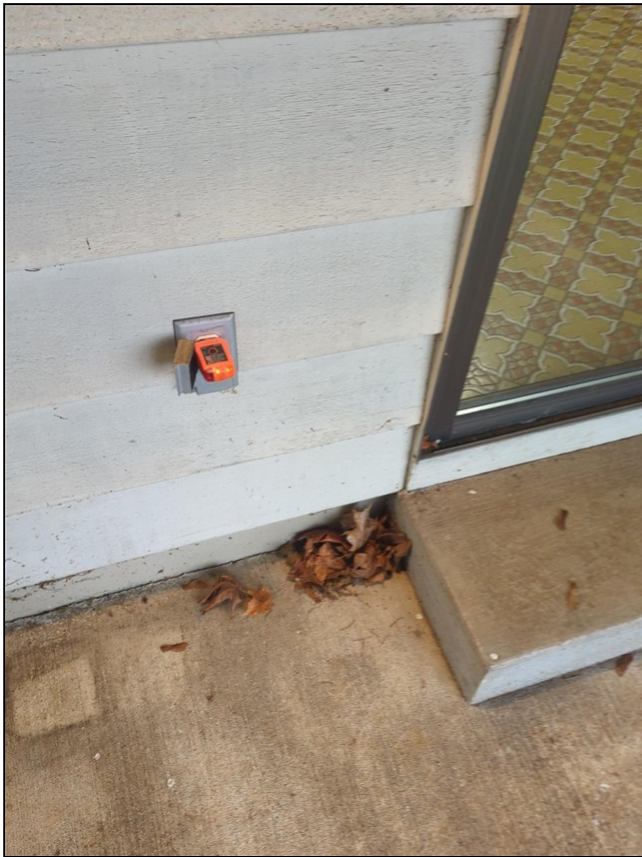
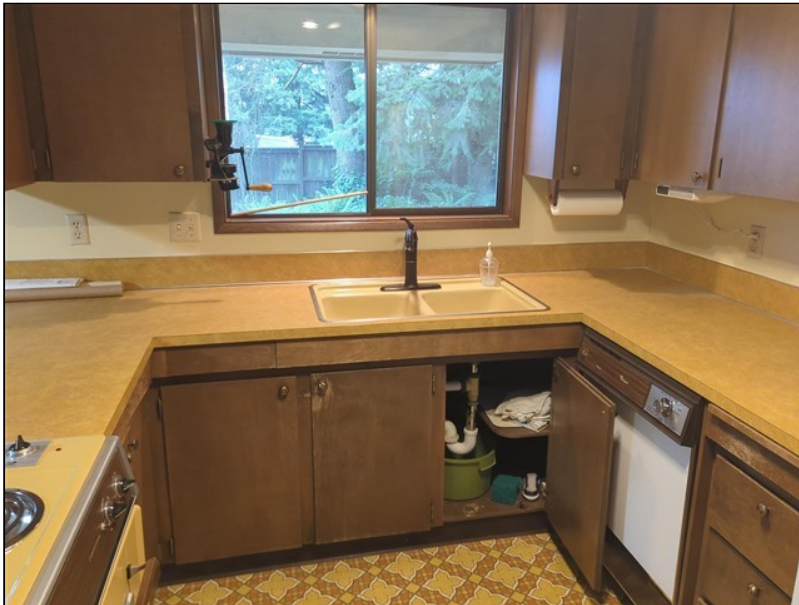
- 🔧 The addition of GFCI's to the building in the exterior, bathrooms, garage and kitchen would be a wise modern safety update.

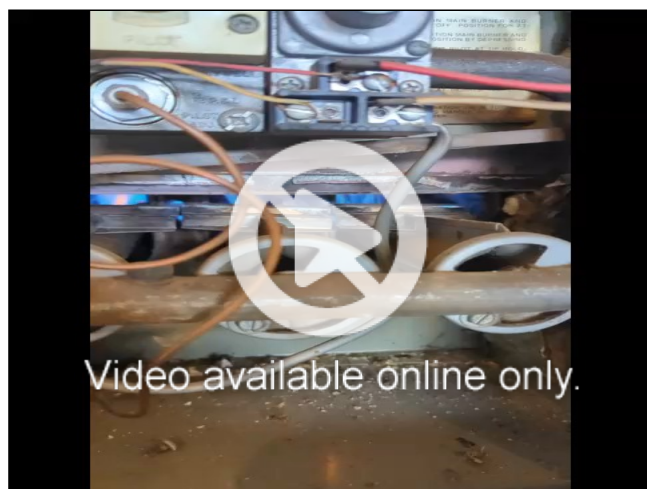
8.0 Item 1(Video)

- 🔧 **The gas furnace was very old will fire, but frequently cycles on and off and but appearance of flame(s) indicate the probable end of its useful life. A more thorough inspection by a qualified contractor is needed. A qualified HVAC person should inspect further and repair or replace as needed.**
