# Perfection Inspection, Inc

**Property Address:  
611 Rockwood St SE  
Salem OR 97306**

**4/18/2024**

**Jim Allhiser**

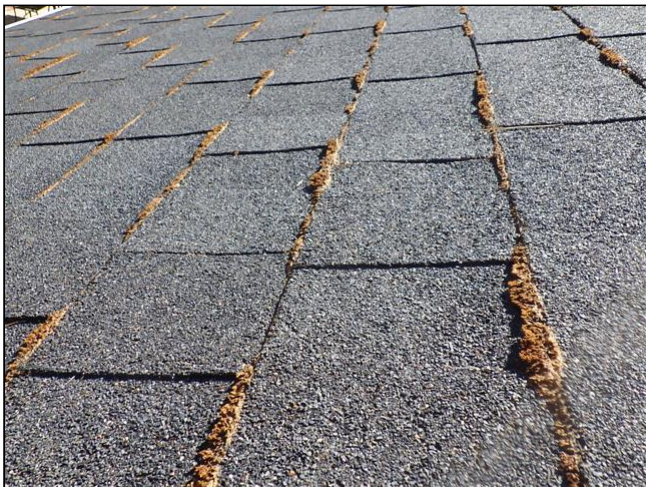
1.0 Item 1(Picture)

Moss noted on the shaded sections of the roof. Moss is best treated chemically annually with as little disturbance to the shingles as possible.

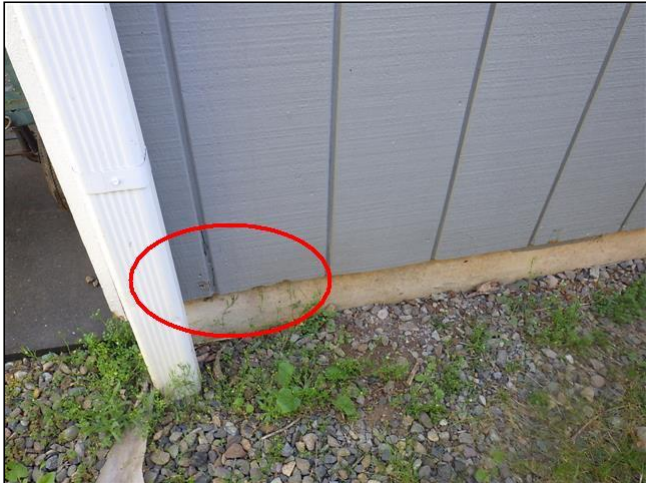
2.0 Item 2(Picture)

(1) The siding was deteriorated on bottom edge along the front and rear of the building (refer to pictures). Further deterioration can occur if not corrected. A qualified contractor should inspect and repair as needed.

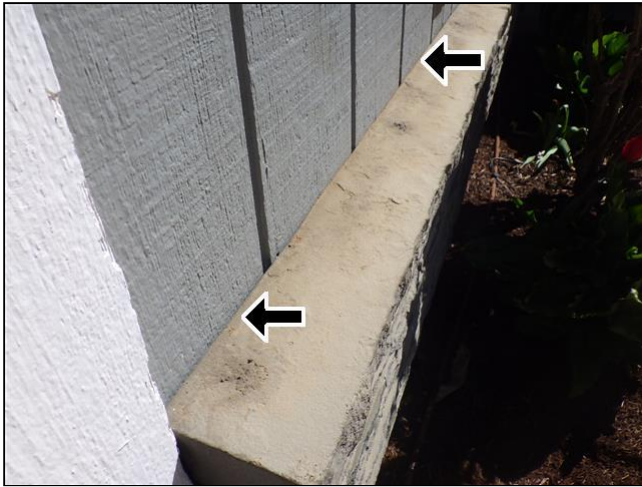
2.0 Item 4(Picture)

*Exterior applications require flashing if other siding products are used above the ledger. Flashing will also cover screws used to attach the ledger for a more professional result. If flashing will not be used, fill screw holes with grout and paint.*

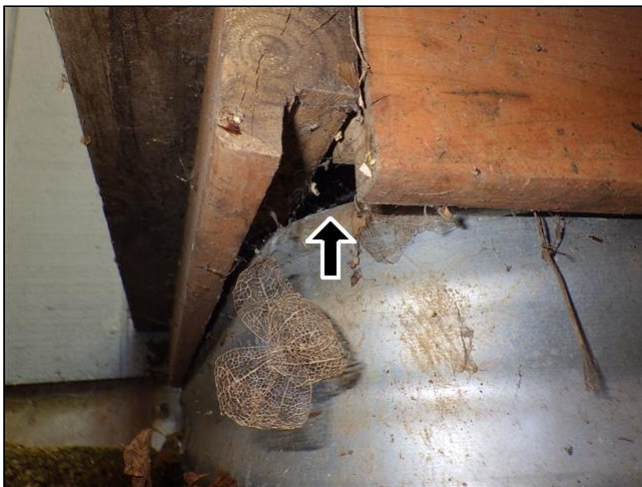
2.1 Item 1(Picture)

(2) The access door to the crawlspace did not completely seal the opening, allowing pest entry. I recommend a licensed professional contractor repair as needed.

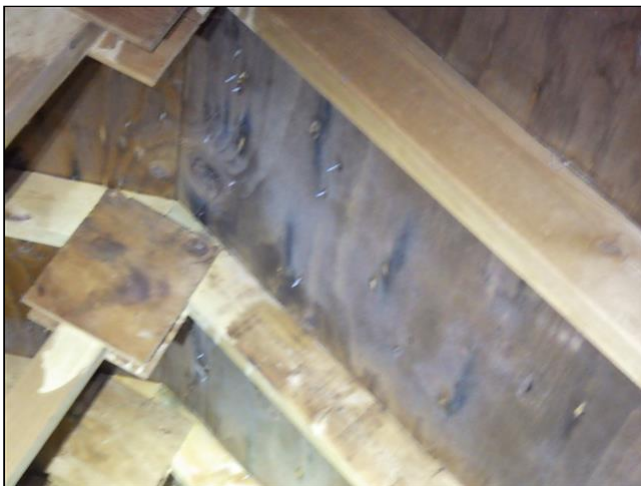
5.6 Item 2(Picture)

(1) The roof sheathing has signs of condensation and apparent fungal growth in areas. Signs of fungi growth indicate that there is too much moisture vapor in the attic. Proper steps to reduce the home's moisture should be taken along with the sealing of the bypasses noted in the attic, to prevent warm, moist house air from readily entering the attic. A insulation/sealing contractor should perform repairs to the bypasses. A qualified, licensed mold remediation should also be performed.

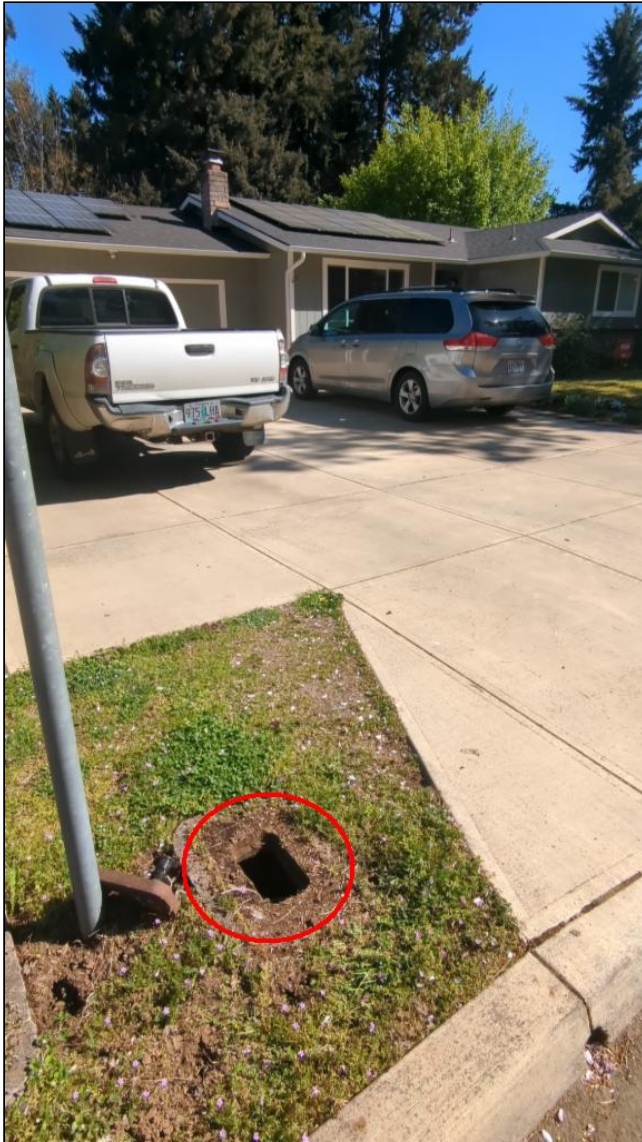
6.3 Item 1(Picture)

The main shut off was located outside in the ground.

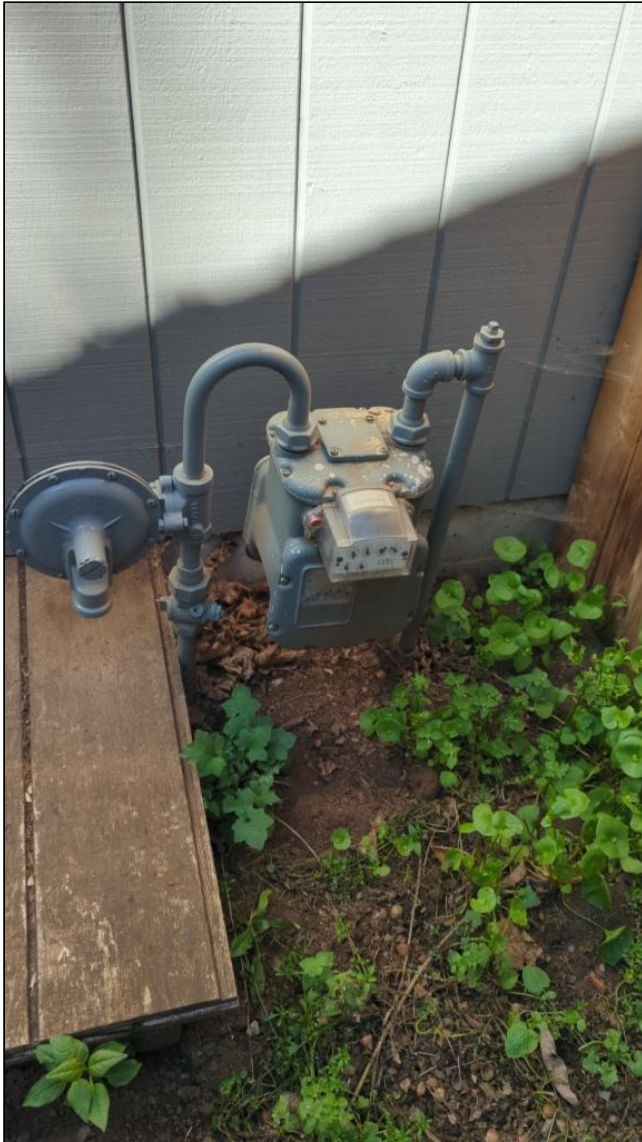
6.5 Item 1(Picture)

The main fuel shut off was at gas meter outside

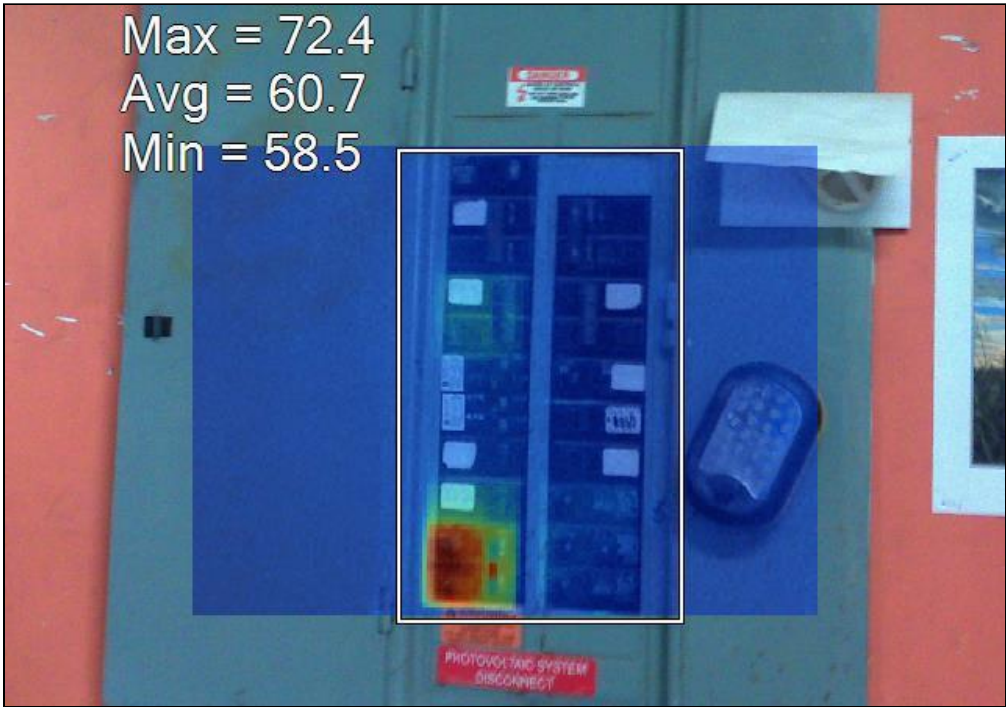
These are normal temperatures under load

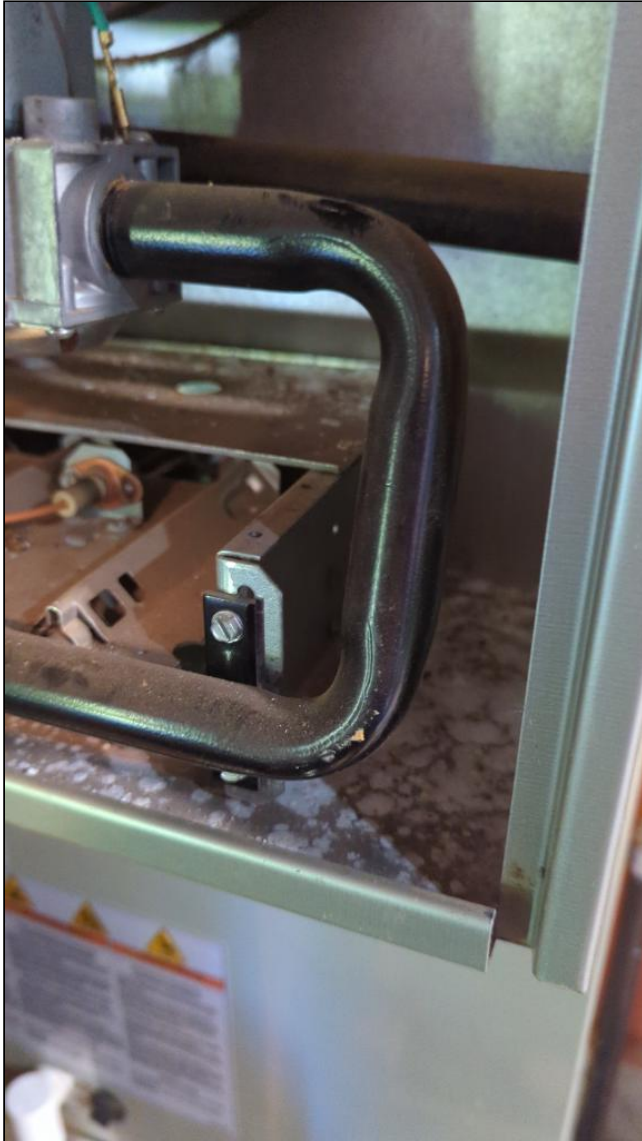
8.0 Item 1(Picture)

The furnace does not appear to have been serviced recently. A licensed HVAC contractor should service or repair unit.
-

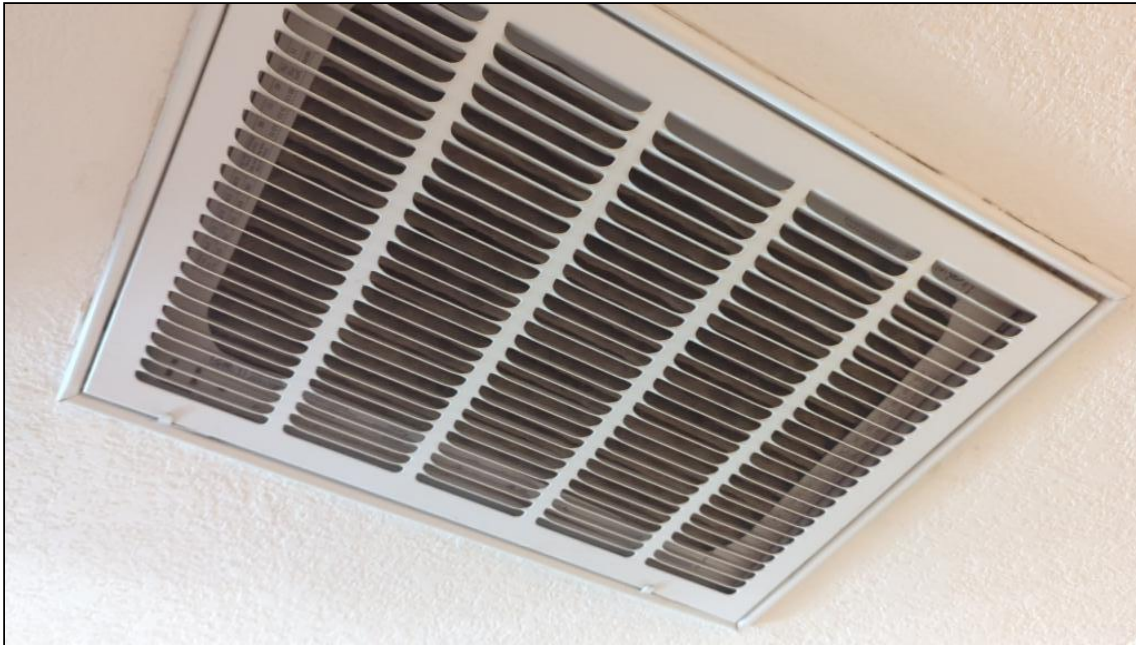
8.3 Item 1(Picture)

The filter was clogged and dirty. The filter needs to be replaced. I recommend repair or replace as needed using a qualified person. Generally filters should be cleaned/replaced every one to two months.

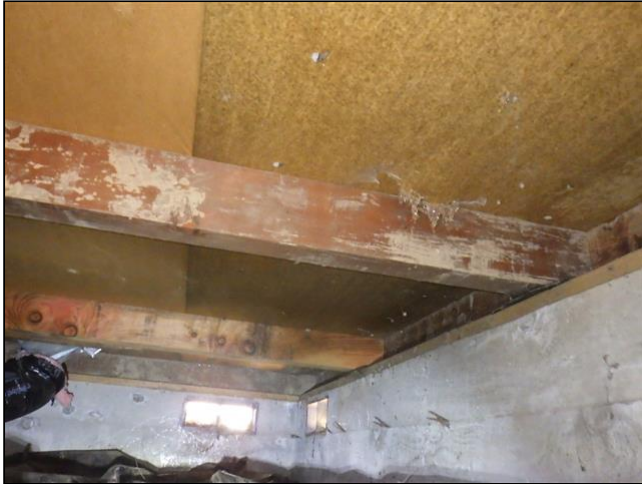
9.1 Item 1(Picture)

- 🔧 The floor system was not insulated. Although this was normal when the building was built, we now know that heat loss can occur more on this building than on one that is properly insulated.

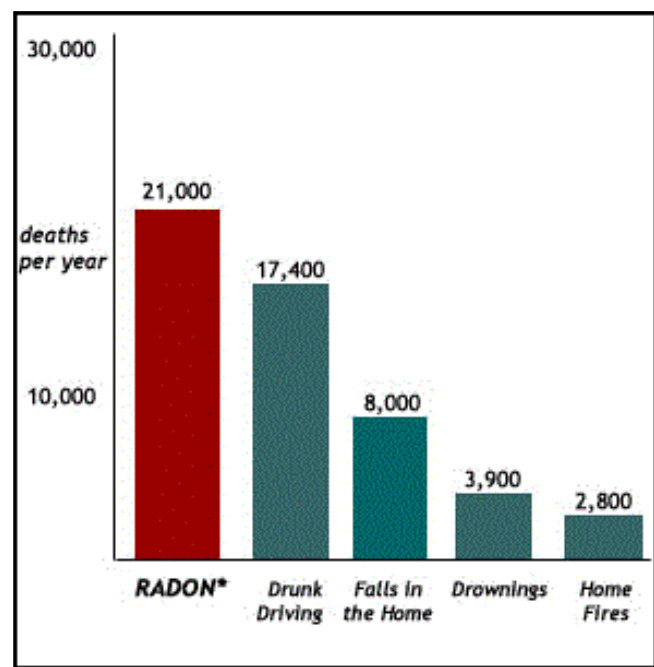
9.5 Item 1(Picture)

🔍 You should strongly consider testing this building for radon. Since 2011 radon mitigation systems have been a building code required in many counties around Oregon.
